IV-2. Some Early Reinforced Brickwork Masterpieces Revisited

D. Bernstein

ABSTRACT

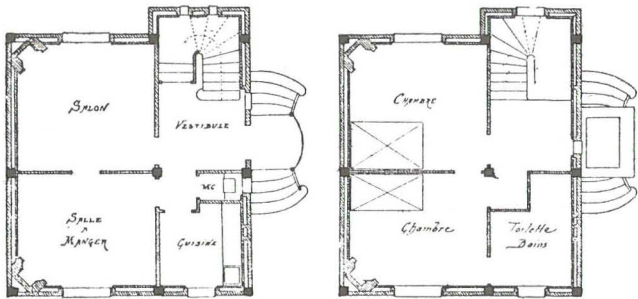
Figure 6.

Three houses built at Antony, near Paris, in 1893 are the first of Baudot's in reinforced brick. Floors and roof are in reinforced mortar. Figure 6 indicates the positions of the 9 inch square reinforced brick columns. (220 × 220 mm) spaced at 8 to 16 feet intervals (2,50 to 5,00 m).

The external leaf is reinforced brick the internal is in plaster (figure 4). The state of the two houses constructed according to the plan in figure 6 is excellent. The third, which is bigger and slightly more exposed, has suffered quite a lot of damage externally. The lack of maintenance in recent times has been the cause of an acceleration in the process.

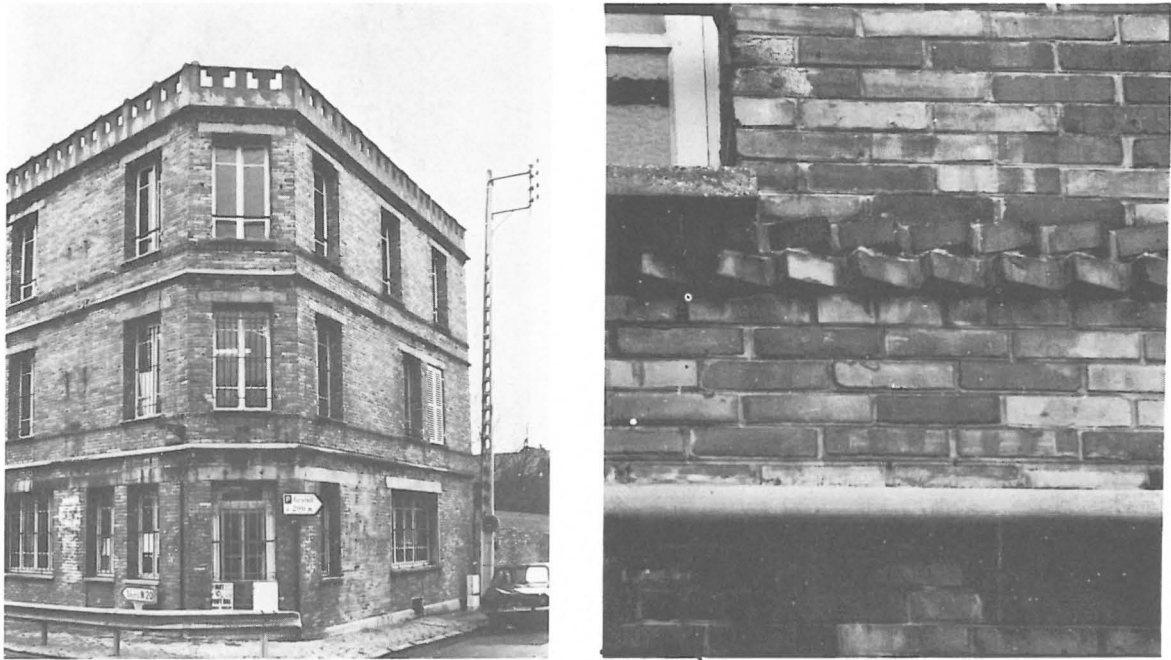
Figure 7.

The main reason for this failure is, doubtlessly, the great number of salient mouldings and strings (figure 7) which are not watertight and permit therefore the ingress of water through their upper horizontal surfaces. The roof is flat and the parapet affords little protection even though

1. The advantages in relation to the integrity of structure and the prevention of cracks (especially in stackbond) are confirmed by the 70 to 80 years old structures.
2. One must avoid water penetration through horizontal surfaces. It is therefore essential to provide good flashings at window cills, parapets, etc.
3. One should avoid external fixings into the brick.
4. Bricks with low porosity afford good protection to reinforcement but need a richer grout. (We tested some of the original bricks according to NF P13-305, French standard)
5. If these, and other principles of good practice, are observed it may be possible to use non-galvanised reinforcement not only in the vertical perforations but also in the horizontal joints provided a cover of 2 inch (50 mm) is maintained externally.

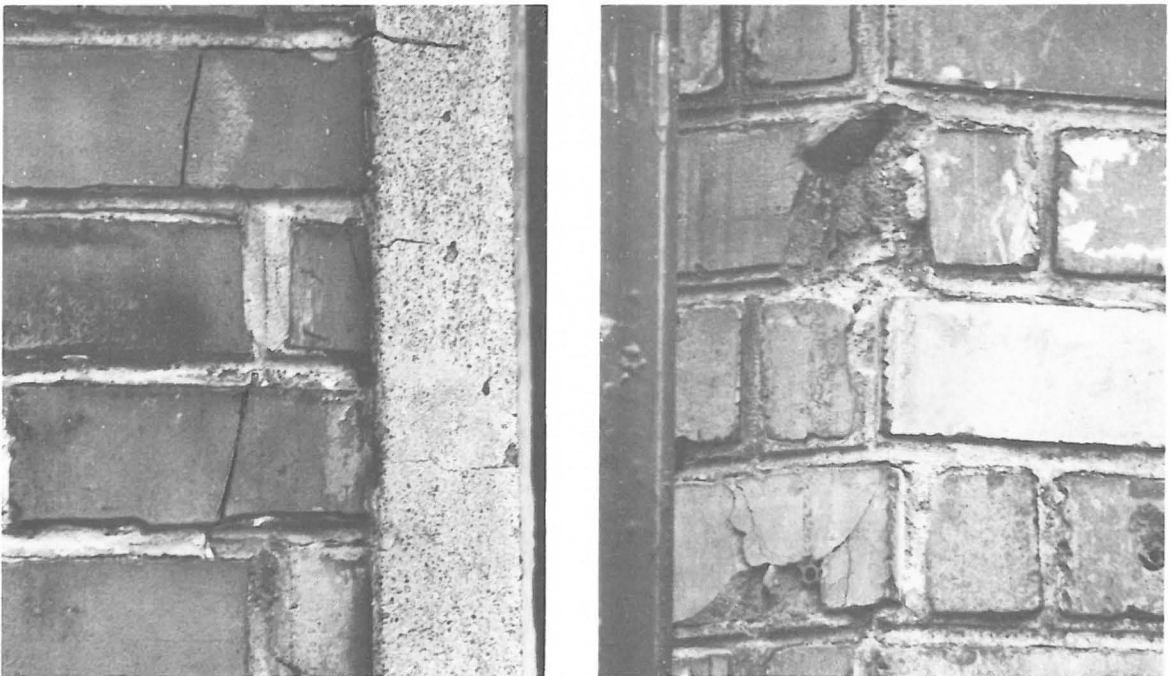
Figure 8.

rendered. Cracks due to the corrosion of the wire combine with frost action and big pieces of brick are expelled eventually, exposing grout and reinforcement (figure 8). Other secondary phenomena have been noted: the damage caused by external fixings, and the deposition of quantities of carbonate and sulphate of calcium, darkened by soot, originating probably in the cement (we are in the course of testing this hypothesis).

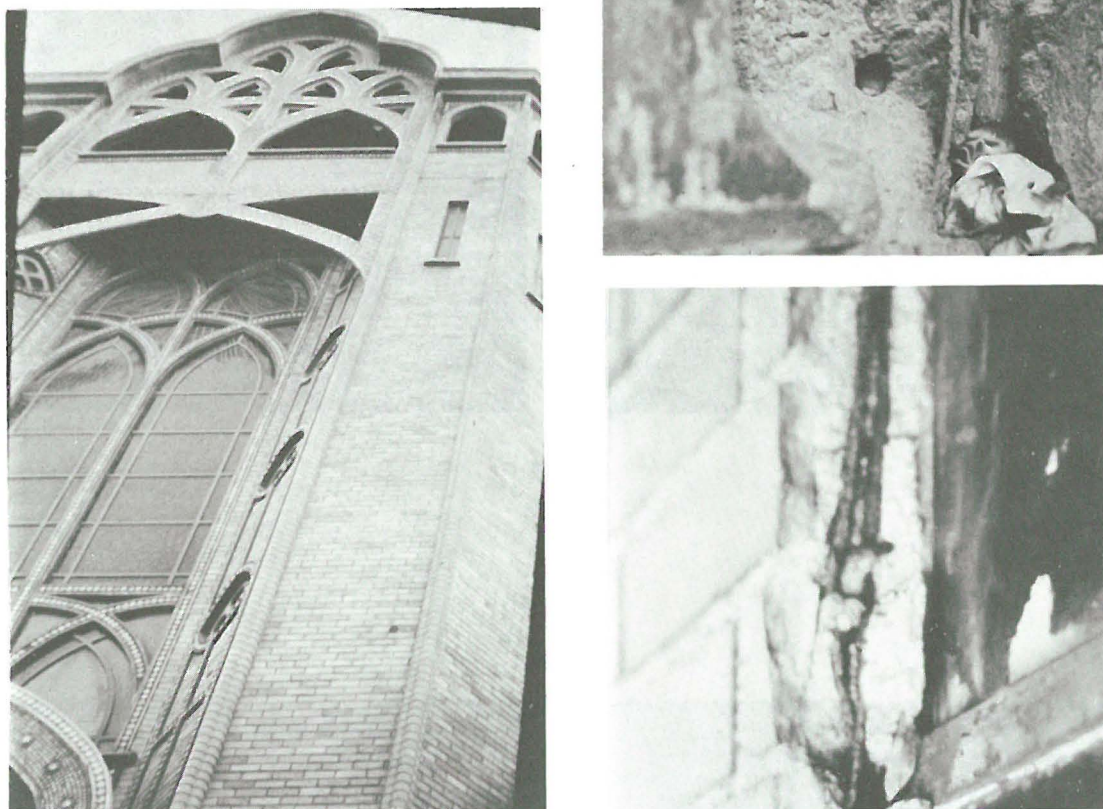
Figure 9.

We have noted similar failures on the belfry of St. Jean de Montmartre (1894–1905), which is in an extremely exposed, and polluted, position (figure 9).
