SESSION VI, Papers 1–9

VI-1. The Larson Waterproofing System for Brick Walls: Its Performance in Newfoundland

J.I. Davison

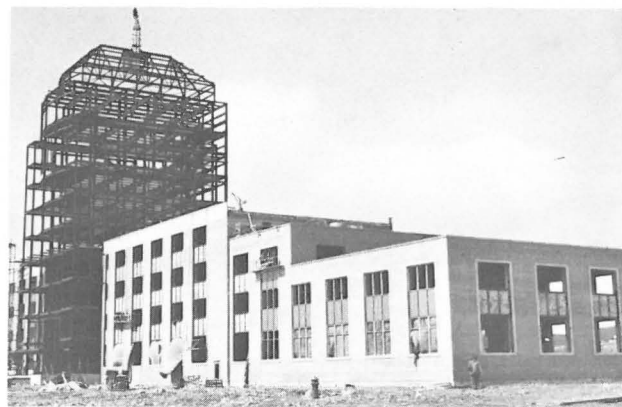
Figure 3. 1959 Confederation Building

A visit during construction in 1959 (Figure 3) revealed a wall system consisting of an interior wythe of 8-in. (203 mm) concrete blocks with an exterior wythe of 4-in. (102 mm) extruded buff clay bricks, the latter manufactured in the area and known to have a good performance record. The wall was laid up with a cement-lime mortar containing a waterproofing additive. The wythes were tied with a row of header bricks every sixth course.

After a rain storm during the visit some dampness appeared along header courses under several windows on the northeast exposure of the building. A year later some efflorescence was noted in this same area. Visits in subsequent years revealed some leakage related to (1) metal windows and (2) the mortar joint under a stone belt course near the top of the building, but there was no evidence of any leakage through the masonry walls. The same isolated areas of efflorescence, becoming more obvious, were noted during these later visits.

A more extensive examination was made in 1977, after the building had been in service for almost eighteen years. The isolated efflorescence areas under a few windows were more pronounced and there was some mortar breakdown in these areas, but there were no wall-related leakage problems and the walls had not been touched since their completion in 1959. The efflorescence problems were attributed to the absence of flashing under the window sills which enabled water to enter the wall through empty still joints from which the mortar had disappeared early on without ever being replaced. These observations were confirmed by the report of a consultant who had recently examined the building prior to planning an extension. He had not found any rain penetration of the masonry walls.

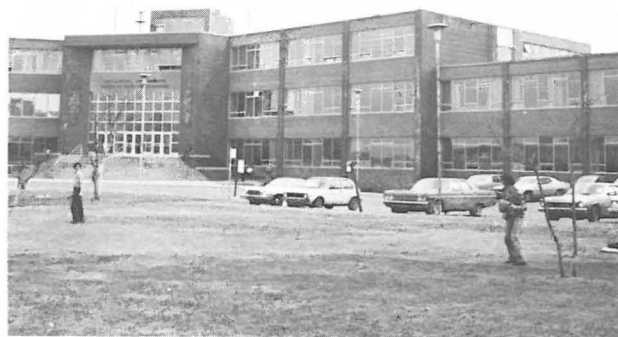
This building (Figure 4) was under construction in 1961. The same wall system was used, with the membrane being installed by the Brisk Company, but other construction personnel had changed. The exterior wythe of the walls contained plum and buff colored dry-press bricks which were prone to efflorescence, early evidenced by a pronounced "bloom" on the darker plum brick during construction. An improved metal window was being used but there was no flashing under the concrete window sills.

During succeeding visits there were always heavy efflorescence deposits on the walls. Efflorescence appeared not only at header courses and under windows, but also covered large wall areas. It was particularly severe under windows on south and east walls, and mortar joints in some of these areas disintegrated rapidly at an early age. In later years there was evidence of isolated repointing, but the severe efflorescence and the progressive deterioration of mortar joints continued.

Figure 4. 1977 Newfoundland and Labrador College of Trades and Technology—Front of building—Efflorescence

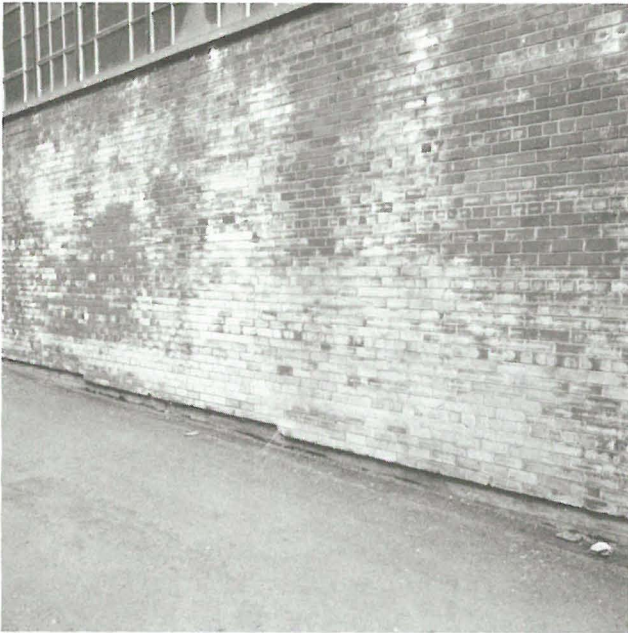
When, at the request of College authorities, the building was examined in 1977 the walls were badly disfigured with efflorescence (Figure 5) and there was serious deterioration of mortar joints in many areas, particularly on the east wall. The mortar on the west wall remained in reasonably good condition, but there was also a lot of efflorescence on this wall. A few instances of brick spalling were noted, but this was a minor problem compared with the mortar deterioration. The deterioration under some windows (Figure 6) was particularly serious, the result of water entering the wall via open sill joints. There was also a serious problem in the wall of a cantilevered section of the second storey resulting from deflection of the steel supporting member which opened the mortar joints to rain penetration.

A number of factors contributed to the deterioration in the exterior wythe of this building including (1) the brick, (2) some relaxing of the supervision and procedures during construction and (3) absence of a maintenance program. The dry-press brick appears to have acted like a sponge, soaking up water during rainy weather, releasing it slowly and keeping the mortar wet and vulnerable to deterioration under the influence of freeze-thaw action.

Figure 5. 1977
Newfoundland and Labrador College of Trades and
Technology—Severe efflorescence

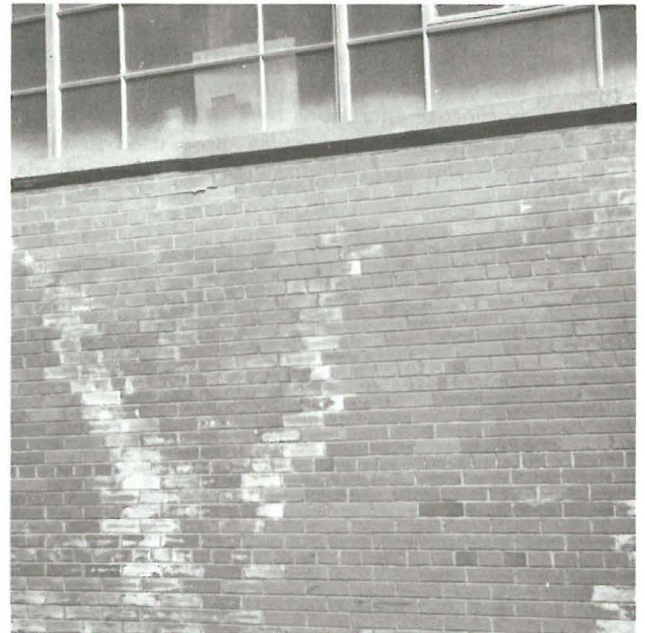
The deterioration and/or absence of mortar in many wall areas would be expected to cause rain penetration but there was no evidence of leakage to the interior in any of these wall areas—the membrane had done its job. There were several isolated leakage problems. One was traced to a penthouse with cavity walls and no base flashing. Water penetrating the wall found a path into the building through the roof membrane. Another leak at a roof-line level may have been due to a break in the seal between the wall membrane and the roof flashing.

Figure 6. 1977
Newfoundland and Labrador College of Trades and
Technology—Deterioration under windows
