## **Brick Cladding Distress in Reinforced Concrete Structures: Four Case Studies**

### Abstract

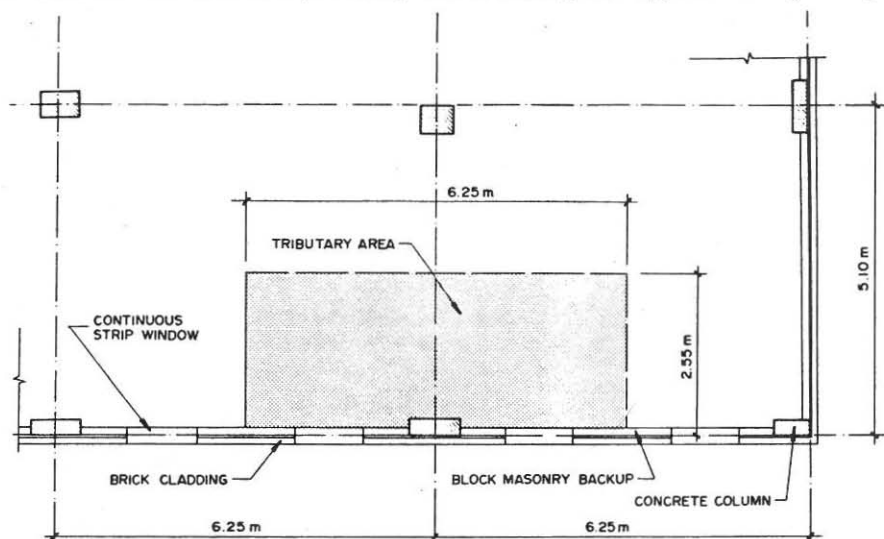
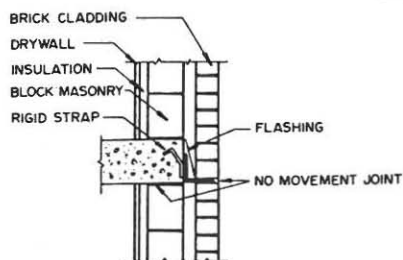
Fig. 1 Case Study 1 Floor Plan and Cladding Detail

The cladding distress in this case consisted of severe vertical cracking in the lower storeys, especially at corners of the building, and of spalling of some of the cladding units between the second and third floor levels. At the time of the distress problem, the building was approximately two years old.

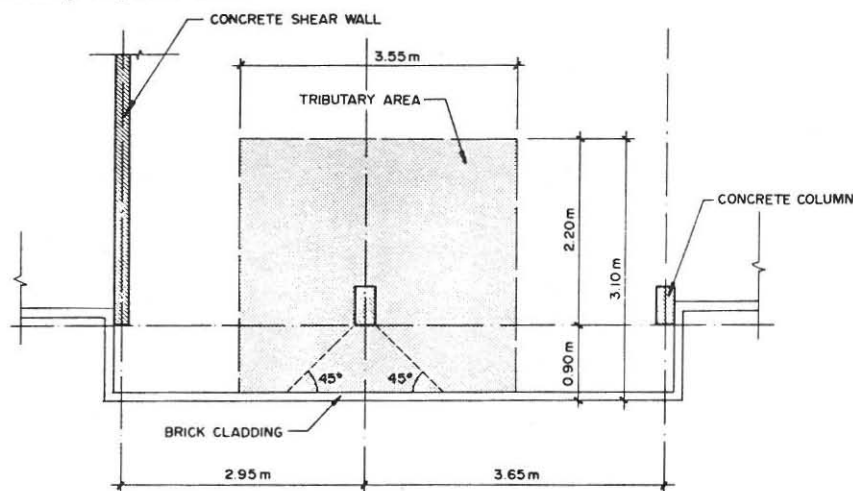
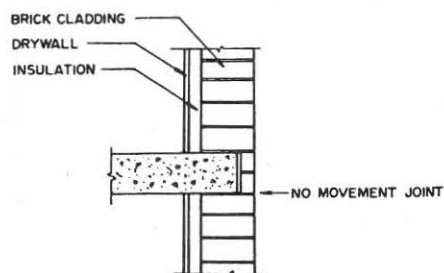
Fig. 2 Case Study 2 Floor Plan and Cladding Detail

Case Study 2 refers to a nineteen storey apartment building of reinforced concrete flat plate and column construction with concrete shear walls designed to resist lateral forces. The cladding consists of 150 mm clay brick which rests directly on each concrete floor slab. A smaller 50 mm wide brick is used to continue the cladding at columns and at the front edge of each slab. Fig. 2 shows a typical section of the floor plan which was investigated and the cladding support detail. Note, that the concrete columns are typically set back by about 0.9 m from the building's outer surface. For the purpose of analysis it was assumed that deformations of the concrete columns affect only that part of the concrete slab which is bounded by a triangle forming  $45^\circ$  angles as indicated in Fig. 2. Hence only the cladding for this part of the slab is considered. Material properties and other building particulars are included in Table 1. The distress was noted as vertical cracking between the second and third floor especially at the south-east and north-west corners, and at the west elevation. Some diagonal cracks and some spalling or crushing of mortar joints at the second floor level was also reported. At the time of the distress the building was approximately 2 years old.

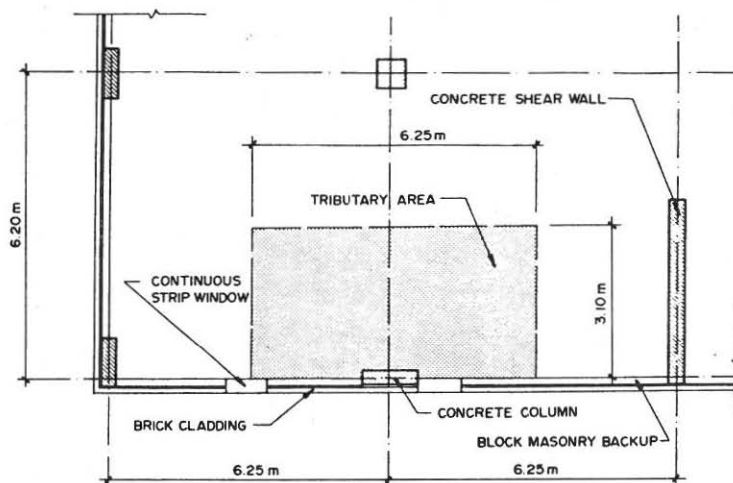
Fig. 3 Case Study 3 Floor Plan and Cladding Detail

The distress of the cladding was reported as vertical cracking at the corners of the building and near some window openings at the west elevation. Crushing of the cladding was noted at its outer face above the shelf angles and at its inner face below the shelf angles at many levels. Spalling of some bricks at the north-east and south-west corners was also observed. At the time of distress the building was approximately 1.5 years old.

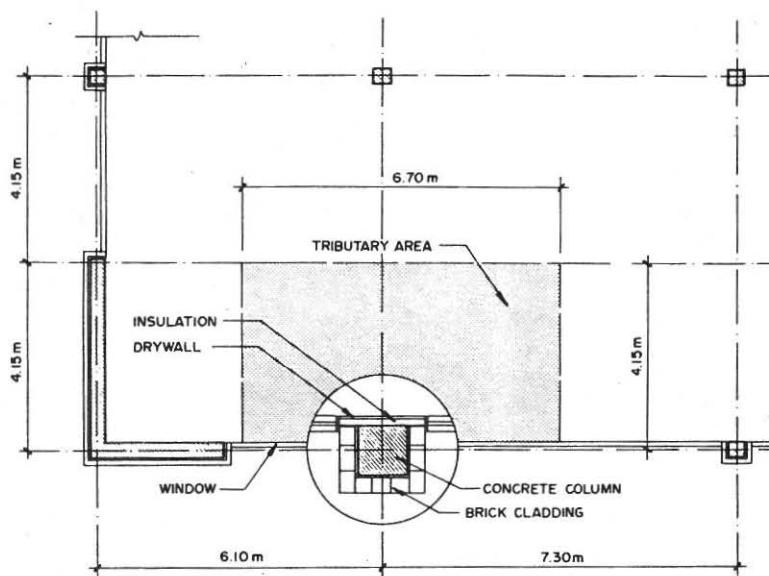
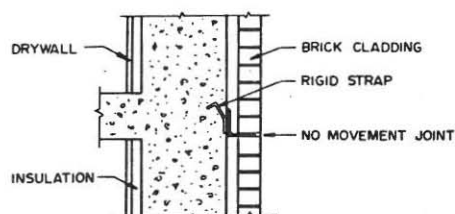
Fig. 4 Case Study 4 Floor Plan and Cladding Detail

Case Study 4 involves an eight storey office building of reinforced concrete flat plate and column construction with concrete shear walls at corners designed to resist lateral forces. The building's cladding consists of 100 mm clay brick supported on shelf angles at each storey. The 38 mm rigid insulation is placed at the inside surface of the concrete columns or shear walls. Fig. 4 shows a typical section of the floor plan and the shelf angle support detail. Material properties and other building particulars are summarized in Table 1. The cladding distress consisted of vertical cracking in the first storey at the corners of some columns at the south elevation. Some cracks at the upper storeys near the corners of the west elevation were also noted. At the time of the distress the building was approximately 1 year old.

The shelf angle connection detail has a significant effect on the possible stress transfer to the cladding. There are basically two methods of fastening shelf angles to concrete slabs. One is by using metal straps embedded in the concrete slab and welded to the shelf angle as seen in Figs. 1, 3 and 4. This method constitutes a fixed connection which is undesirable because it may lead to large variations both in thickness of a horizontal movement joint and width of seating of the brick on the shelf angle. The second method employs a bolted connection between shelf angle and a cast-in-place insert; it allows for adjustment of the shelf angle as the cladding is being constructed and hence is recommended.

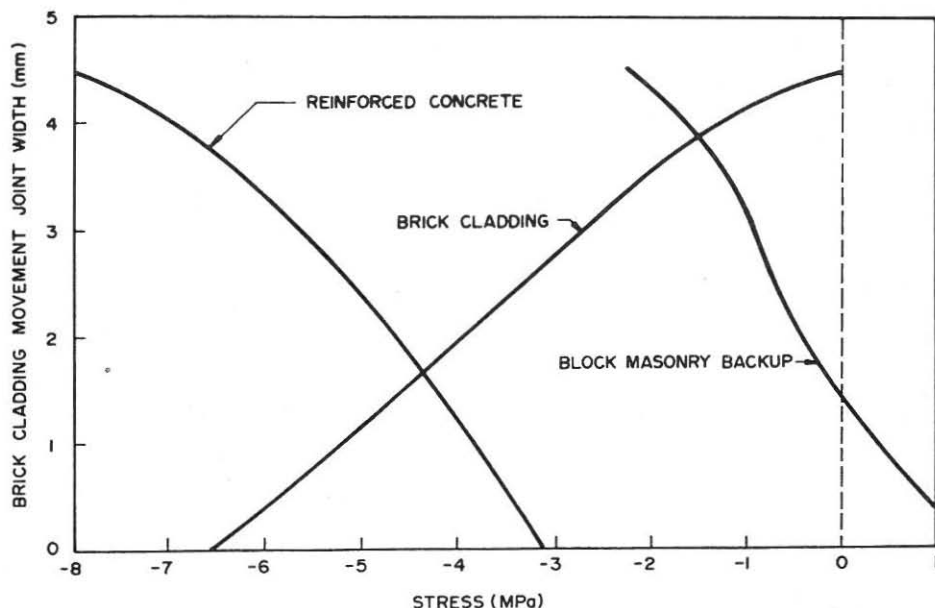
Fig. 5 Case Study 1 Stresses Versus Movement Joint Width at First Storey for 20 years and 100% Support Stiffness

Typical stress results from the computer program for case study 1 are listed in Table 3 and illustrated in Fig. 5. It is seen that as the movement joint width in the brick cladding decreases, more and more compressive loading is shifted from the reinforced concrete columns and the block backup (known to be built tight to the underside of the slab) to the brick cladding.

In summary it can be stated that although the differential deformations can lead to overstressing, they could not by themselves cause the cracking and failure of the cladding observed on the four structures.
