SOME VICTORIAN EXAMPLES OF  
STRUCTURAL BRICK MASONRY

DAVID BEAUCHAMP

ABSTRACT:

A number of examples of the use of diaphragm walls and reinforced brickwork and the construction problems experienced during the building of these projects are given in this paper.

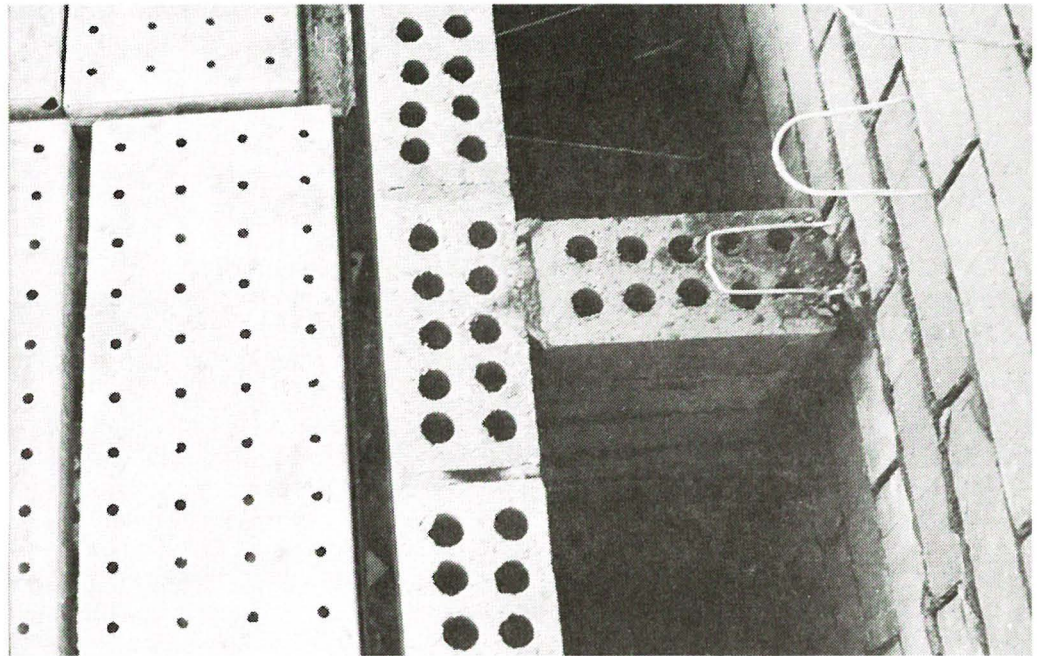
At Bonegilla we were not responsible for the supervision and despite a tightly written specification the initial brickwork was not built as specified. No pre-construction testing was carried out to resolve problems with the brickwork and when the site was visited after construction had started a number of faults were discovered.

1. Wire cut bricks were being used instead of solid pressed bricks.
2. Perpendis were not adequately filled.
3. The mortar joint between the diaphragm bricks and the face bricks not properly filled.
4. Wrong ties being used in the diaphragm walls.

Figure 7. Diaphragm Wall with incorrect ties and perpend not filled.

Work on the brickwork was stopped and a series of tests were carried out by the B.D.R.I.

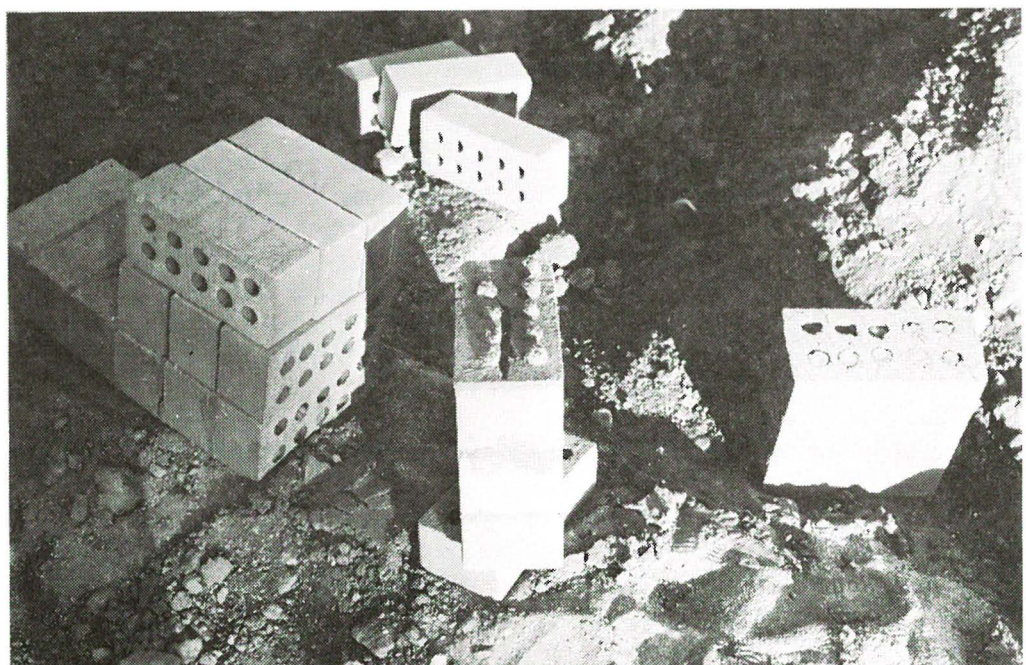
5. Shovel batching of mortar and additives used in the mortar.
6. When the first bond-beam was lifted to be tested it fell apart and the other bond beams tested failed at bond stresses of 0.1 and 0.13 MPa instead of the minimum specified of 0.28MPa.

Figure 8. Failed Bond Beam.

The failed bond beams were tested using the B.D.R.I. bond wrench, different mortar mixes were made using the various sands available at Bonegilla and a test was devised to check the effect of not having the joint between the diaphragm bricks and the outer skin completely filled. Tests were also done to evaluate the effect of ties on the strength of the joint.

Tests on the mortar sand resulted in changes to the type of sand used in the mortar and the bond beams tested on site once the job re-commenced gave strengths in excess of 0.4 MPa.
