RISING DAMP AND SALT ATTACK IN OLD MASONRY BUILDINGS

J L HEIMAN Principal Research Engineer
Experimental Building Station, Department of Housing and Construction,
North Ryde, NSW, Australia.

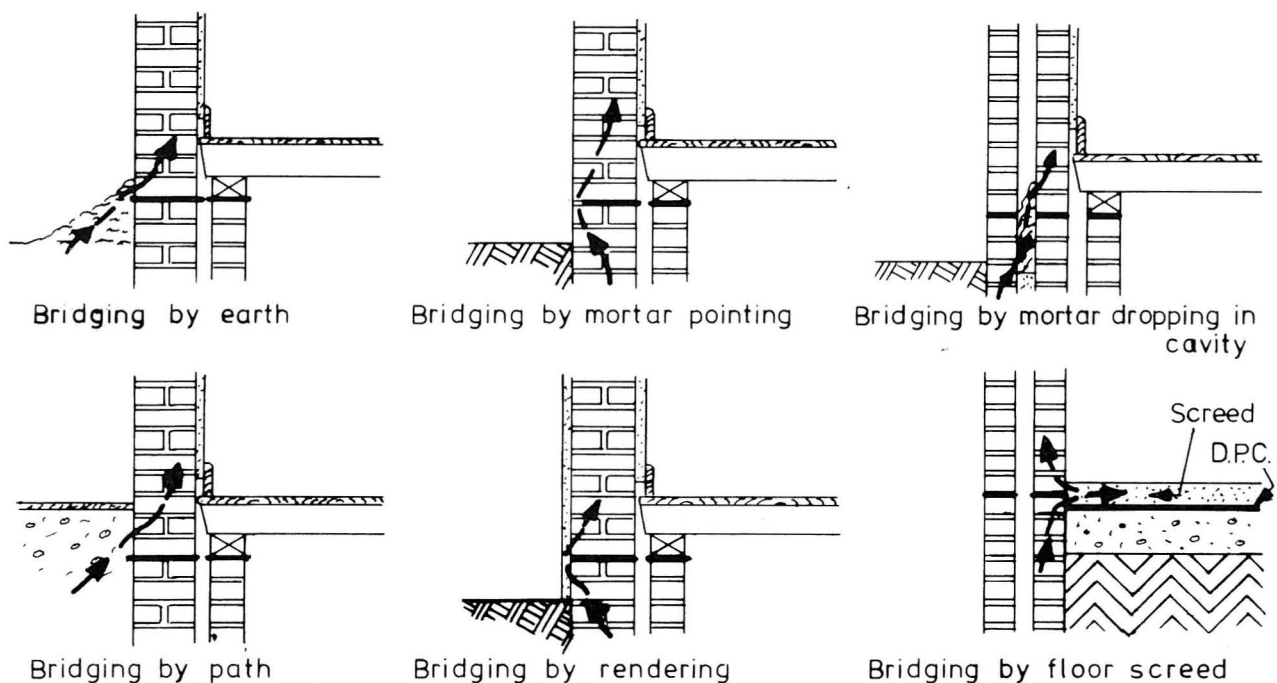
FIG. 1 BRIDGING OF DAMP-PROOF COURSE.
(From B.R.S. Digest 27.)

Rising damp problems can be caused by the bridging of the damp-proof course which allows water to rise up the wall above the level of the membrane. This can sometimes be rectified without much difficulty or expense.

As shown in Fig. 1 some common sources of bridging action are

- (a) the heaping of soil or debris against the wall.
- (b) the location of a concrete path or floor slab directly against the wall.
- (c) the building up of mortar droppings or other debris inside the cavity.
- (d) failure to extend the damp-proof course a sufficient distance across the wall so that moisture can travel up the wall through the render or mortar pointing.
- (e) perforation of the damp-proof course by building operations and subsequent bridging.

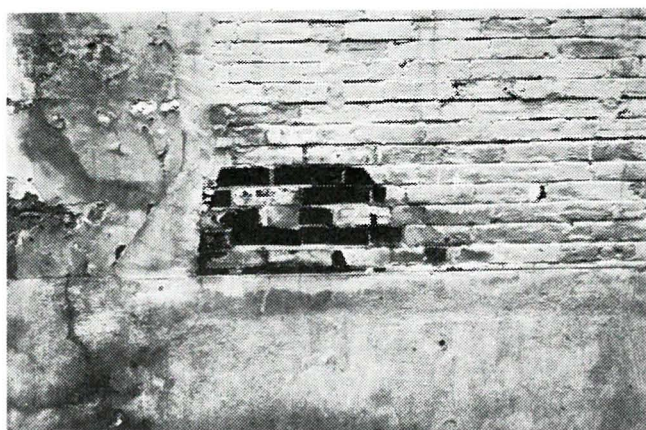
5.4.1 Coatings. The application of impervious surface coatings on walls where there is rising damp might not provide a permanent and effective solution to the problem. Often it will result in an increase in the height of the capillary rise of the moisture or it can result in the dampness appearing on parts of the walls which were previously unaffected, Fig. 2. There is also the possibility of failure because of a loss of adhesion of the coating caused by disruptive forces associated with salt deposition close to the interface between the coating and the masonry.

Fig. 2 Cement Render Diverted
Salt Attack Higher

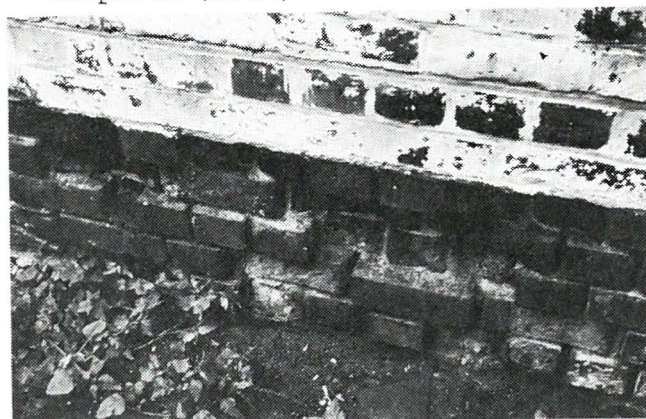
Salt attack problems are not confined to old buildings of sandstock bricks. They can occur also in modern construction where light-coloured, underfired

clay bricks are not sufficiently durable for the severity of the exposure. Such situations can occur when they are placed below damp-proof course level on highly saline soils or they are exposed to salt spray in coastal areas, Fig. 5.

Fig. 5 Salt Damp Attack
Below Damp-proof Course

If replacement becomes necessary or new work is being undertaken in salty environments, a well-fired brick (above 1100°C) with a low permeability and a good resistance to salt attack should be used. The water absorption and sulphate tests given in AS 1226 can be helpful in the selection of a durable brick. For example an extruded brick that has a cold water absorption less than 6 per cent and survives 40 cycles of immersion in the sodium sulphate solution is likely to have a good resistance to salt attack.

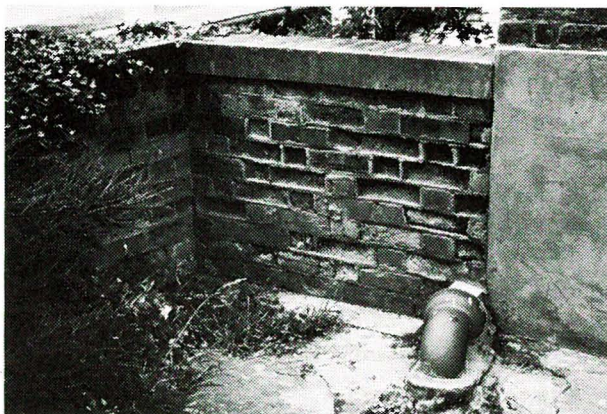
Although in some situations portland cement can contribute to the durability of masonry mortar it also has disadvantages. Cement-rich mortars have a tendency to develop shrinkage cracks which permit moisture to enter the fabric and at the same time their low permeability makes it difficult for the moisture to escape. If the masonry is already contaminated with soluble salts, low permeability joints encourage salt deposition in the adjoining masonry where fretting can occur, Fig. 6. Lime mortar or weak composition mortars (1:2:9 or 1:3:12) are preferable where their higher permeability will encourage migration of the salts into the joints. The joints will deteriorate but it is easier to repair decayed joints than decayed masonry. Lime-rich mortars are also more flexible than strong cement mixes and are better able to accommodate cyclic stresses that occur in external masonry as a result of frequent changes in the temperature and moisture content of the masonry.

Fig. 6 Cement mortar contributed to sandstock decay

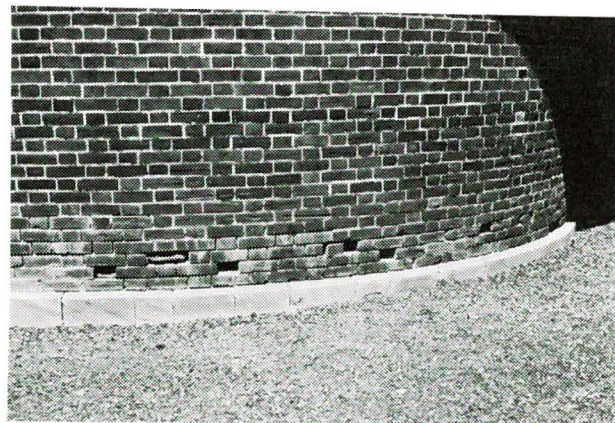
solid walls (370 to 1040 mm) and the presence in places of a rubble core, it was not feasible to insert a damp-proof course to overcome the rising damp problem. The church was built in 1820 with walls of sandstock bricks without damp-proof courses and salt attack associated with the rising damp has caused fretting of the external brickwork and damage to the internal plaster. In 1965 many of the decayed external bricks were replaced with sound sandstocks taken from another historic site but when the building was examined by EBS 7 years later, a number of the replaced bricks and some of the mortar showed severe decay, Fig. 8. In places the brick fretting had resulted in voids 40 mm deep. The rate of decay had been accelerated by the replacement of the original timber floor by a concrete slab which diverted additional sub-floor moisture into the walls.

Tests carried out by the CSIRO showed that the firing temperature of the bricks had been between 800°C and 900°C and the 24 hour cold water absorption was around 20 per cent. These factors would contribute to the poor resistance of the bricks to salt attack and their vulnerability to the disruptive forces associated with crystallisation and hydration.

Salt analyses of drillings taken from the damaged walls showed the presence of chlorides, sulphates and carbonates. The predominant salts were chlorides with a maximum concentration of 0.5 per cent.

Fig. 8 Fretting Brickwork
St Mathews Church.

It was decided as an interim protective measure to apply a sacrificial render over the damaged external brickwork to a height of about 1 m to draw the salts out of the walls and also to protect the brickwork against continued decay. A mixture of 1 part of slaked rock lime and 3 parts of sand was applied to the external walls to give a coating thickness of 20 mm. Internally the defective plaster was replaced with the same mix. A smooth internal finish was obtained by then applying a thin coat of 3 parts of lime to 1 part of sand followed by two coats of acrylic paint.

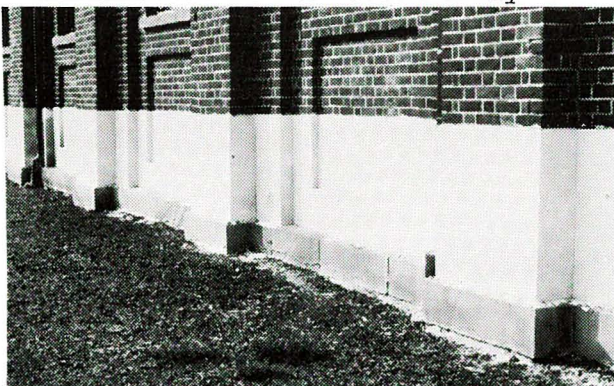
Periodic inspections have been made of the repairs since they were completed and after 4 years the internal surfaces are still in good condition. Externally there has been some localised decay of the render by salt attack which is in keeping with its sacrificial role and indicates that a transfer of salts is taking place, and the brickwork is being protected, Fig. 9. A sacrificial render was also applied to parts of the walls of the adjacent rectory (which is of similar construction to the church) with similar results.

Fig. 9 Sacrificial Render after 4 years service

It will be necessary to maintain the sacrificial render until a permanent solution is found for the rising damp problems but so far this has not proved onerous.

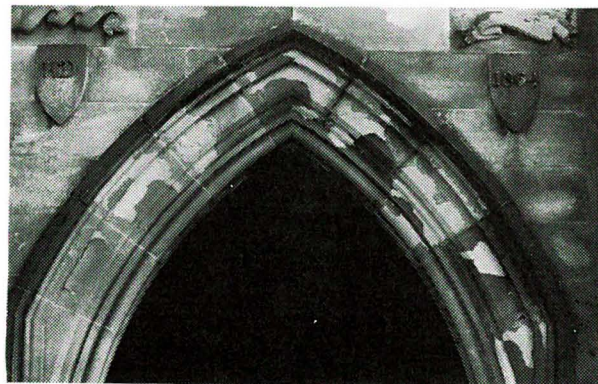
The use of water repellents or consolidants to protect masonry against moisture penetration and salt attack should be considered with caution(5). In some instances they accelerate decay. Moisture might penetrate through the coating or enter the fabric through an untreated part of the building. Salt deposition and crystallisation can then occur near or at the interface between the treated and untreated zones and increased spalling or exfoliation follows. (An example is shown in Fig. 10 where a silicone coating was applied on the facade of an old sandstone building contaminated by salts). It might therefore be necessary to carry out a desalination treatment before these materials can be used. Laboratory and field trials on some protective treatments have shown

Fig. 10 Silicone caused accelerated exfoliation
