PERFORMANCE OF BRICK MASONRY VENEERS

A.A. Hamid

I.J. Becica

H.G. Harris

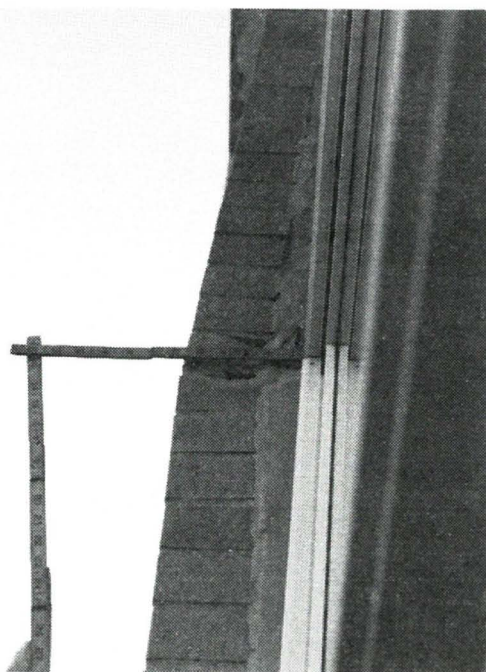
Fig. 3 Lateral Displacement at Shelf Angle

Distress in the structure consisted of bowing of the masonry veneer at the shelf angle locations and spalling of the first two courses either above and/or below the bearing location of the shelf angle. Ninety percent of the spalling failures noted and 100 percent of the bowing failures occurred on the southeast elevation of the building. In the northern hemisphere this fact coincides with the greatest wall panel temperature gain. Because of the apparent sporadic nature of the veneer failures, a detailed analysis was called for to determine the cause of distress.

studied using documents provided by the building Owner. It became necessary to sample the brickwork in question to determine accurately masonry properties and to verify as-built conditions. A typical wall sample was selected and a diamond saw used to cut masonry prisms and individual brick specimens. Findings of the wall investigation indicated poor workmanship. The minimal number of weep holes were found and the cavity between backup masonry and veneer was not kept clean of mortar, therefore rendering the secondary drainage system consisting of flashing and weep holes inoperative. The caulk joint used to seal the offset brick panels was found to be severely cracked due to either non maintenance or improper installation. The shelf angle was bolted rigidly to the spandrel slab with only a slotted hole used for adjustment. Brickwork was found to be bearing on both the underside and topside of the relieving angle. An insufficient number of masonry wall ties were located. Wall ties consisted of 5mm diameter crimped "Z" type galvanized wire ties in combination with dovetail corrugated metal ties at reinforced concrete column locations. Of the wall ties located, forty percent were yielded in the vicinity of the shelf angle. In the test panel selected, a lateral deflection of approximately 50mm was indicated as shown in Fig. 3.

Assuming the mason contractor laid up brick to the underside of the relieving angle, and because there was no adjustment provided in the relieving angle installation, a gap between the last course beneath the angle and the angle must have existed. Under the influence of the forces described above, this gap would close causing uplift forces to be exerted on the story height above the relieving angle. Under this loading condition, which is essentially an eccentric load occurring well outside the kern of the panel, a net rotation at the relieving angle in the clockwise direction is produced. It is believed that this rotation occurred prior to brickwork spalling and is the cause of the lateral displacement.

The remedial action called for removing 15 courses of brick in the vicinity of the shelf angle at distress locations and reinstalling new brick with the proper expansion joint detail. Addition of expansive wall ties was specified with new flashings and weepholes. The entire building was then waterproofed and re-caulked to minimize water penetration.

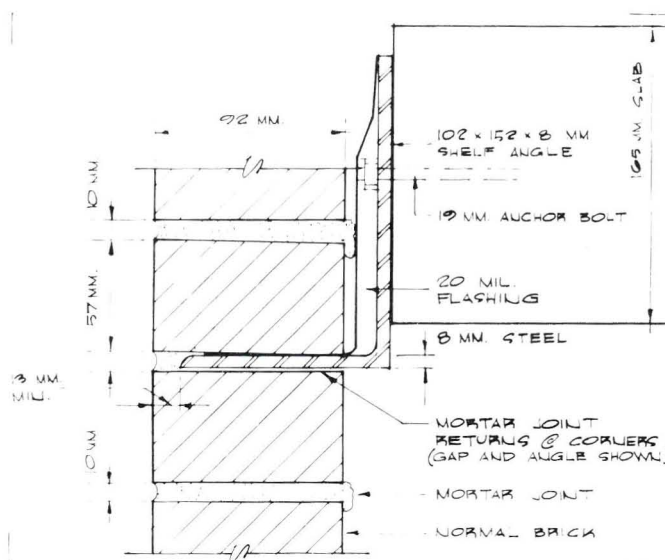
Fig. 4 As-Built Shelf Angle Detail

A closer examination of the construction detail at the shelf angle is shown in Fig. 4. The 13mm mortar joint indicated at the front of the relieving angle represents a point of support for the brickwork panel above. The applied load on this mortar joint is one-half the total load of the brickwork which is approximately 52 N/mm². This represents a stress of 2.1 times the ultimate masonry strength and is sufficient to cause local spalling.

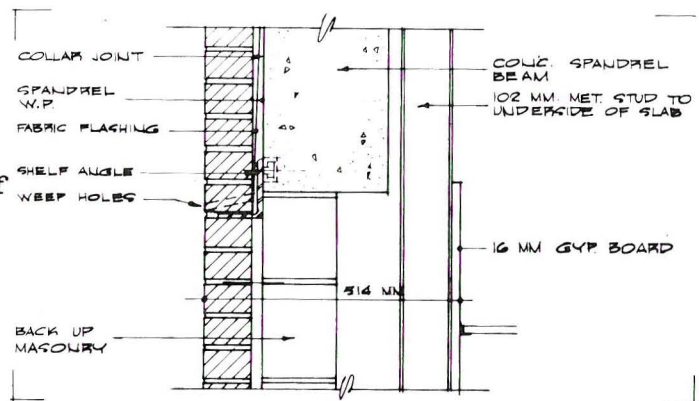
Fig. 5 Typical Wall Section

Case Study No. 2 is a five story reinforced concrete flat slab structure. The exterior veneer is a composite block-brick masonry with a solid collar joint (Fig. 5). Despite the fact that the wall is solid, shelf angles, flashing and weep holes were provided (Fig. 5). The design requires that a plastic flashing material extend from the base of the back up block (top of floor slab) down to the shelf angle. This is a distance of approximately one meter. In order to protect the integrity of the flashing, the designers indicate that no metal ties be located in this area. The result is a one meter high section of wall which is not connected in any fashion to the back up material. This results in a section of wall which is extremely vulnerable to horizontal displacement due to freezing of the water behind the wall.

The analysis indicated that the cause of the problem is one of design. The design requires construction of a composite wall as opposed to a cavity wall. A composite wall has the space behind the brick and in front of the back-up block filled solidly with mortar. A cavity wall leaves a clean space between the back of the brick and the front of the block as in Case Study #1. A cavity wall permits water which penetrates the brick wall to fall freely through the cavity and collect at the shelf angle. The shelf angles are protected with non-corrosive flashing and the flashing directs the water to weep holes which permit the water to drain from the cavity. A composite wall assumes that water will not penetrate the brickwork. This often is an unreasonable assumption because wind driven rain can penetrate the wall through the mortar joints as well as the porous brick. The result of the utilization of the composite wall details is that the collar joint material becomes saturated and in winter freezes, forcing the brick to separate from the back-up block.

The inspection openings cut into the building at strategic locations also pointed up areas of construction deficiency. The omission of the brick ties which were required by the design (Fig. 5) were observed. Secondly, it was noted that some brick was cut excessively so that a thin veneer of face brick supports an entire story height. Also, areas were noted where the bolts which anchor the shelf angles to the main frame were spaced too far apart. Laboratory testing pointed out that the workmanship of the mortar was poor.

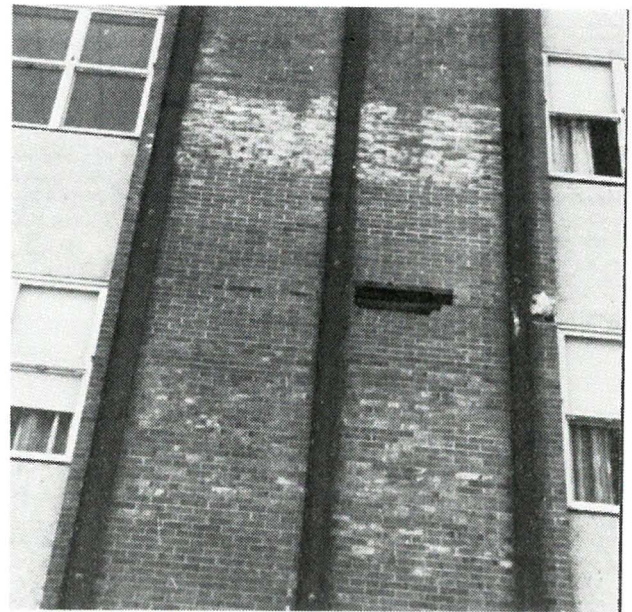
Fig. 6 Spalling of Brick Veneer

It was observed in the east wall of the south building that the bricks immediately above the shelf angle had spalled (Fig. 6) indicating high compressive stresses in the brick. The exterior wall construction is such that the water penetration normally associated with masonry is not handled properly. Adequate building envelope insulation was not provided which resulted in a dew point location with the wall. The problem manifested itself as large brick panels sliding off of their supporting angles with the potential of falling from the building. Structural steel channels were attached to the exterior wall for temporary support (see Fig. 6).

The recommended solution was a complete removal and replacement or covering of all veneers with an integrated synthetic stucco and insulating system. This material would solve the problems of veneer separation, inadequate insulation, water penetration, window leakage, dew point location and aesthetics.

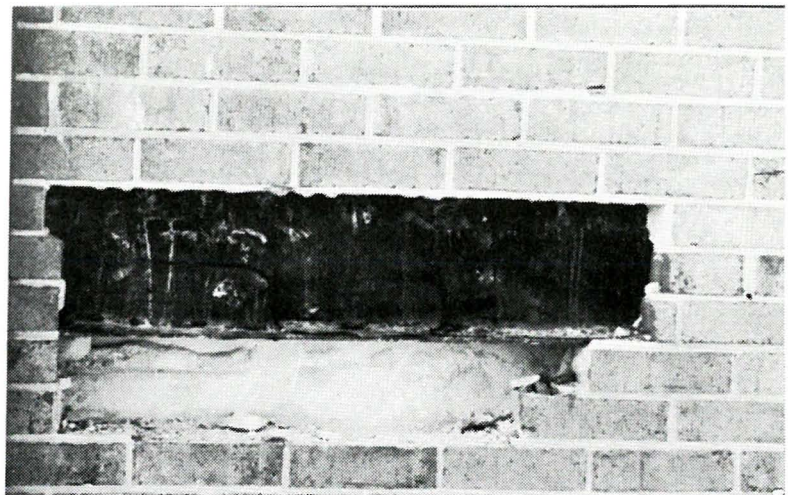
Fig. 7 Brick Veneer at Shelf Angle

The designer did not detail nor specify a compressible expansion material directly beneath each shelf angle (Fig. 7).

This compressible joint material is mandatory to accommodate the differential movements which occur between the brick facade and the reinforced concrete frame. The analysis revealed a total differential movement of 5.8mm per story. Elastic, creep, shrinkage, thermal and moisture deformations were considered. The absence of this material produces

very high compressive stresses within the brickwork, which combined with shearing force due to restraint of lateral movement, would lead to the failure in the brick which was observed. Also, the lack of proper sealant at the shelf angle leads to water penetration and corrosion of the shelf angle which causes the mortar at that point to disintegrate thereby permitting addi-

tional water to enter the wall. Freezing of this water causes additional deterioration.
