DETERIORATION OF HISTORIC BRICK MASONRY DUE TO COMBINED GYPSUM, ETTRINGITE AND THAUMASITE: A CASE STUDY

Tomas Wijffels¹, Timo G. Nijland²

Figure 1. Overview of Moerputten Bridge.

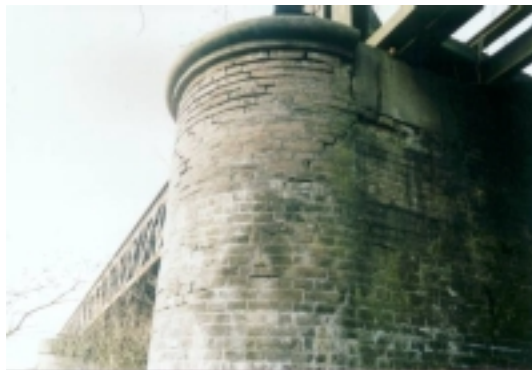
- White efflorescence, notably in the lower part of the piles; the efflorescence is probably due to washing out of mortar components (Fig. 2)
- Absence of pointing (Fig. 2)
- Absence of limestone cover plates and partial absence of masonry
- Development of algae, moss, and, locally higher plants
- Cracking through both brick and joints, up to several centimetres wide (Fig. 3-5), as well as internal cracking in the mortar, not visible from the outside (Fig. 4-5)
- Crumbling of mortar behind debonded pointing (Fig. 4)
- Debonding of brick and mortar

Figure 2. Absence of pointing below limestone plate and wash out (notably in the lower part of the picture).

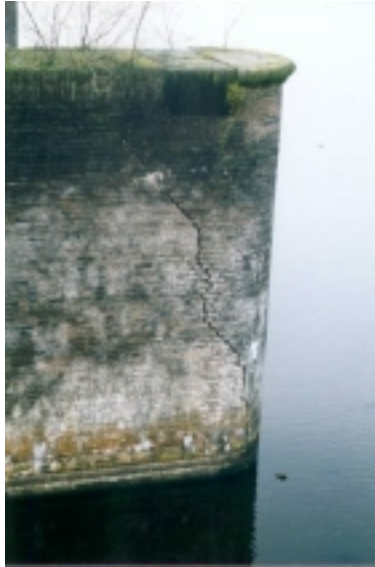
Figure 3. Example of cracking in one of the brick masonry piles.

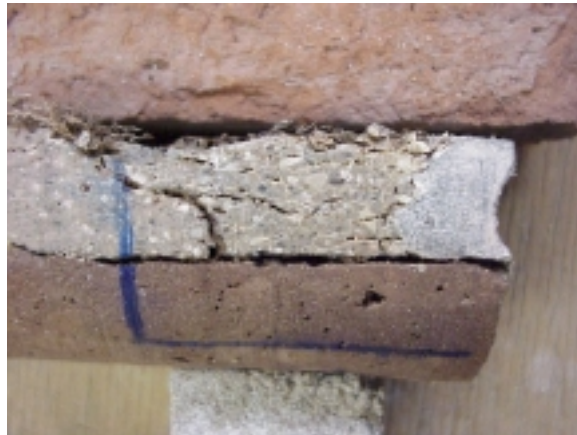
Figure 4. Cracking and crumbling of mortar behind the pointing in a core removed from the pile in fig. 3; cracking is not visible from the outside.

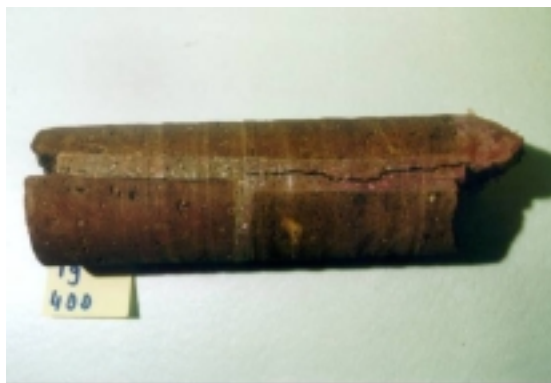
Figure 5. Cracking of mortar in a core removed from the pile in fig. 3; again, cracking is not visible from the outside.

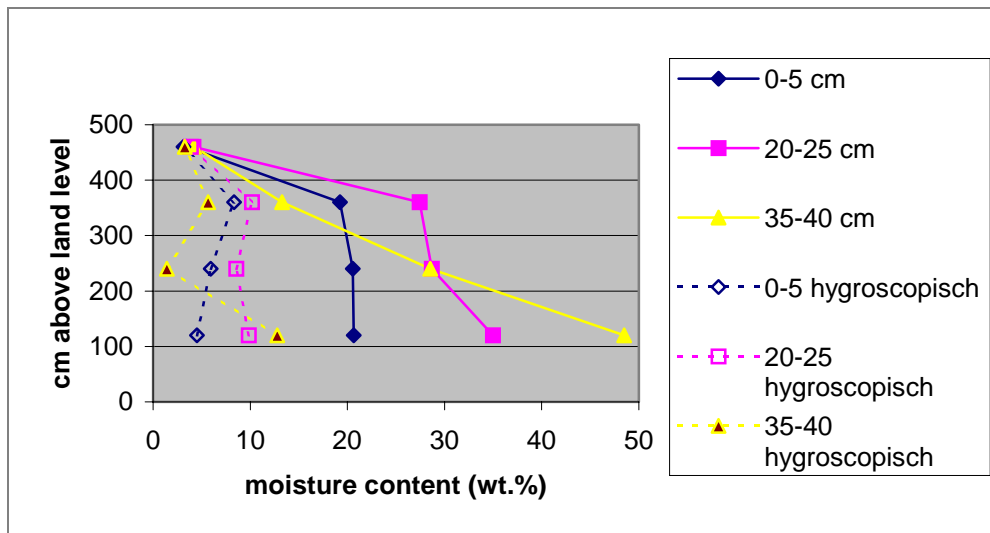
Determination of actual moisture contents, as well as hygroscopic moisture contents after equilibration at 95 RH show the masonry being very moist, with raising water from below and rain water from above being sources in the lower and upper parts of the piles (Fig. 6). Hygroscopic moisture contents are variable, for example 2 to 12 wt.% in the pile shown in fig. 3-5, indicating the presence of hygroscopic salts in the masonry,

Figure 6. Distribution of actual and hygroscopic moisture contents in one of the piles with depth in the masonry and centrimetres above land level.

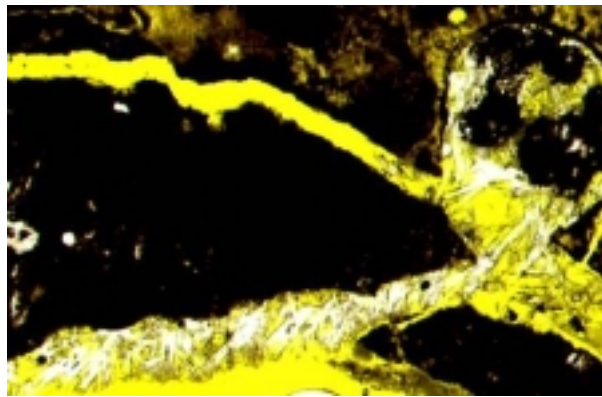
On a microscopic scale, both original mortar from a pile with visible cracking (Fig. 3-5) and from a pile without visible cracks, show cracking in the masonry mortar. In the sample from the pile with visible cracking, the cracks are (partially) filled by portlandite, gypsum, ettringite and thaumasite (Fig. 7-8). In the pointing, ettringite is present in some voids, but not causing any damage (Fig. 9). In the sample from the pile without visible cracking, microcracks and voids are filled with thaumasite (Fig. 10), whereas the interface between brick and mortar contains abundant calcite.

Figure 7. Microphotograph showing elongate gypsum crystals in a microcrack in the original masonry mortar from the pile in fig. 3. View 1.8 x 0.9 mm.

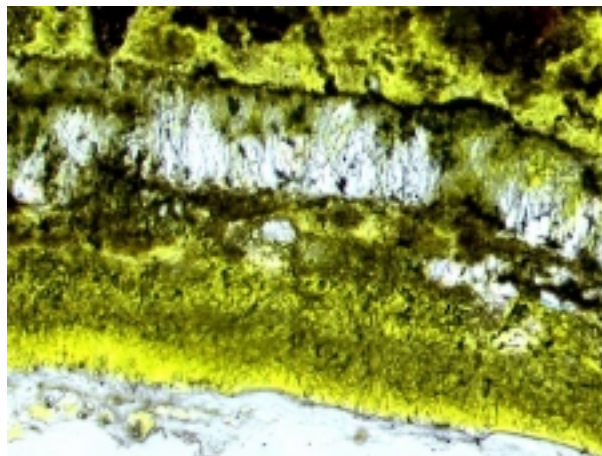
Figure 8. Microphotograph showing crack filled with (dominantly) ettringite in the original masonry mortar from the pile in fig. 3. View 0.7 x 0.45 mm.

The presence of ettringite in the mortar is more remarkable, as trass – lime mortars are free of portland clinker, and hence contain no C_3A . Another source of alumina

necessary for ettringite has not been identified, but most likely derives from the trass. Rhenish trass represents ground volcanic tuff from the German Eifel area added as pozzolana. Rhenish tuffs contain abundant zeolites, notably philipsite and chabazite, hydrated Ca-Al-silicates (Sersale and Aiello 1964; Nijland et al 2003), which may be the source for alumina in ettringite. Ettringite has, however, also been identified by optical and electron microscopy in historic mortars with hydraulic lime as a binder (Brocken and Nijland 2004) and the genesis of ettringite in lime mortars and role in degradation of masonry deserves further investigation (van Balen et al 2003).

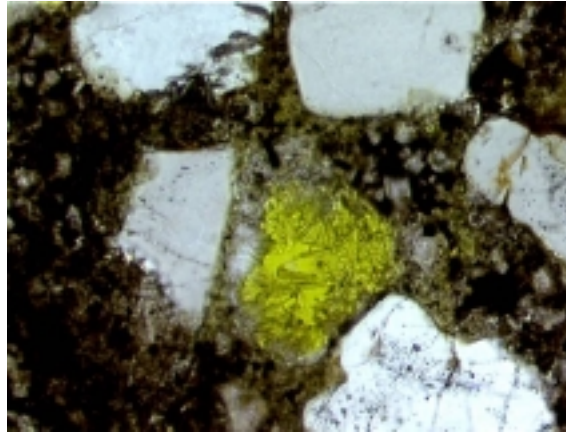
Figure 9. Microphotograph showing non-deleterious ettringite in a void in the new pointing in the sample from the pile in fig. 3. View 0.7 x 0.45 mm.

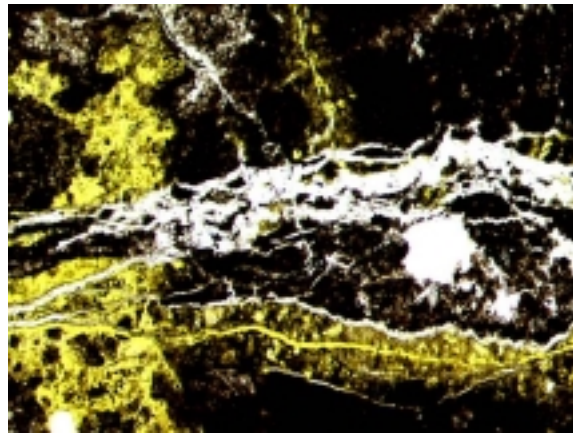
Figure 10. Microphotograph showing cracks and voids filled with thaumasite in the masonry mortar from a pile without externally visible cracking. View 1.4 x 0.9 mm.

Trass cements, i.e. mixtures ordinary Portland cement and trass, are known in several European countries, and have a long standing reputation of sulphate resistance (e.g. Dreyfus 1950; Biczök 1972). Trass – lime mortars in masonry also have a durable reputation. Nevertheless, microscopic investigation clearly demonstrated that cracking of the mortar and resulting deterioration of the masonry was caused by the formation of sulphate-bearing phases, viz. gypsum, ettringite and thaumasite, of which the latter is most important. As far as known, the combined occurrence of these minerals in trass – lime mortars has not previously been reported. The source of components for their formation is not in all cases evident. Applied bricks are (nowadays) low in water soluble sulphate, which may represent an original feature of the brick, or due to removal of the sulphate and transport to the mortar joint. In the former case, sulphate may be derived from external sources (either ground or river water or possibly air pollution, which contained much higher sulphate contents in the past), or, possibly, from the trass used. Gypsum has been identified as a component of quarry samples of tuff stored in open air (Nijland et al 2003). Both calcium and reactive silica, required for the formation of thaumasite, are present in a pozzolanic trass – lime mortar.
