## **DIAGNOSTIC INVESTIGATION ON THE HISTORICAL MASONRY STRUCTURES OF A CASTLE BY THE COMPLEMENTARY USE OF NON DESTRUCTIVE TECHNIQUES.**

**L. Binda <sup>1</sup>, L. Cantini <sup>1</sup>, F. Fernandes<sup>2</sup>, A. Saisi <sup>1</sup>, C. Tedeschi <sup>1</sup>, L. Zanzi <sup>1</sup>**

An on-site investigation was carried out on the Pisece Castle in order to compare different non destructive tests and to check their complementarity in the detection of unknown masonry features. Some typical problems solved by the authors with the combination of different techniques such as boroscopy, radar and sonic tests, flat-jack and others together with laboratory tests on sampled materials are presented.

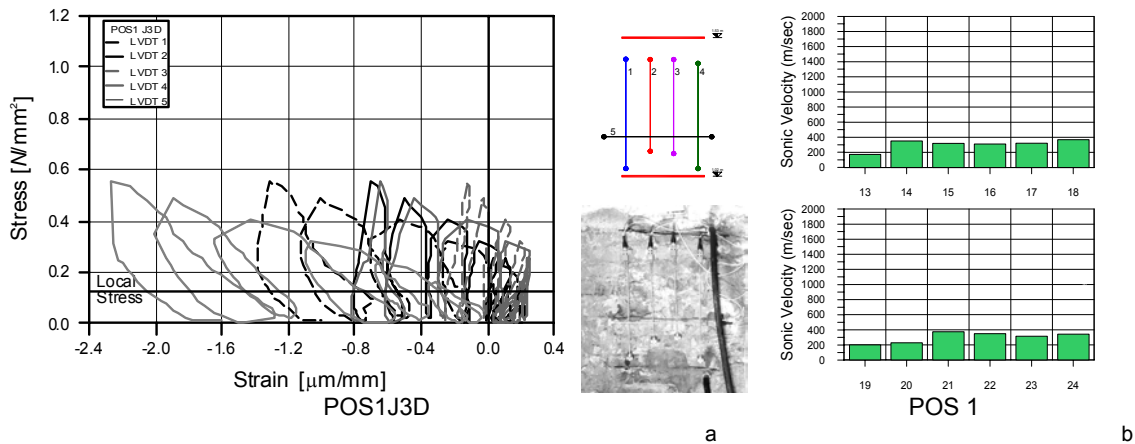
This was the case of the test carried out at the position called POS1J3D (Fig. 2). Even if the masonry was compressed, the strain gauges measured vertical elongation (Fig. 2a). This fact is explicable by the wall characteristic, successively investigated, with the presence of a wide void, a fireplace, closed by a thin brick wall. The measured vertical elongation is due to the instability of the thin wall produced by the compression.

The unknown masonry morphology affected the results. Sonic tests, in fact, revealed the presence of a cavity behind the tested area. This is very clear considering the low sonic velocity measured. (Fig. 2b) The videoboroscopy inspection of Fig. 3a confirms this observation, revealing the presence of a real fireplace. The superficial brick masonry texture appears unregular (Fig. 3b).

Figure 2 Comparison of the double flat-jack with the sonic tests.

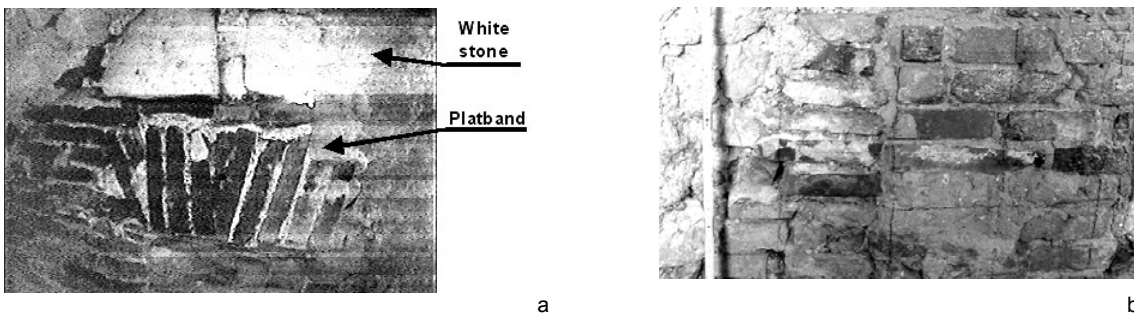
Figure 3 Videoboroscopy and detail of the masonry in the position POS1.

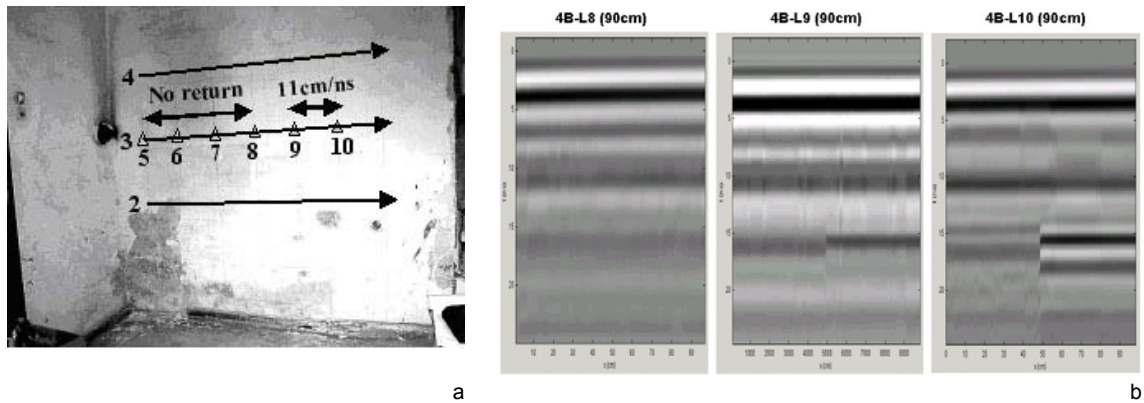
The first inspection was made by radar profiles (Figs. 4 and 5) that clearly showed a position where the signal could not pass through the wall section although the thickness is not particularly large (about 90cm). Profile and time acquisitions were carried out with 1 GHz and 500 MHz antennas. The time acquisitions were performed in positions 5 to 10 placing a metal shield on the backside of the wall during the second

half of the experiment. Moving from left to right positions, the shield reflection is absent (positions 5, 6, 7), then it appears as a weak signal (position 8) and finally as a good signal (positions 9 and 10). To show this transition, the radar data collected at positions 8, 9 and 10 are plotted in Fig. 4b. Where the radar signal could penetrate, an average velocity of 11cm/ns was measured which is a rather common value for a stone masonry.

Figure 4 Geometry of the radar survey a) and time radar data b) acquired at positions 8, 9 and 10. A metal shield was placed on the backside of the wall during the second half of the experiment to enhance the backside reflection.

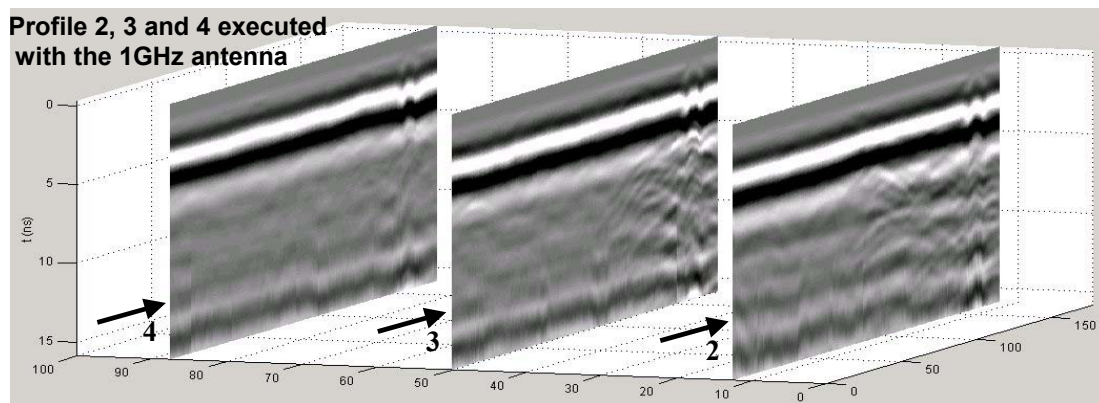
Figure 5 Results of the radar test along the profile 2,3,4 of Fig. 4a.

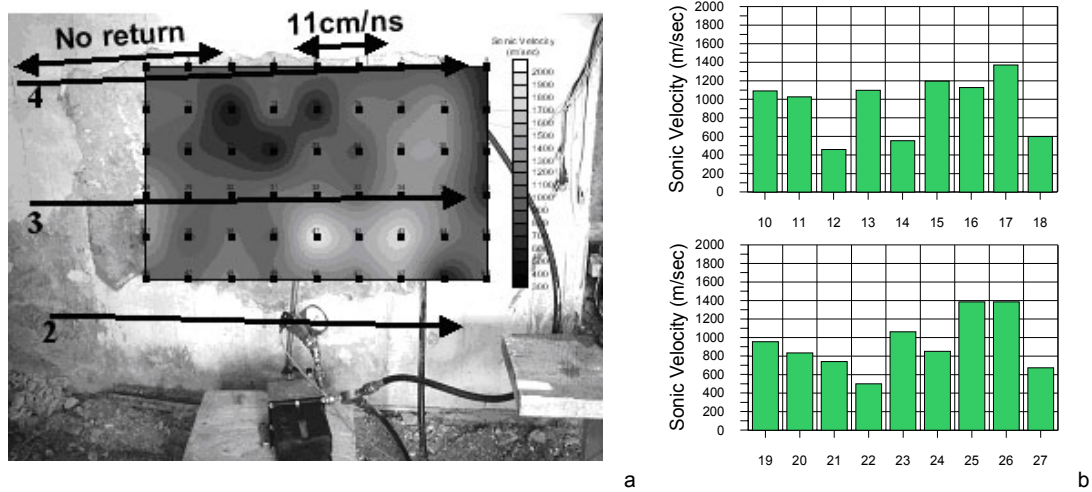
Fig. 6a shows the sonic velocity map compared to the no return area revealed by the radar test. The area where the radar was unable to reach the backside of the wall is associated with low sonic velocities. This indicates the presence of a void or a deteriorated masonry that results in a poor elastic response for the sonic test and in a high absorption effect for the radar test. The profiles acquired by high frequency radar (Fig. 5) confirm a low penetration on the left side where no reflections and/or diffractions appear after the background signal.

Figure 6 Results of the sonic tests in the position POS 4b

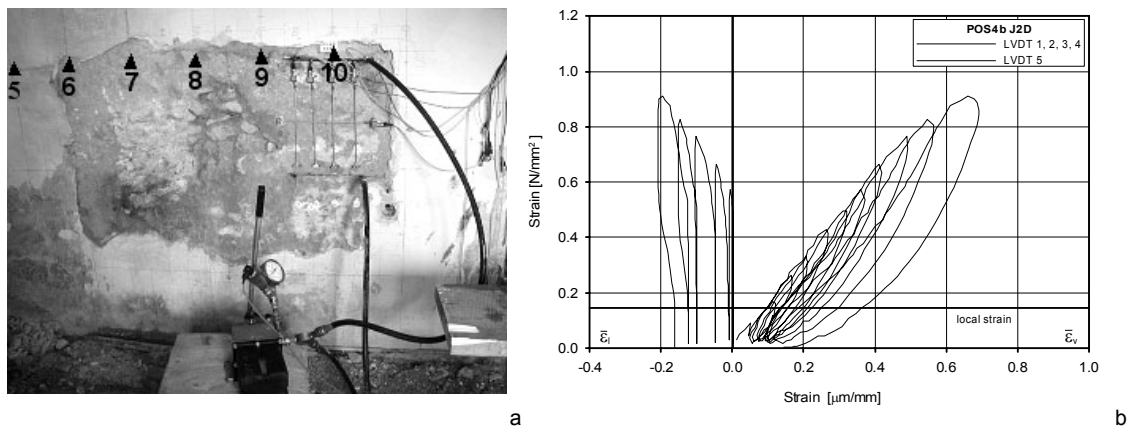
The no return positions were avoided for the flat jack tests that were instead located in the area of Fig. 7a. The flat jack results show a good behaviour of the masonry (Fig. 7b); also boroscopy shows a non homogeneous but rather solid masonry with an elastic modulus around 1490 N/mm<sup>2</sup> (Fig. 8).

Figure 7 Localisation and result of the double flat jack test POS4b.

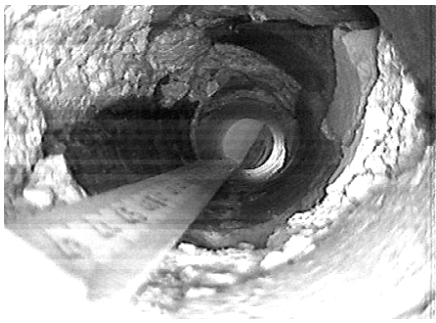
Figure 8 Videoboroscopes in the position POS 4b.

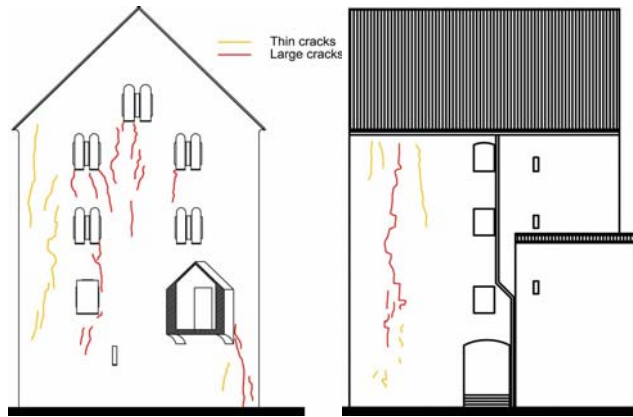
Positions TOW1, TOW2 and TOW3 are part of the Tower structure that seems to be made by regular stone blocks. It was expected that this masonry typology should provide different and better results compared to the others walls. However the tower is highly affected by deep and major cracks, also at the highest floors (Fig. 9).

Thus, an accurate crack pattern survey was carried out on every side of the Tower (Fig. 9). At the highest levels (third and fourth floors) radar tests were also executed with medium and high frequency antennas to explore the morphology of the walls. In spite of the huge thickness of the wall (2.3m at the third floor and 2m at the fourth floor), even the 1GHz antenna could penetrate through the whole section and could show the signal reflected by the backside. Average velocities of 12cm/ns and 11cm/ns were measured at positions TOW1 and TOW2 respectively. From these values and from the horizontal profiles executed at these levels, as the one showed in Fig. 10, it can be excluded the presence of voids or slow material inside the wall section. The wall is rather homogeneous and the radar sections are only disturbed by some diffractions mainly correlated with the presence of large cracks already observed with the crack pattern survey.

Figure 9 Crack pattern survey of the Tower in the South and East side

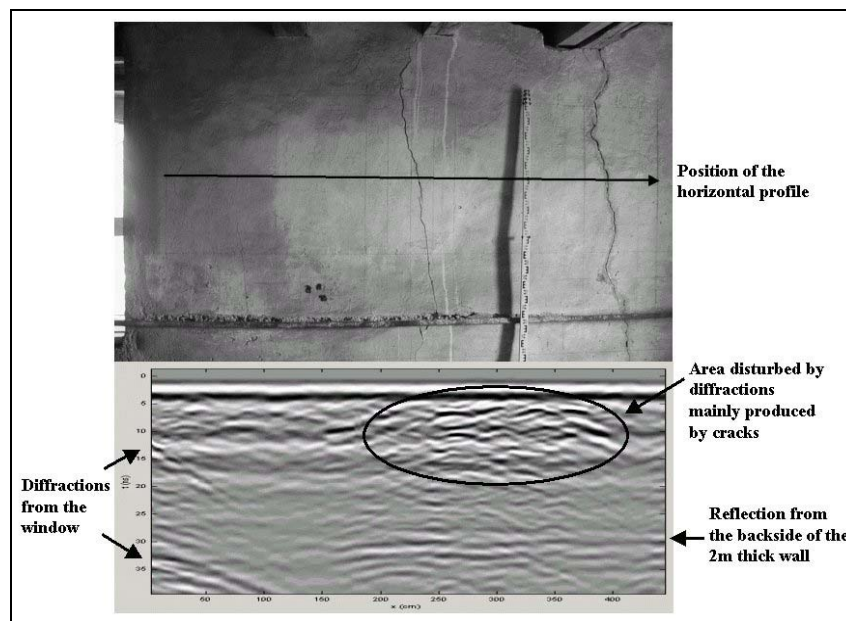
Figure 10 Position of one the horizontal radar profiles collected at the fourth floor of the tower (TOW1). The interpreted radar section is shown below. Some diffractions from main cracks and the reflection from the backside can be observed. The diffractions at the left side are lateral artefacts produced by the window at the left of the profile.

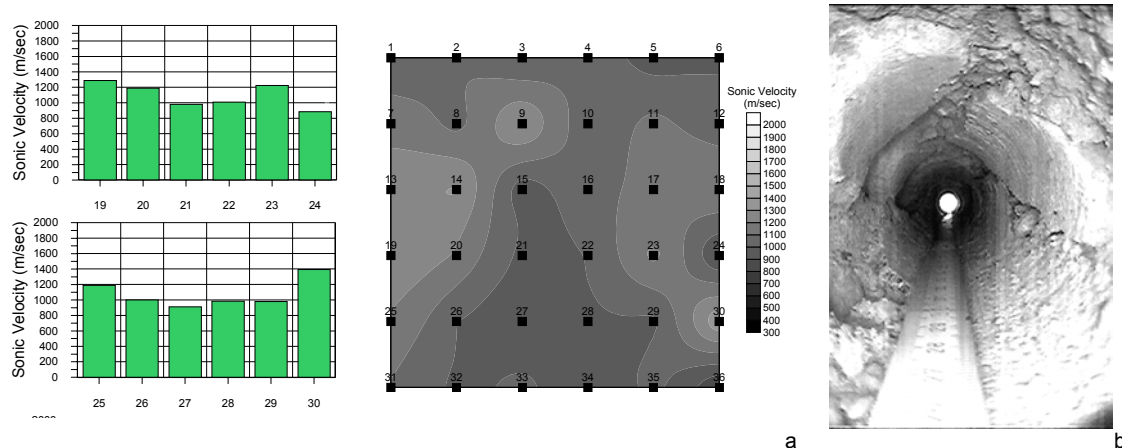
The distribution of the sonic velocity is more homogeneous than in the other cases (Fig. 11a). The inspection by videoboroscopy showed a section made with regularly cut stones (Fig. 11b). At TOW3 stone blocks appear regular but the survey showed the

presence of some small voids near the joints that could be produced by the drilling operation.

Figure 11 Sonic tests results and videoboroscopy carried out on position TOW3

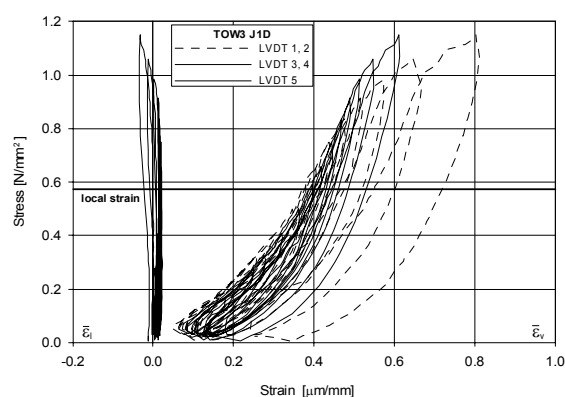
Also the result of the double flat jack test shows a rather good behaviour (Fig. 12) with an average elastic modulus of  $1700 \text{ N/mm}^2$ , even if the state of stress is the highest.

Figure 12 Results of the double flat jack in the position TOW3

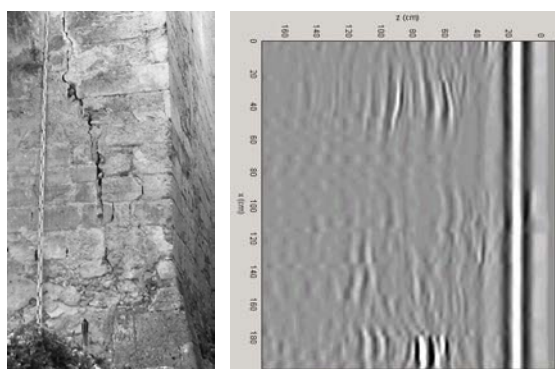
Finally, a radar vertical profile was executed on the external side of the tower starting at an eight of 190cm from the base and moving upward (Fig. 13). The profile is parallel to the corner at a distance from the corner of 70cm. The inspection was carried out in order to verify if radar was able to detect the presence and the depth of the wide cracks visible on the corner (Fig. 14).

The acquisition geometry has a great importance on the effectiveness of the test, for this type of application. In fact, the possibility to survey the wall from a surface that is nearly parallel to the cracks is essential. Fig. 14 shows the processed radar profile rotated vertically to facilitate the correlation with the picture of the adjacent side of the tower while Fig. 15 presents the interpretation of the main reflections and diffractions

Figure 14 Cracks as observed on the adjacent wall and processed radar section.

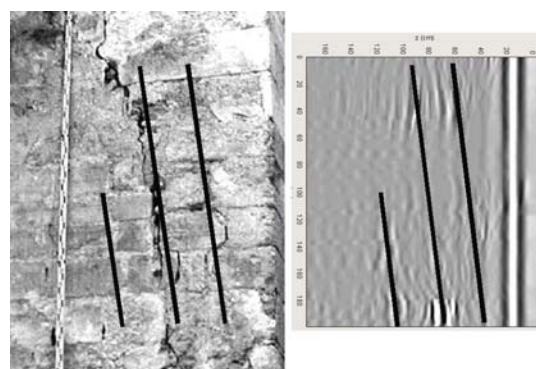
Figure 15 Interpretation of the vertical radar profile. A system of three main cracks seems to be detected by the radar profile at increasing depth from the surface.

apparently associated with three main cracks running at three different depths from the surface.

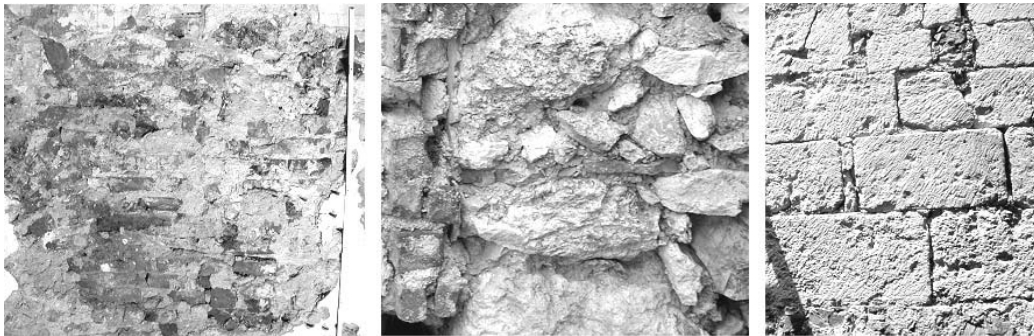
The Castle seems characterised by 3 different masonry typologies, as reported in Fig. 16, regular in brick, irregular and regular in stone. The tests carried out have also shown that the real characteristic of the walls can also be detected from the knowledge of their section.

*Figure 16 Masonry typologies: regular in brick (POS1), irregular (POS4) and regular in stone (TOW3).*

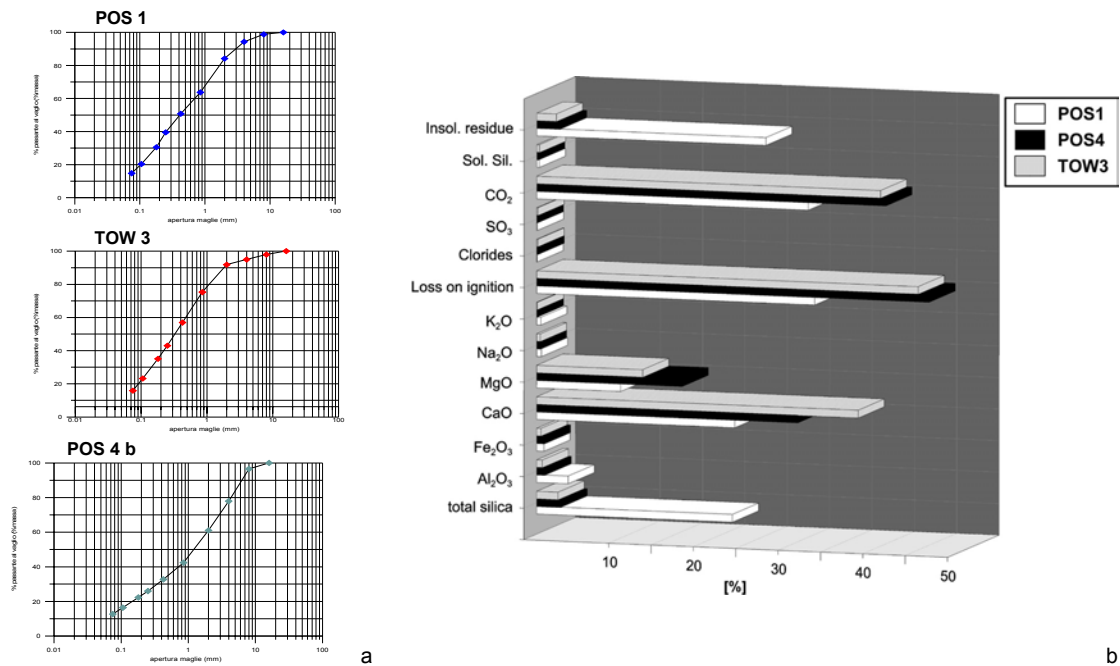
The results of the chemical analysis show very similar materials, as it is possible to deduct from Fig. 17. The low value of Soluble Silica reveals the binder as lime. The aggregate origin, instead, is in two cases calcareous and in a case mix calcareous/siliceous (even prevalently calcareous), as demonstrated by the value of the Insoluble residue.

In conclusions the mortars are very similar and made probably with local materials.

Figure 17 Grain size distribution and chemical analysis of the sampled mortars.
