CRACKING OF THE APSE OF S. LORENZO IN CREMONA: STRUCTURAL INVESTIGATION AND MONITORING

A. ANZANI¹, L. BINDA², L. CANTINI³, G. CARDANI⁴, P. CONDOLEO⁵

¹Associate Professor, ²Full Professor, ³Research Assistant, ⁴Assistant Professor, ⁵PhD
D.I.S. Politecnico di Milano
Milano - Italy

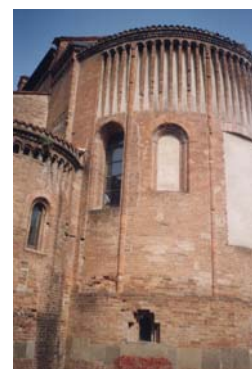
In June 1962 strengthening interventions were carried out due to the presence of serious cracks on the main apse (Figure 7), during which part of the foundations of the apse were demolished. Having reached a stronger subsoil, more than 20 reinforced concrete piles were trusted in the ground, connected to a thick r.c. beam running all around the apses.

Figure 7. Particular of the external side of the main apse

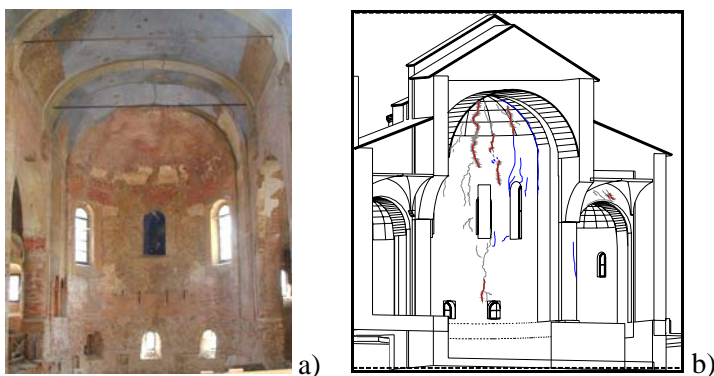
Different phenomena seemed to have caused the crack patterns visible in the presbytery and in the central nave. The cracks in the main apse depart from the centre of the semi-dome and develop along the wall (Figures 10 and 11); most of them had been repaired and re-opened. In order to gain a better understanding of the apse behaviour, and to formulate a strengthening project, the masonry quality and the state of stress has been assessed by sonic and flat-jack tests and a monitoring of the crack evolution has been carried out, as described in the following.

Figure 10. Apse: a) interior, b) crack pattern.

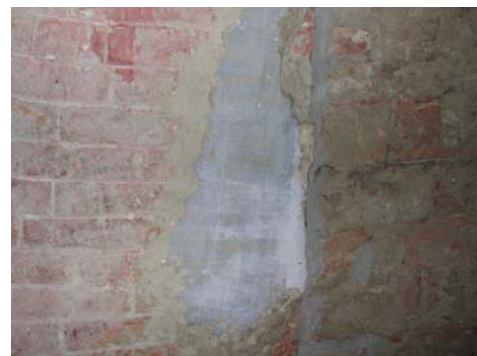
Figure 11. Repaired crack in the apse.

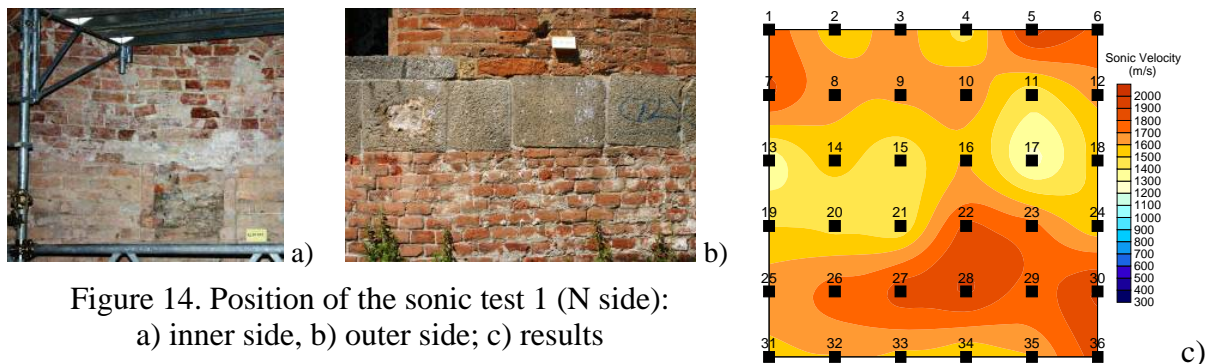
In Figures 12-15 the positions where sonic and flat-jack tests have been carried out on the apse are indicated. In both cases, sonic tests gave homogeneous results as shown; fairly high values of the sonic velocity were obtained, ranging between 1500 m/s and 2100 m/s. The lowest values of sonic velocities were detected in some parts of the pillars (PA2a, PA3b) due to the presence of local interventions weakening the masonry.

Figure 14. Position of the sonic test 1 (N side):
a) inner side, b) outer side; c) results

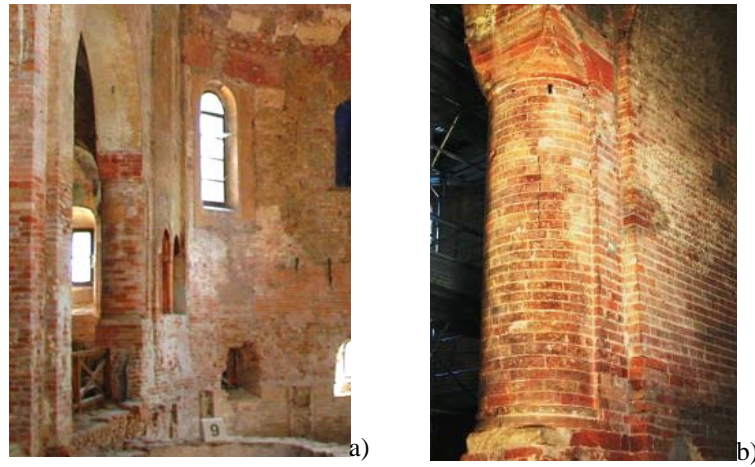
Figure 15 shows a vertical crack recently opened on pillar PA3b between the apse and the naves. In Figure 16 the sonic tests on pillar PA3b are illustrated. Also in this case a single flat jack test was carried out. As shown in Table 1, fairly high values of sonic velocity for a brick masonry have been obtained, the lowest value corresponding to pillar PA3b at church level. Particularly high values of stress have been recorded on pillars PA3a and PA3b in the apse, and on the large pillars in the presbytery, with values around or higher than 1 N/mm^2 . A non uniform stress distribution has to be highlighted in the case of the apse at point 1 N side (see Table 2) and in the case of pillar PA2b (see Table 1); this is in agreement with the results of verticality loss and tie rod stress commented below. Results of double flat jack tests are shown in Table 1, where values of E are indicated for pillar PA2a and PA1b. Values of the results of the assessment are also illustrated in Figure 17.

Figure 15. Pillars of the main apse: a) PA3a and b) PA3b.

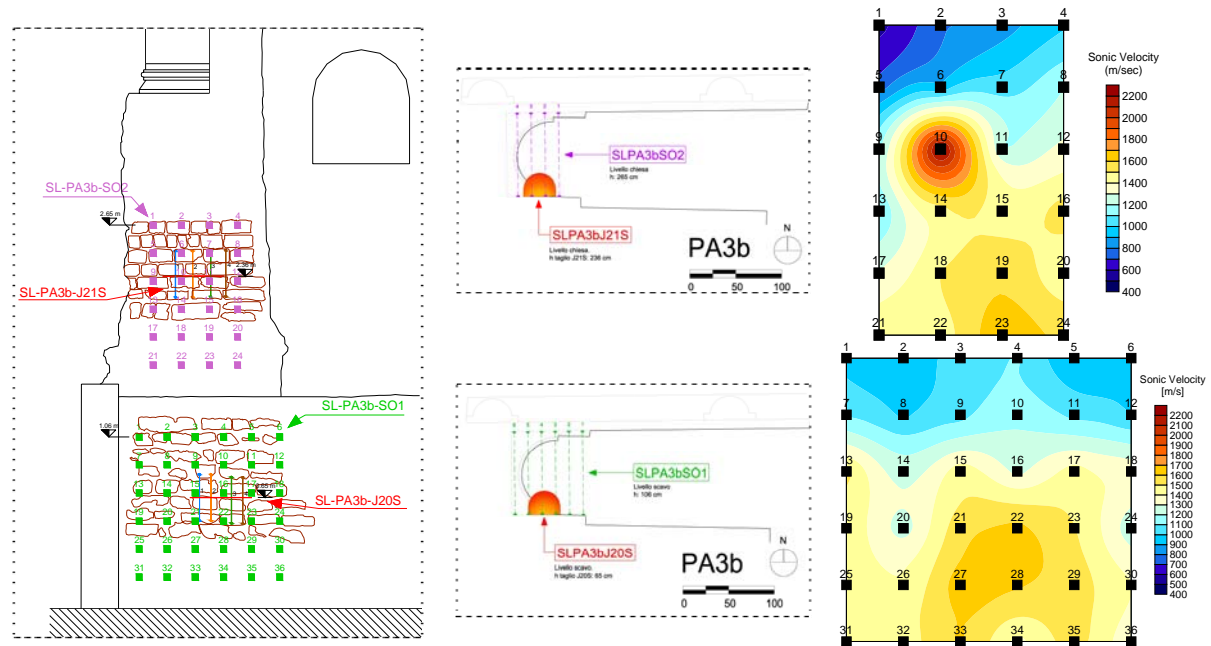
Figure 16. Sonic tests on pillar PA3b

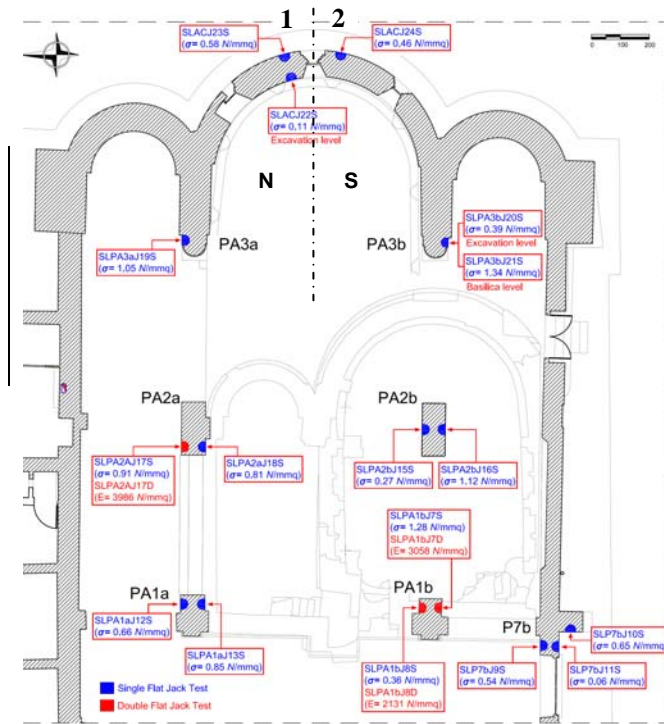
Figure 17. Results of single and double flat-jack tests.

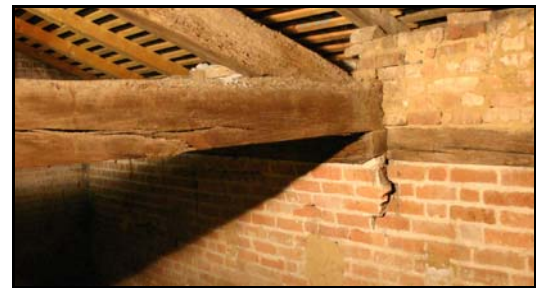
Figure 18 show a crack indicating a rotation of the south wall above the presbytery.

Figure 18. Crack and rotation of the south wall above the presbytery.

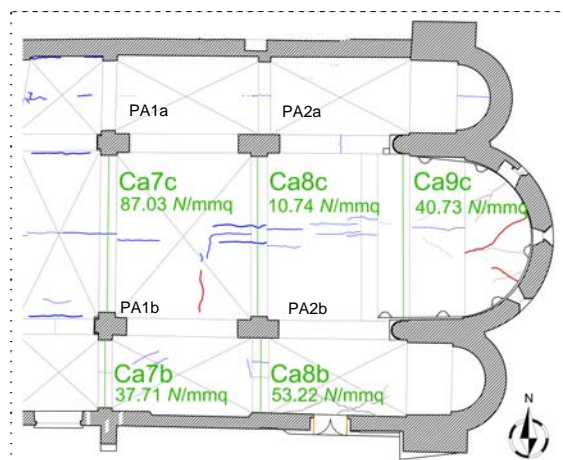
Figure 19. Tie rod tension.

The rods of the central nave resulted generally more stressed than those of the south nave. In particular, the highest and lowest values correspond respectively to rod CAC7c and CAC8c in the presbytery (Figure 19). The corresponding rods CAC7b and CAC8b are those showing the highest stress of the southern aisle. This is in agreement with the hypothesised settlement of the southern side of the church, one of the effects of which is the crack and rotation shown in Figure 18. This is also in coherence with the recorded verticality loss of the large pillars in the presbytery (Figure 20) and with the results of flat-jack tests highlighted above.

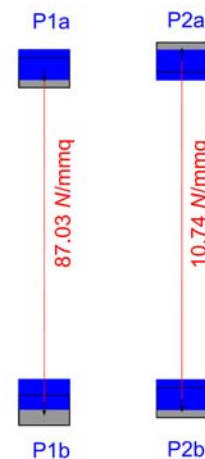
Figure 20. Verticality loss of pillars in the presbytery.

It should be taken into account in order to better understand the movements, that the archaeological excavation eliminated most of the soil covering the foundation, leaving only 1 m of soil depth. So that the constraint for the foundation seems to be very weak, allowing probably the pillars tilting.

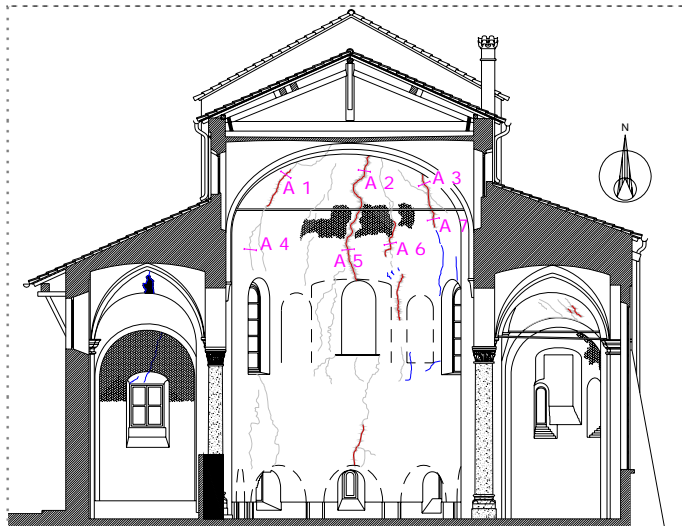
The evolution of the extensive crack pattern on many of the vaults has been studied continuously through the monitoring of 36 cracks. The cracks have been chosen considering their path, thickness and position relatively to the geometry of each vaults. The monitored cracks are shown in Figures 21-24.

Figure 22. Monitored cracks in the apse zone.

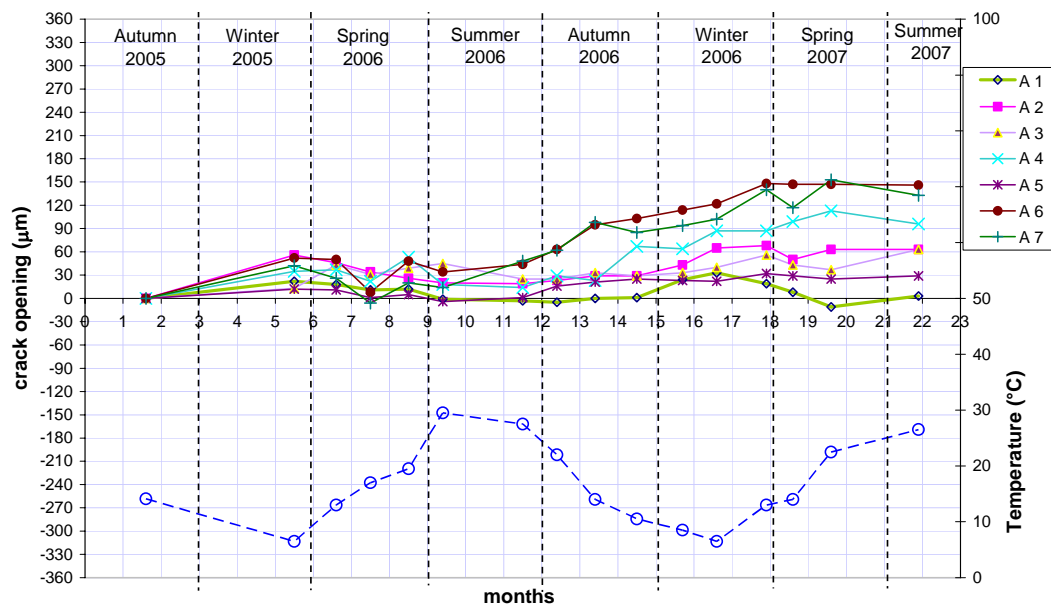
Ambient temperature has also been recorded in the same periods: results of the variation of crack thickness and of the corresponding temperature monitored on seven cracks of the apse are shown in Figure 24. As it appears from the diagrams, the crack thickness' trend is opposite to the temperature's trend, except for A4, A6 and A7 which show a rather remarkable trend of opening after 22 months (between 90 and 150 μm). This indicates that the apse movements are still active, showing that a soil settlement is proceeding despite the r.c. piles and beam.

Figure 24. Results of crack monitoring of the central apse: S. Lorenzo Basilica (CR).
