THE REHABILITATION OF THE PIERS OF A 125 YEAR OLD CLAY BRICK RAILWAY VIADUCT

S.W. GARRITY

SUMMARY

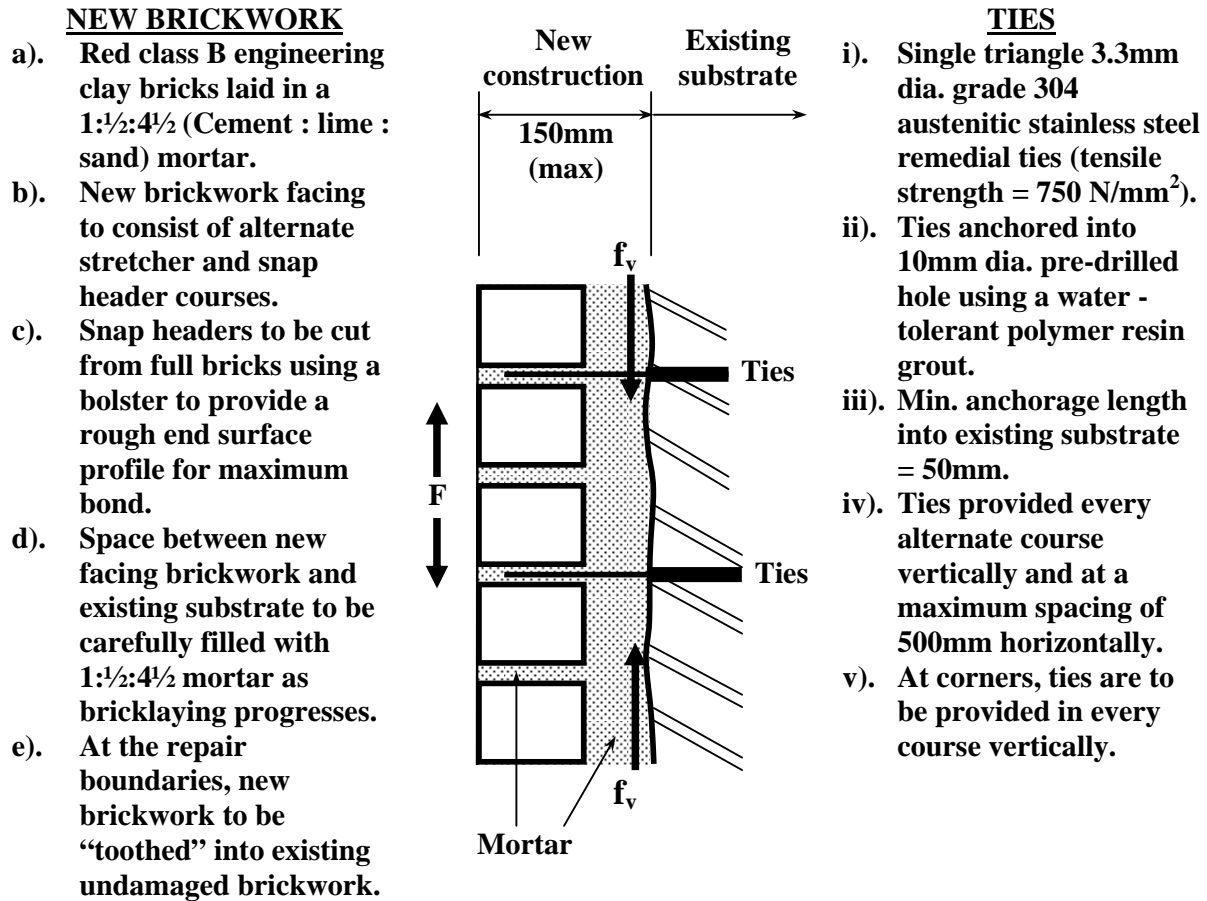
Figure 4. Typical detail of pier rehabilitation works

connection between the two materials leading to premature failure. The proposed rehabilitation works, shown in Figure 4, are built in to the existing substrate without the provision of any movement joints. As a result, any moisture expansion of the new brickwork and differential thermal expansion will create a restraining force, F . Ignoring the effect of the ties, force F is assumed to be transferred into the existing substrate via vertical shear stresses (f_v) at the interface between the new & existing construction. When evaluating the capability of the proposed detail to accommodate such forces and stresses, based on the guidance obtained from Hendry (1998) and BS 5628 (2005), the author assumed a free irreversible moisture expansion of 0.045%; a coefficient of linear thermal expansion for the facing brickwork of $8 \times 10^{-6} \text{ }^\circ\text{C}^{-1}$, a design temperature difference between the new brickwork and the existing substrate of 30°C and an elastic modulus of the order of 7600 kN/mm^2 to calculate the force, F produced by restrained thermal and moisture expansion over a maximum thickness of 150mm of facing brickwork. Any reduction in the restraining force due to creep was ignored. Assuming a characteristic shear strength of 0.7 N/mm^2 and a partial safety factor of 2.5, a 1m wide section of facing brickwork would require to remain bonded to the substrate for a height of approximately 3m. This seemed to be reasonable given the provision of ties every alternate course (i.e. a vertical spacing of 150mm) and at a horizontal spacing of 500mm, should any partial de-bonding occur. The ties also provide lateral restraint against buckling in the unlikely event of a possible compression failure of the facing brickwork. In summary, the rehabilitation detail proposed by RPL was judged to be satisfactory.

In summary, the materials selected for the new brickwork construction matched that of the existing viaduct as well as can be reasonably expected. Although some aspects of the contractor’s method of working helped to maximise bond between the new and existing materials, the standard of workmanship and quality control on site were in need of improvement. These issues were addressed by increasing the level of independent supervision on site and by carrying out a pull-out test on randomly selected ties at regular stages throughout construction.
