## **REPAIR OF REINFORCED MASONRY WALLS WITH PREVIOUS SHEAR FAILURE**

### **SUMMARY**

A series of cyclic lateral load tests were performed to simulate earthquake behaviour on full scale masonry walls. One wall was made of clay bricks and confined by reinforced concrete elements, while the other one was made of fully grouted hollow concrete blocks with interior reinforcement. After the shear failure, they were repaired using welded mesh jacketing, covered with mortar.

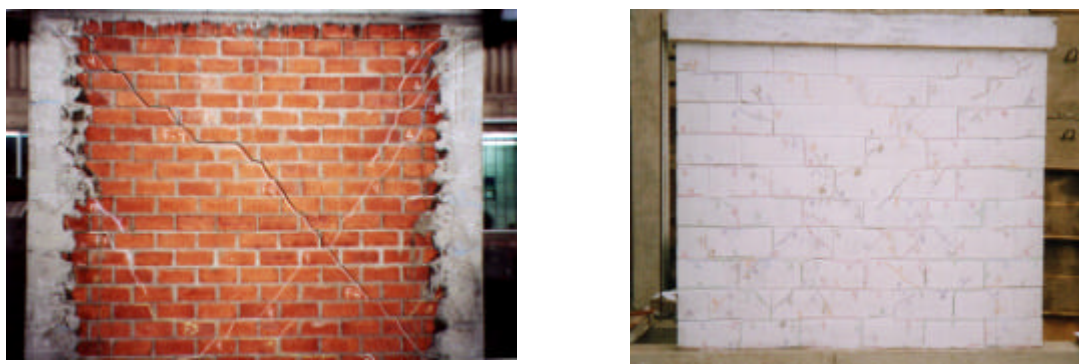
setting for both walls are shown. Figure 5 displays the walls at the end of the test. In both walls the shear failure was produced.

Figure 5. Original Walls after Lateral Load Tests

The original walls W1 and W2, had a shear failure with diagonal cracking. After being repaired using jacketing technique, both walls showed a flexural failure with crushing of the wall base endings, which switched to a sliding failure; this behavior can be explained due to the increase of shear strength given by the welded mesh and mortar cover. The sliding failure is extremely dangerous, however, the sliding occurred for lateral drifts of 0.007, larger than the maximum drift allowed by the Peruvian Seismic Code for economic repair purposes, which is 0.005 (SENCICO 2003).

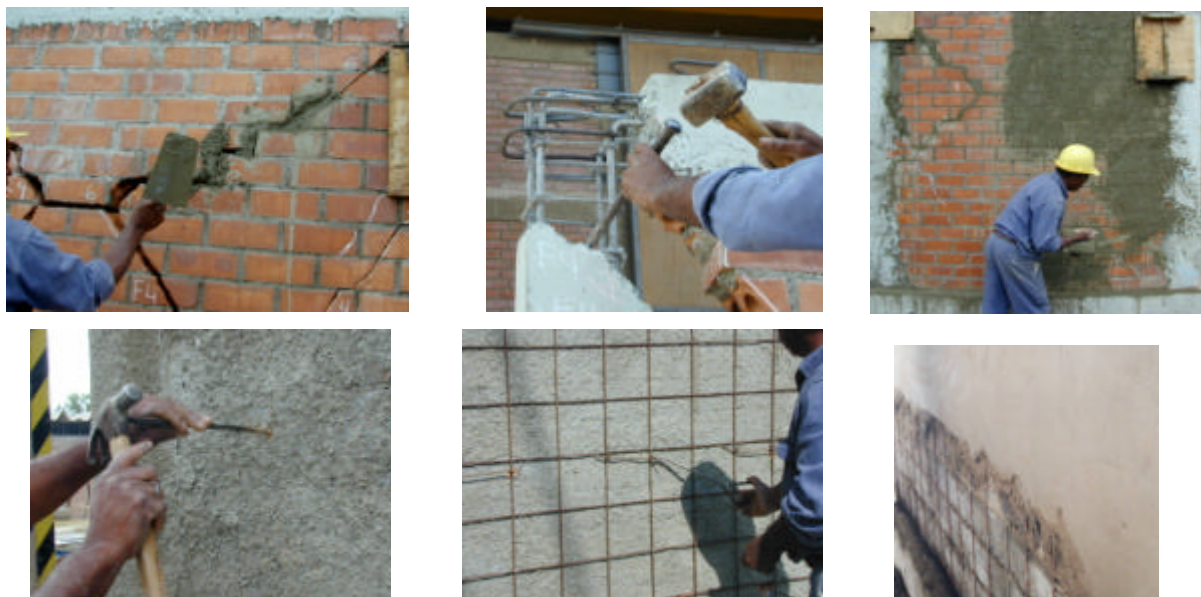
Figure 6. Repair of the Tested Brick Confined Wall W1

Figure 6 illustrates some of the steps taken during the repair process. The thicker cracks were cleaned, wetted and filled up with mortar 1:3. The thinner cracks were not treated. Crushed bricks were replaced with plain concrete. The concrete at the column-beam joint that cracked was replaced by other similar, using an epoxy resin to glue the concrete of different ages.

Afterwards, the wall was lightly covered with mortar 1:4. Then, holes were performed at the brick wall every 450 mm, which is three times the spacing of the welded mesh. Immediately, these holes were cleaned up with compressed air.

The welded meshes were placed, connecting wires were introduced through the holes, bend to 90°, and tied to the mesh with smaller wires. Later, the holes were filled with a liquid mortar with a proportion cement to fine sand 1:3. Finally, the whole wall was covered with mortar with a proportion cement to fine sand 1:4. The final wall thickness was 180 mm, including the meshes and coverings.

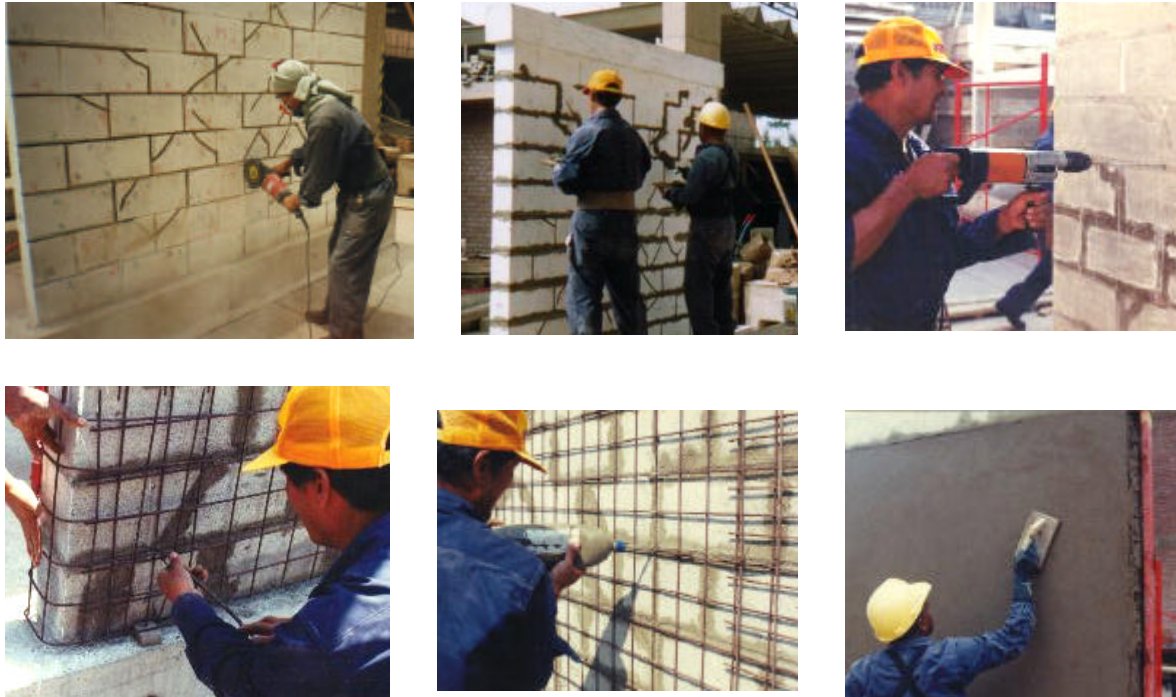
Figure 7. Repairation of the Tested Concrete Block Reinforced Wall W2

Figure 7 illustrates some of the steps taken during the repair process. With a cutter, 15-mm depth slots were done on the mortar and the blocks with the main cracks. The thinner cracks and the grout were not treated. Two powder admixtures were prepared with mortar to cover the slots; these admixtures increase the bond between the existing blocks and mortar.

Afterwards, holes were performed at the wall every 400 mm, at the intersection of vertical and horizontal joints, in order to not drill the original wall grout where existing reinforcing bars are. The connecting wires and the welded meshes were installed and tied together with smaller wires.

At both ends of the wall, a U-shape piece of welded mesh was added. This mesh had the objective to provide confinement to the free borders of the wall, in prevention of crushing due to flexural failure. Later, the holes were filled with a liquid mortar. Finally, the whole wall was covered with two layers of mortar with cement: sand 1:4 proportions. The wall thickness increased from 140 to 200 mm.

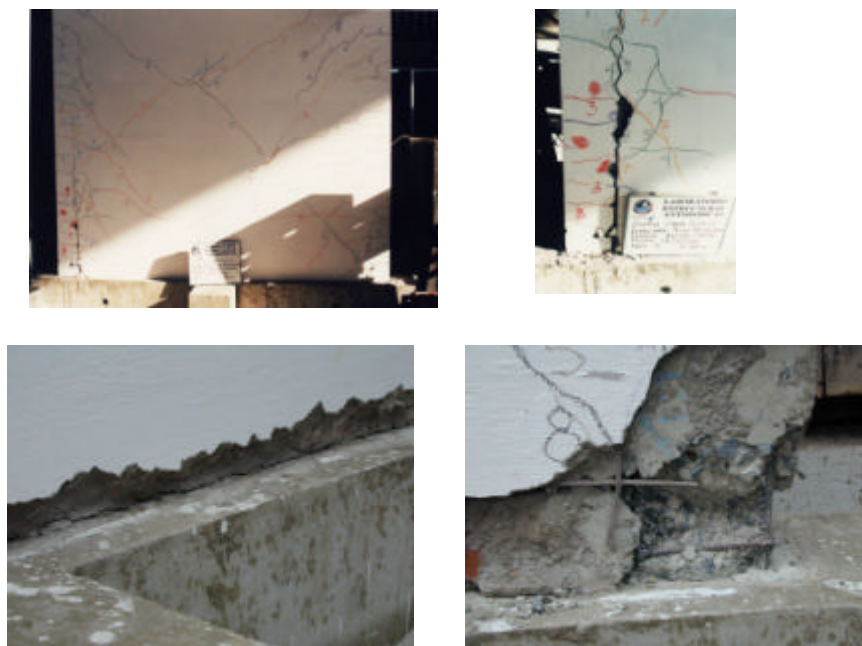
The welded mesh controlled the diagonal shear cracks, and the wall showed a pattern of flexure cracks. In step 7, a vertical crack in the column-wall lower joint; this crack occurred at a drift similar to the maximum limit established by the Peruvian Seismic Code (SENCICO 2003), which is 0.005. The covering started to fell in step 9, and a wall sliding of 10 mm was recorded. Figure 8 display the wall after the end of the test (after step 9). The crack pattern, the sliding and buckling of the vertical column bars may be observed.

Figure 8. Repaired Confined Wall W1 After the Cyclic Load Test

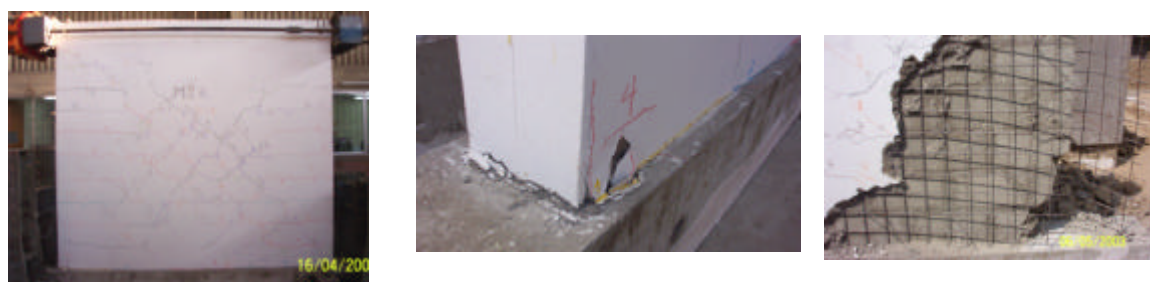
Some small diagonal cracks appeared in step 4, located toward the upper half of the wall, which were much thinner than those in the original wall. However, the flexural failure was predominantly clear in steps 5 through 7, with some crushing of one of the free ends. At step 8, a sliding failure started at the wall base with the foundation beam. Figure 9 shows the repaired wall after the test and some details of the cracks mentioned.

Figure 9. Repaired Wall W2 After the Cyclic Load Test
