MASONRY INFLUENCE IN SEISMIC PERFORMANCE OF BUILDINGS - CASE STUDY IN PERU

DANIEL QUIUN

SUMMARY

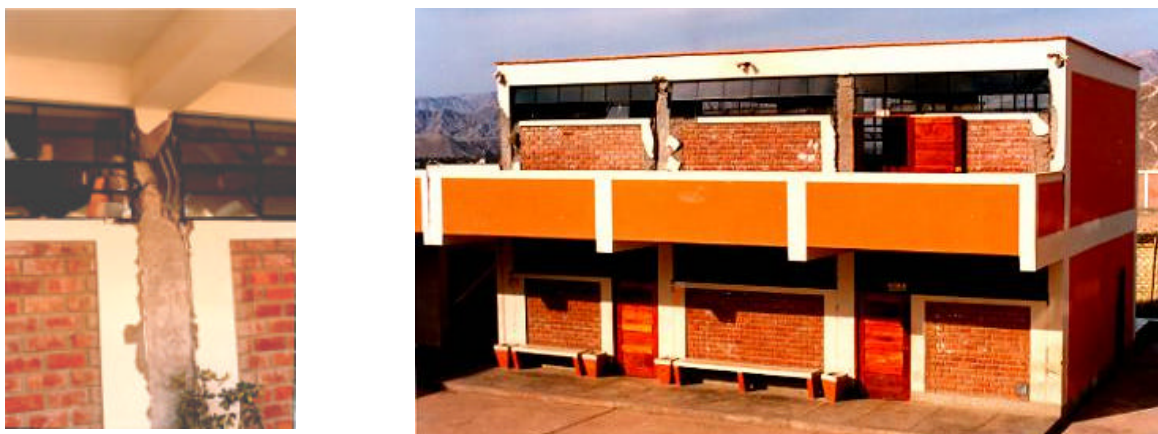
The seismic resistant structure of typical Peruvian school buildings older than 1997, feature a weak longitudinal direction (flexible concrete frames) and a strong transversal direction (rigid masonry walls). Moreover, nonstructural masonry walls in the longitudinal direction usually are poorly isolated from the concrete frame, and can produce short-column effect even in moderate earthquakes. The 1996 Mw 7.5 Nasca earthquake (Quiun et. al. 1997) in central Peru coast, produced several damages to school buildings, mainly due to excessive lateral displacements in the longitudinal direction, that concluded in shear failure in short columns (figure 3). However, in the transverse direction, confined masonry walls were very effective to control lateral displacements and therefore no damage was observed.

Figure 3. School buildings affected in Nasca earthquake, only in the longitudinal direction

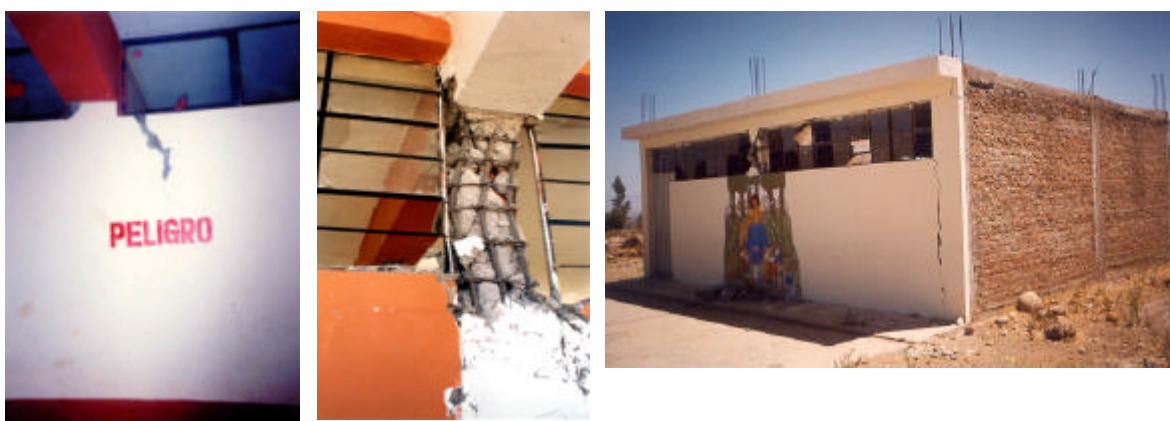
Similar behaviors in other school buildings were observed in the 2001 Mw 8.4 Atico earthquake (Muñoz, et. al. 2004) in south Peru. Figure 4 shows affected buildings in 3 different cities, 1 and 2-story high, in which nonstructural but stiff masonry walls produced short columns, while structural confined walls in the other direction avoided damage.

Figure 4. School buildings affected in Atico earthquake, only in the longitudinal direction

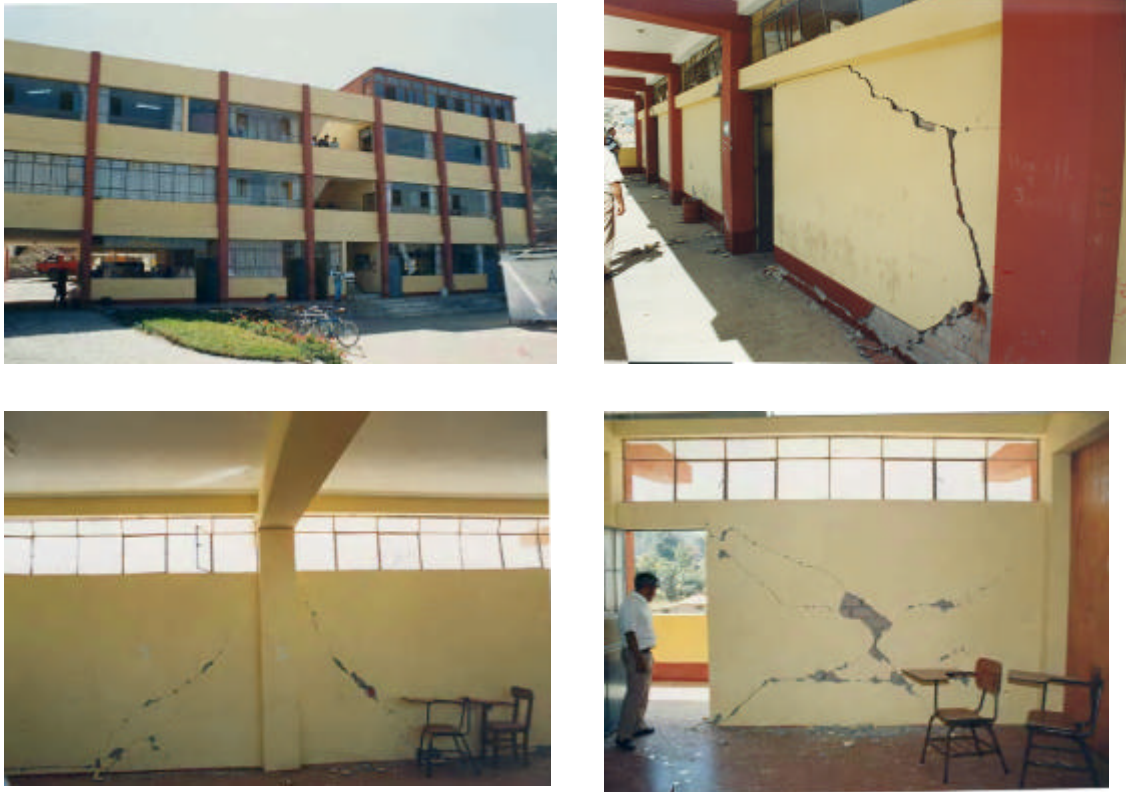
Another type of failure could be observed in a university 3-story building. The nonbearing walls with a lintel concrete beam, had diagonal cracking indicating that those walls worked resisting in-plane seismic forces (figure 5).

Figure 5. Nonbearing walls in university building damaged in Atico earthquake

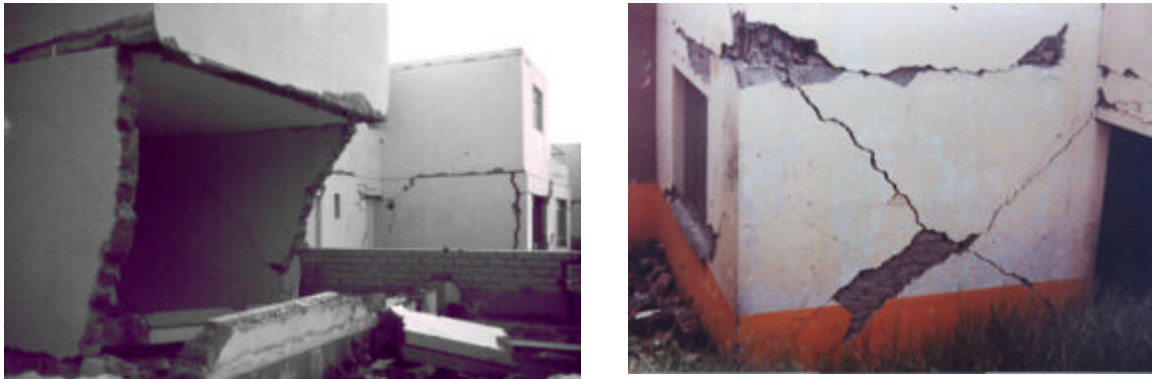
Between about 1940 and 1965, the use of concrete columns as confinements and braces in bearing walls was introduced. This way of reinforcing masonry in Peru was still lacking of experimental and engineering studies. Also, the needs of more space in urban constructions lead to thinner walls of 0.15m width, reducing the wall density. Some collapses in unreinforced 2-story buildings occurred in the 1970 earthquake (Mw 7.8) in central Peru in bad soil conditions (figure 8). Failures displayed include: 1) sliding of the roofs; 2) tension failure; 3) overturning due to out-of-plane bending moments; and 4) shear.

Figure 8. Unreinforced masonry buildings damaged in the 1970 earthquake

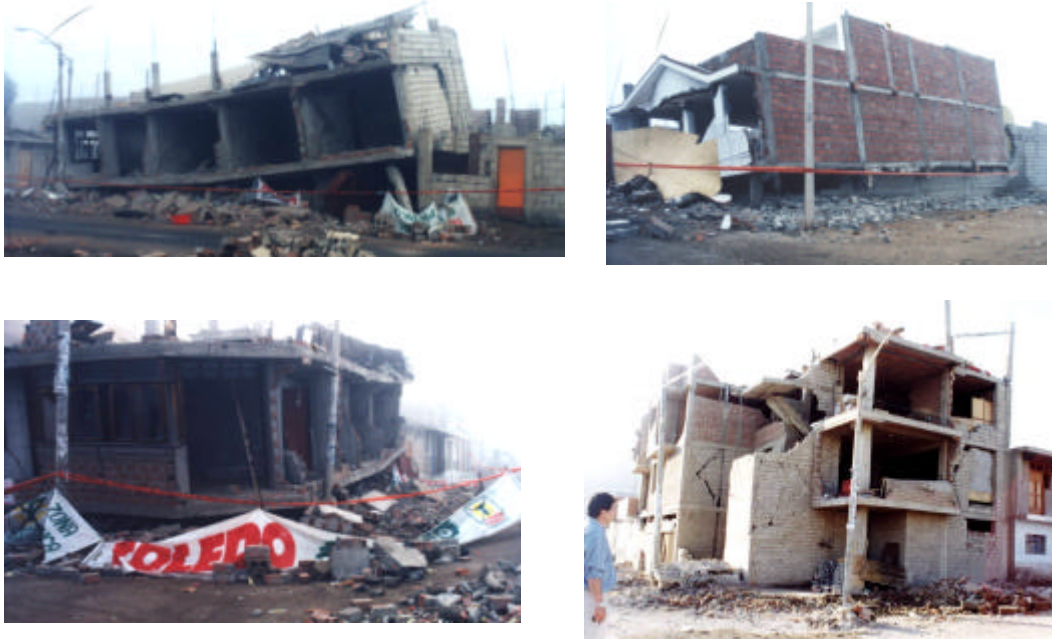
In more recent years, popular and informal constructions have misunderstood the way confined masonry must work. Concrete columns and beams are wrongly thought to be more important than the masonry itself, and the use of hollow and tubular bricks for bearing walls and seismic resistant walls are quite common. The 2001 Atico earthquake and recent 2007 Pisco earthquake showed the importance of having a minimum wall density (wall area respect to plan area) and the use of solid bricks, to prevent damage. Several houses collapsed or had heavy damage due to insufficient walls in the first floor and poor quality construction in the city of Tacna in southern Peru (figure 9) in 2001; similar failures could be observed in the city of Pisco in central Peru in 2007.

Figure 9. Collapsed housing buildings in the 2001 earthquake

These particular issues, a minimum wall density, the need for solid units in structural walls, as well as quality control of masonry, are assessed in the new Peruvian Masonry Code (SENCICO 2006) as explained below. More features of this code concerning confined masonry are given by San Bartolomé and Quiun (2006).

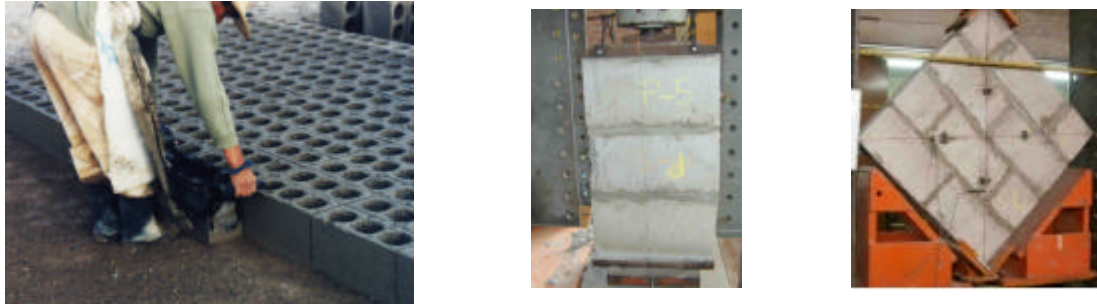
The poor structural configuration of Tacna buildings has been also combined with the use of artisan-made hollow concrete units in bearing walls (figure 10). Such units dimensions are 400x200x150 mm. They feature 3 circular holes 120 mm diameter each in only one of the bearing surfaces, while the other is completely full; the holes area is around 40% of the gross area, therefore the units classify as hollow and should not be used for structural walls. For placement, the surface with holes is located downwards so that mortar may be placed in the full surface. Laboratory tests on masonry of this hollow units indicate that prisms subjected to axial compression have a compression resistance of $f'_m=1.7$ MPa, and small walls subjected to diagonal compression have a shear resistance of $v'_m=0.26$ MPa (Quiun et. al., 2005). As a reference, the Peruvian Masonry Code states that typical values for solid artisan units, are $f'_m=3.4$ MPa, and $v'_m=0.5$ MPa. Therefore, the Tacna hollow units do not fulfill any of the requirements for use in structural walls. However, despite the poor quality of the material and the recent collapses, these units are still popular.

Figure 10. Artisan concrete hollow blocks used in Tacna, southern Peru, poor quality confirmed by laboratory tests

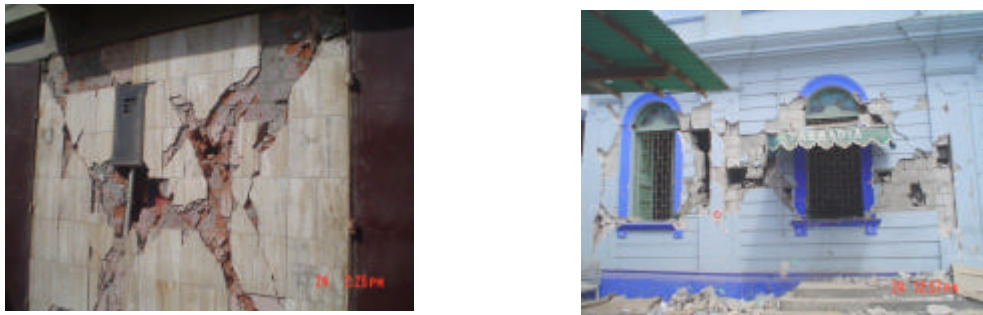
The recent Pisco earthquake of August 15, 2007 (Mw 7.9), showed a poor performance of several confined masonry buildings that did not comply the 2006 Masonry Code specifications. Some of the main points were: 1) weak artisan clay bricks and hollow concrete blocks in bearing walls (figure 11); 2) poor wall density; and, a wrong construction sequence, in which the columns were constructed before the masonry wall was erected (figure 12). In this last case, the out-of-plane failure was observed in the upper stories where the accelerations are higher and the vertical load is small (figure 12, middle). As in previous earthquakes, old school buildings have heavy damage specially in short columns and collapsed fences (figure 12, right), while those built after 1997 were undamaged.

Figure 11. Crushing of poor quality units in masonry buildings in Pisco after the 2007 earthquake; hotel (left) and hospital (right)

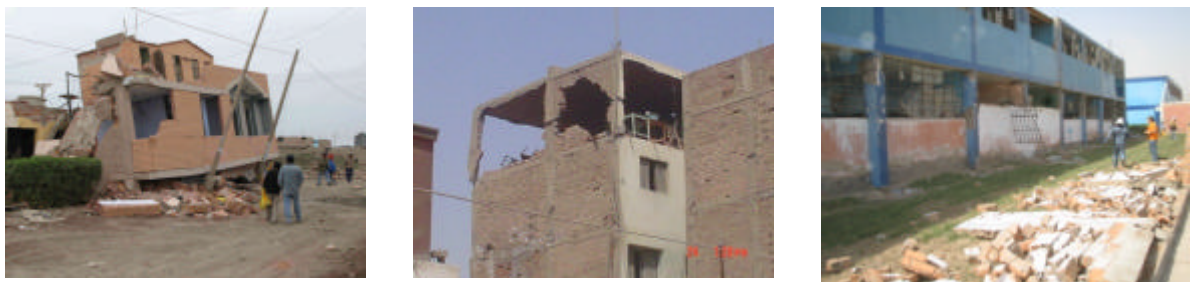
Figure 12. Collapse of masonry buildings in 2007 Pisco earthquake, low wall density (left); wrong sequence in construction (middle); and old school fence (right).
