ANALYSIS OF PATHOLOGICAL DEFECTS OF LOAD-BEARING MASONRY TECHNOLOGY IN LOW INCOME PROJECTS

C. RICHTER; C.T. FORMOSO; A. B. MASUERO

School of Engineering
Federal University of Rio Grande do Sul
Porto Alegre RS BRAZIL

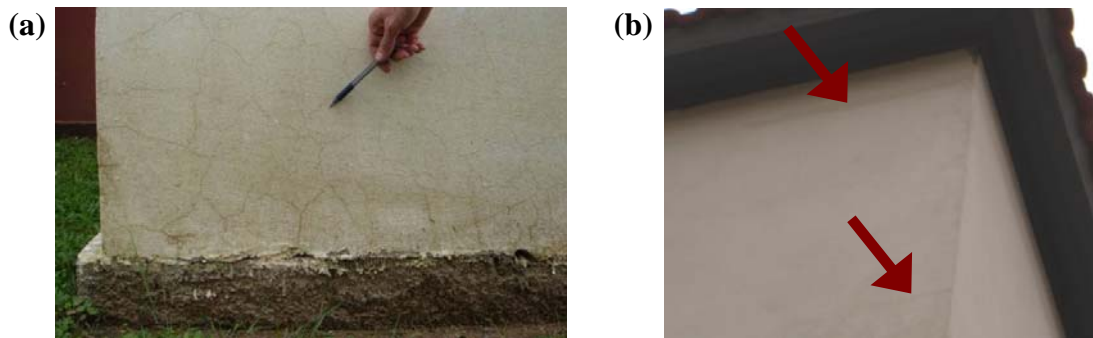
Figure 2. Illustrative example of main external pathological defects: (a) map-like cracks and (b) horizontal cracks

Map-like cracks identified in the façades of buildings presented a uniform distribution: crack lines crossed one another in angles of 90 degrees. According to Cincotto (1991), when map-like cracks have this particular distribution the problem might be because of mortar shrinkage. The cause could be linked to the inadequate proportioning of the mortar (such as too much fines), bad application (early surface finishing), and/or condition of exposition: wind and high temperature (Thomaz, 1989).

Horizontal cracks next to the last floor slabs occur with a certain frequency in buildings made of structural masonry (Duarte, 1998). These cracks are caused by shrinkage movements and contraction caused by variations in temperature throughout the whole height of the building. These movements lead to tensile and shear stresses in the walls, which typically cause horizontal cracks (Thomaz, 1989). Besides, the shortening of slabs – especially the last floor slab – caused by shrinkage, has the tendency to rotate the course bricks near to the slabs (ABCI, 1990). Cracks in walls can also occur if shrinkage is intense and beam elements have low structural tightness, particularly in external walls with openings of windows.

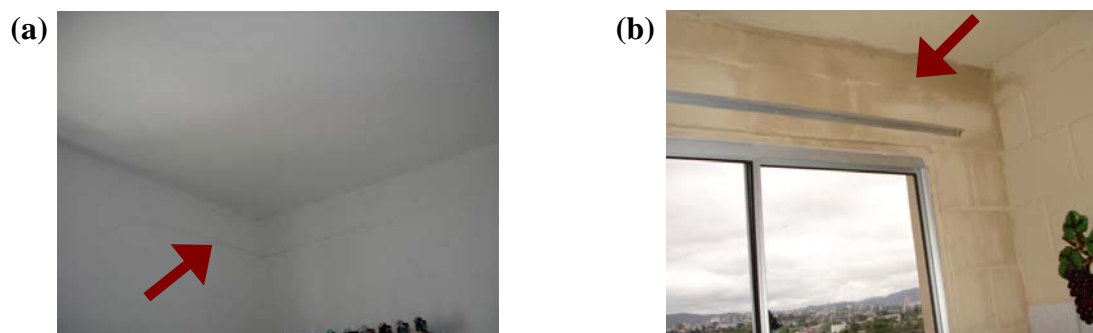
Figure 3. Illustrative example of main internal pathologic defects: (a) horizontal cracks and (b) moisture problems

Horizontal cracks were identified in the internal faces of walls especially next to the last floor slabs, following the horizontal mortar joint approximately 20 cm under the ceiling. These horizontal cracks were also identified in smaller amounts in regions surrounding openings of windows, and these internal cracks are quite similar to those found in the external faces. This may be caused mainly by dilatation and contraction of slabs caused by temperature changes.

The presence of moisture in the internal faces of walls was mainly due to infiltration of rain water through horizontal and map-like cracks in the façades. This problem was identified particularly in projects PAR5 and PAR8. In project PAR5 this problem of moisture by infiltration was added to problems of moisture by condensation, which has led to mouldy environments in some units.

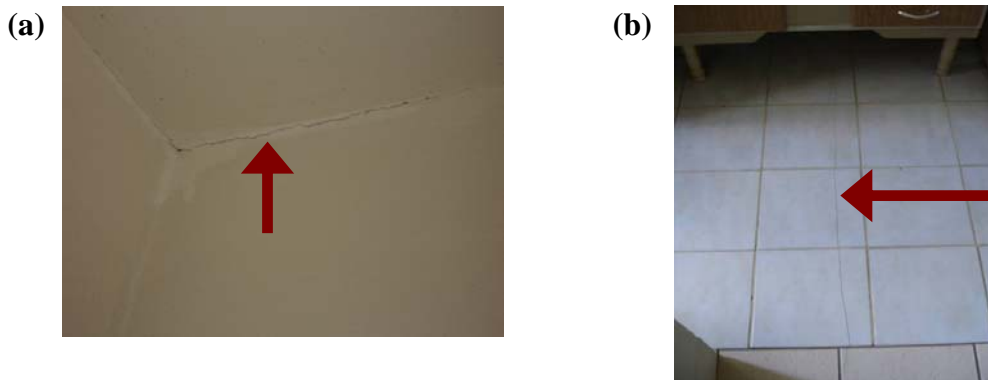
Cracks in the interfaces were identified in two situations: as cracks and irregularities in the interface slabs-walls (figure 4-a) and in the interface slab-slab for concrete poured in situ or precast panel (figure 4-b).

Figure 4. Illustrative example of main pathological defects in slabs: (a) cracks in the interface labs-walls and (b) in the interface slab-slab for precast panel

In framed structural systems made of reinforced concrete, columns and beams impose a restriction to concrete shrinkage coming from the slabs. This situation is different in buildings made of structural masonry as these buildings do not have those structural elements to absorb such shrinkage loads, and slabs are free to deform - particularly on the top of the building (Duarte, 1999). Thus, it is necessary to use support joints to release these movements.
