REHABILITATION OF MASONRY FACADES DAMAGED BY REINFORCEMENT CORROSION

M. MOLNÁR, J. JÖNSSON, T. GUSTAVSSON

Lund University
Lund, Sweden

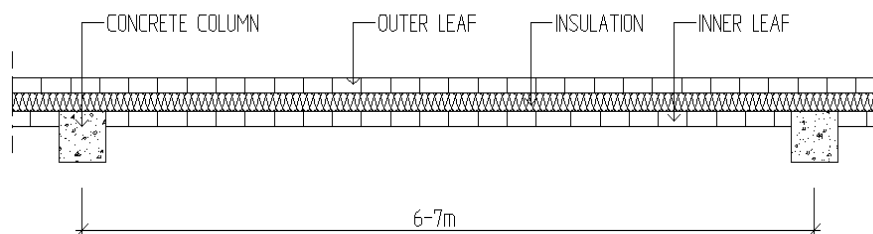
The municipal bath Högevall in Lund, Sweden, was built during 1979-1980. The external walls consist of a cavity wall of clay brick masonry with stabilising reinforced concrete columns spaced at 6-7 m, see Figure 1.

Figure 1. Horizontal section through the external cavity walls, Municipal Bath, Lund, Sweden.

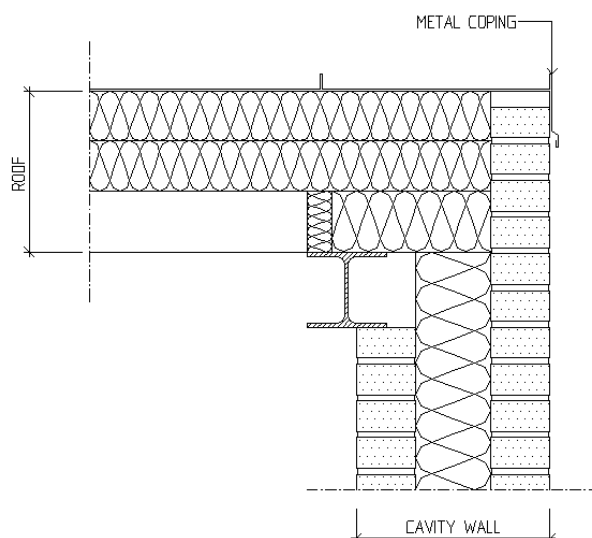
The outer and inner leaves of the wall are connected to each other and the stabilising columns by corrosion resistant ties. Both leaves are reinforced with two unprotected steel bars with 8 mm diameter in every sixth bed joint. The roof is supported by trusses as primary and corrugated sandwich elements as secondary load bearing elements, see Figure 2. The trusses are supported by columns, whereas the sandwich elements are connected to the outer leaf of the wall by metal coping.

Figure 2. Vertical section through the external cavity walls, Municipal Bath, Lund, Sweden.

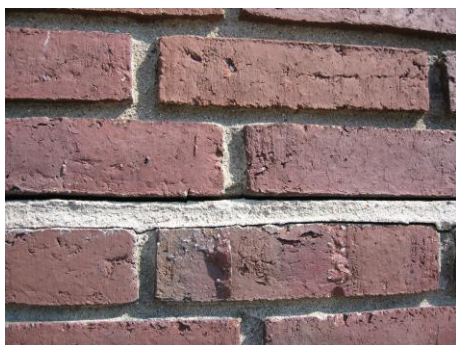
During the rehabilitation, the outer reinforcement bars in the outer leaf of the walls has been removed and replaced by corrosion resistant reinforcement. The inner reinforcement bar was not removed, probably due to higher costs associated with this measure. With progressing corrosion in the inner reinforcement bar, new cracks appeared already five years after the rehabilitation, see Figures 3 and 4.

Figure 3. New cracks five year after rehabilitation due to progressing corrosion in the inner reinforcement bar.

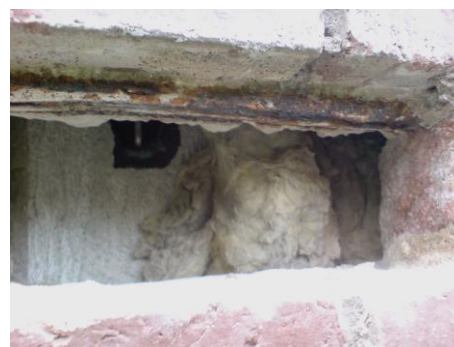
Figure 4. Inner corroding reinforcement bar causes new cracks.

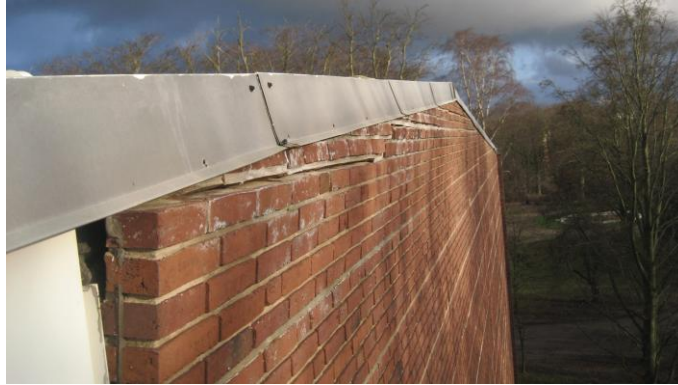
After the storm in January 28, 2007, it was discovered that the upper two meters of the facade walls facing south respectively west have been dislocated. The dislocated wall parts were hindered from falling down by a metal coping, which exhibited large deformations, Figure 5.

A subsequent inspection of the building disclosed that the outer leaf of the wall has been elongated by 60 mm in the vertical direction relative to the inner leaf and caused failure in the wall ties in the upper part of the wall. Corrosion expansion in the bed joints was diagnosed to be the main cause of the damaging wall elongation. The dislocated wall parts were removed and replaced by plywood as rehabilitation of the entire facade and an expansion of the bath was already scheduled for 2008-2009. For security reasons, the bath was closed during the inspection and demolition works.

Figure 5. The metal coping hinders the upper part of the facade from falling down

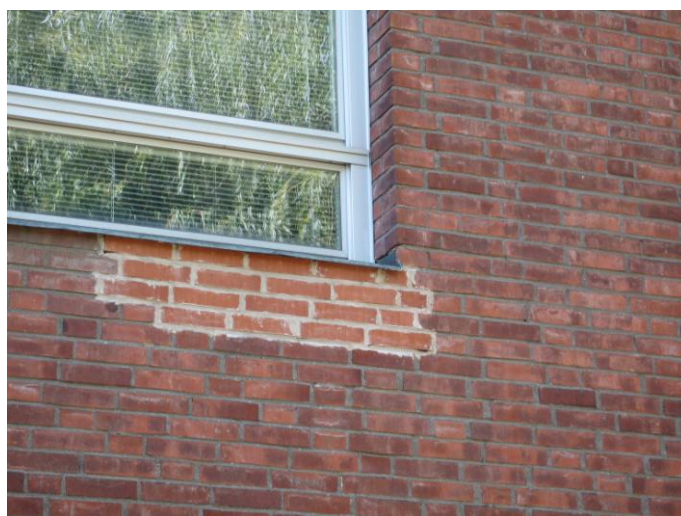
- All the corroding bed joint reinforcement during rehabilitation is not removed, which causes new cracks and continuing deterioration of the technical condition of the facades
- Rehabilitation works are carried out with little concern to good craftsmanship, which results in deterioration of the character of the facades, Figure 6.

Figure 6. Use of bricks and mortar with deviating colour compromises the character of the facade

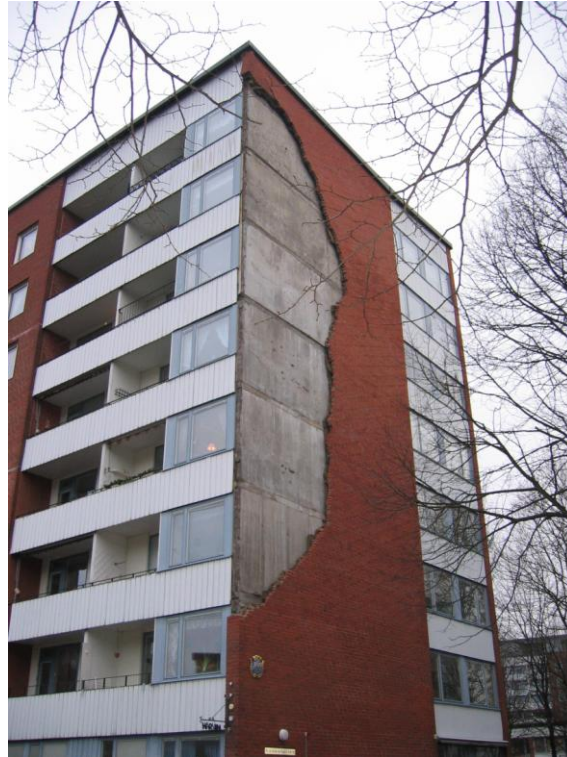
- Tying of the facades to the stabilizing structures is not checked, which results in occasional failures during storms and maintenance works, Figure 7.

Figure 7. Collapse of a facade after a storm in January 2005, Lund, Sweden.

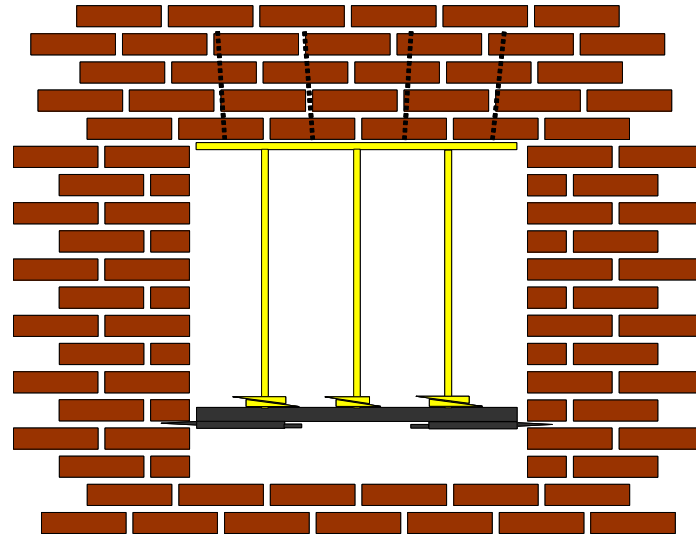
Figure 8. Fixture used to avoid damage on window sheets and to secure the beam from falling down.

1. The damaged beam is secured from falling down by means of a re-usable and adjustable fixture, (Kruglyak and Olsson 2007). In order to avoid damage on the window sheets, the fixture is anchored in the masonry joints, Figure 8.
