## **THE DISASTERS OF SEPTEMBER 11, 2001**

DAVID T. BIGGS, P.E.

### **SUMMARY**

This paper presents some structural observations, findings, and recommendations regarding the masonry performance of the buildings affected by the September 11 attacks in New York City and Washington D.C.

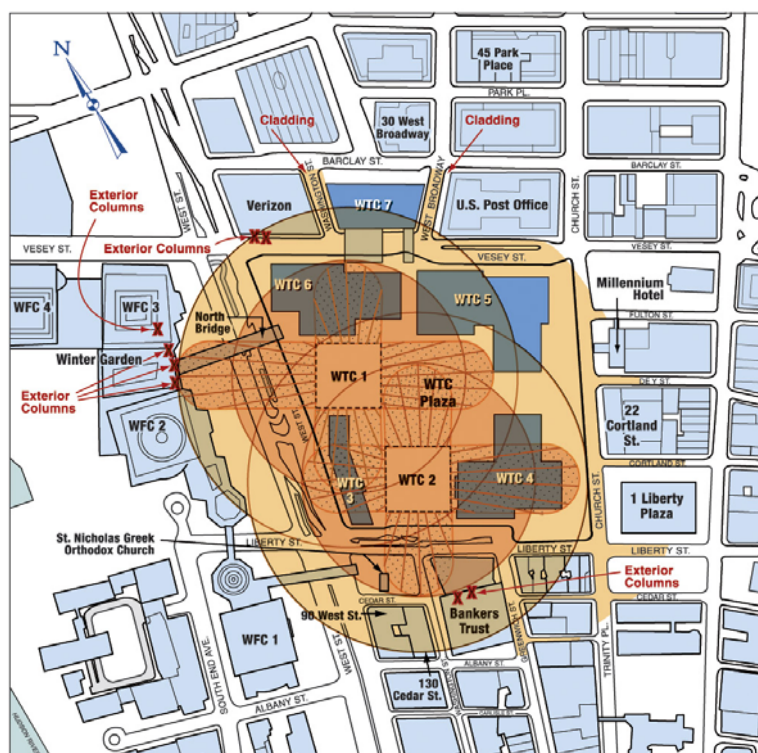
All of the surrounding buildings suffered damage from the falling debris, wreckage, and fires caused by the collapse of the towers (WTC 1 and WTC 2) and WTC 7. Figure 2 shows the debris field created by the collapses of the towers. The inner circle around each building represents the primary location of the debris from the walls with the outer circles being an approximate maximum limit. The collapse of WTC 7 impacted adjacent buildings also.

Figure 2 - Outline of debris fields from collapse of WTC 1 and WTC 2.

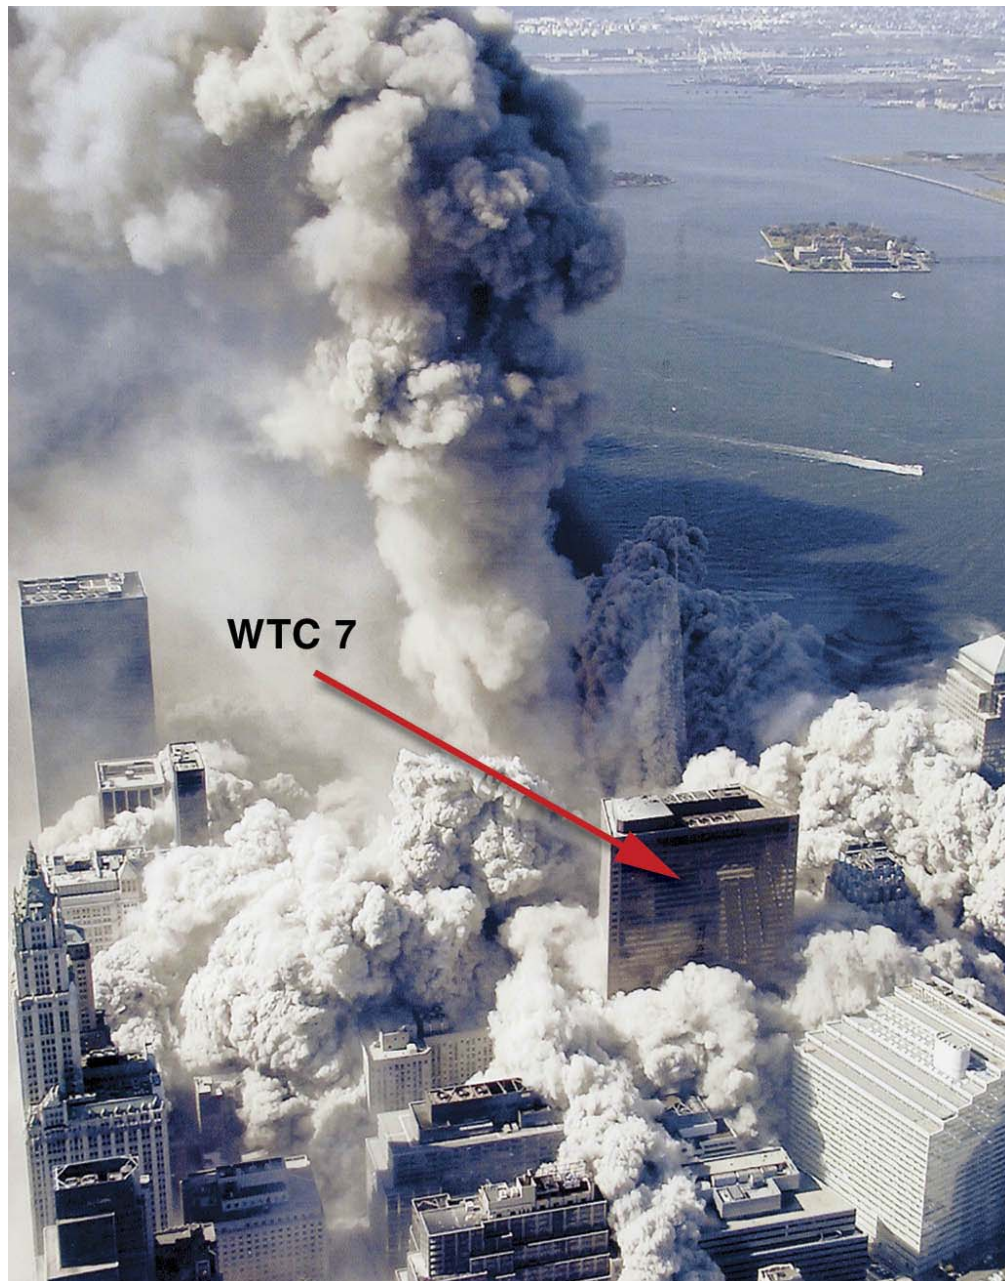
While the impact of portions of the collapsing buildings did the majority of the damage, there was also damage resulting from flying debris and the air pressure created by the collapses. Figure 3 shows the debris and dust cloud created by the collapse of WTC 1.

Figure 3 - Dust cloud from the collapse of WTC 1 viewed from the north. WTC 7 in foreground.

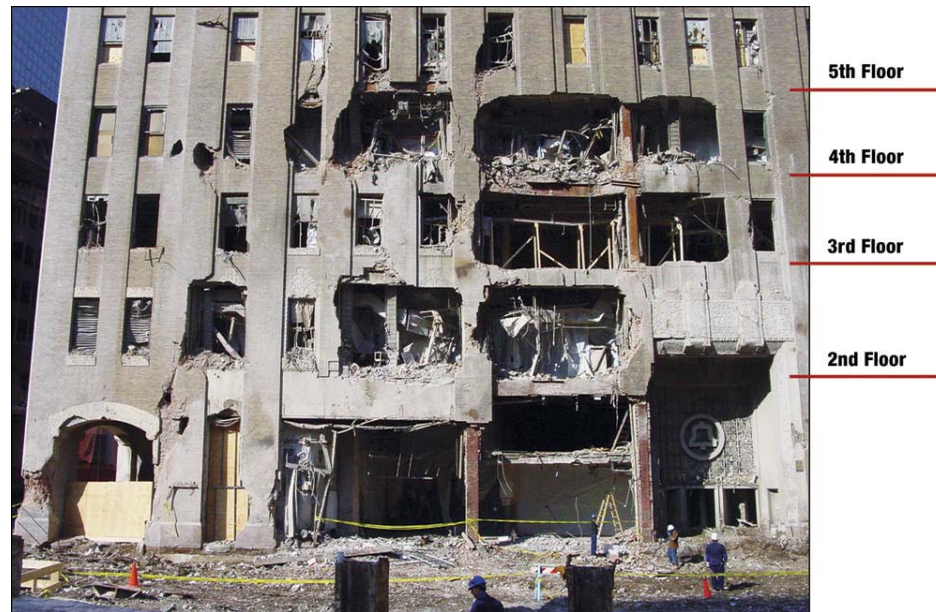
1. **Frame Buildings**  
Several buildings sustained localized damage resulting from impact from the collapse of the towers and WTC 7.
  - a. Figure 4 shows the east wall of the Verizon building at 140 West Street (c 1924) which is just north of Tower 1. This wall was damaged by the collapsed of WTC 7. Impact from the north tower resulted in several penetrations on the south walls. The exterior walls are at least 300-mm thick brick with clay tile backup.

Figure 4 - East elevation of Verizon building damaged by WTC 7.

- b. Infill provided redundancy for beams and girders as well. In Figure 4, except for the outer leaf of the wall, the masonry is in plane with the perimeter framing; this provided redundancy to the framing and allowed the walls to arch over openings created by the damage.

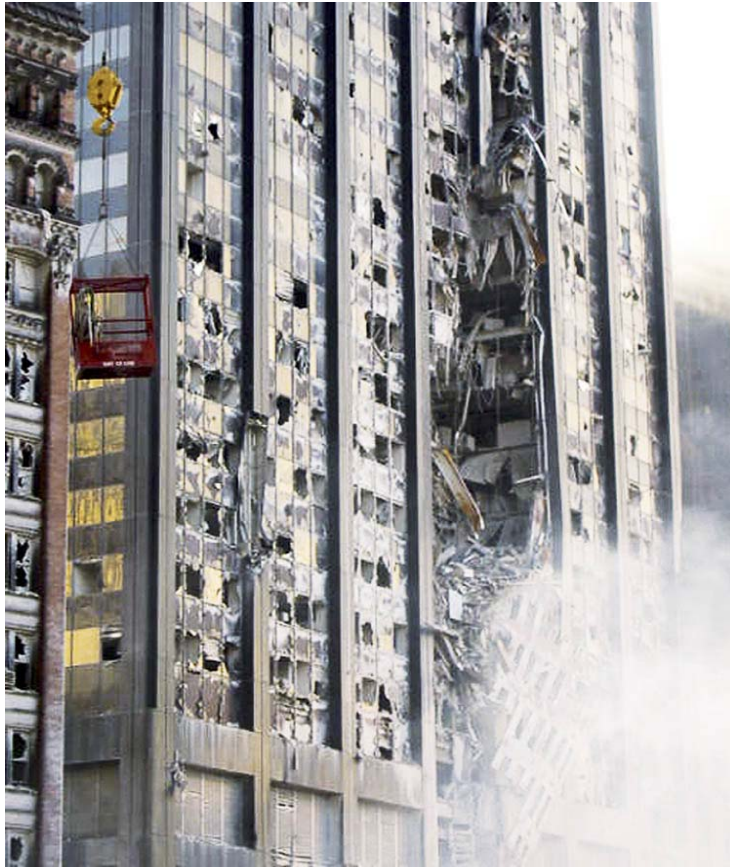
- b. In contrast to the masonry walls of the older frame buildings, the modern curtain walls did not provide protection to the frame. Figure 5 shows the curtain wall damage to 130 Liberty Street primarily resulting from wind borne debris and impact from the south tower (No. 2). This building was ultimately demolished.

Figure 5 – 130 Liberty Street, Banker's Trust

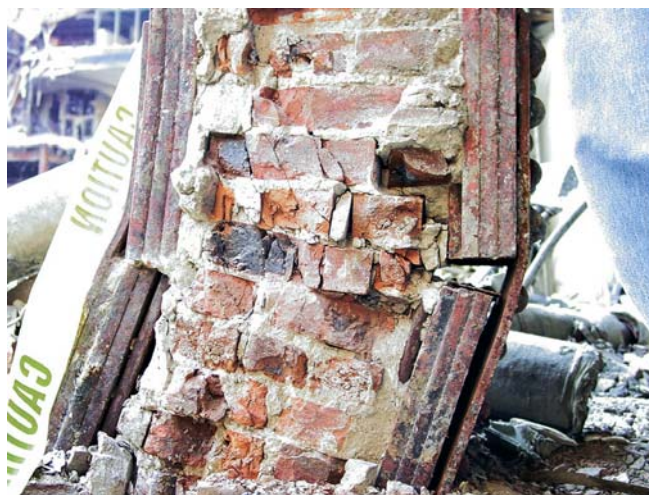
2. Masonry Infill
    - a. Masonry encasement of steel framed structures proved beneficial for several buildings. Figure 6 shows one of the damaged columns that deflected out-of-plane but remained stable and did not collapse because of the structural redundancy provided by the masonry infill.

Figure 6 – Redundancy of masonry infill

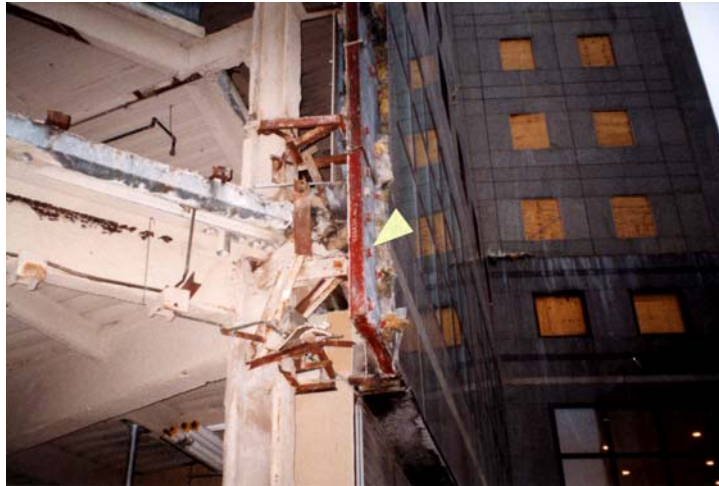
3. Masonry Veneer and Panels
    - a. In comparison to lightweight wall systems, masonry veneer was capable of absorbing significant impact energy and protecting the underlying frame. Figure 7 shows a building impacted by the south tower. The masonry veneer was damaged by replaceable; the framing was repaired.

Figure 7 – Panel damage showing sub-frame

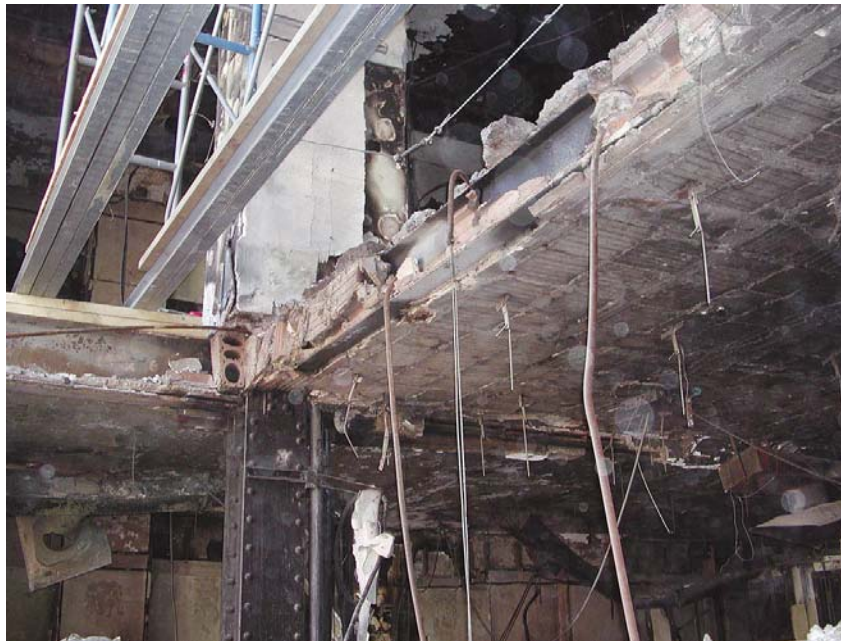
Masonry floor structures within an historic building performed better than the floors of any modern building. Figure 8 shows a portion of the floor system from the 1906 building at the corner of West and Liberty. The framing includes built-up and rolled section steel columns and beams. Columns are spaced at approximately 5.5 m on center. The girders run north-south with beams spanning in the east-west direction. The slabs are constructed of terra cotta flat arches covered with cinder-concrete fill

Figure 8 shows the exposed framing and flat arches where a portion of WTC 2 penetrated the building and damaged the floor. The adjacent bays remained intact in spite of the subsequent fire exposure.

Figure 8 - Flat arches intact except from debris damage from WTC 2.

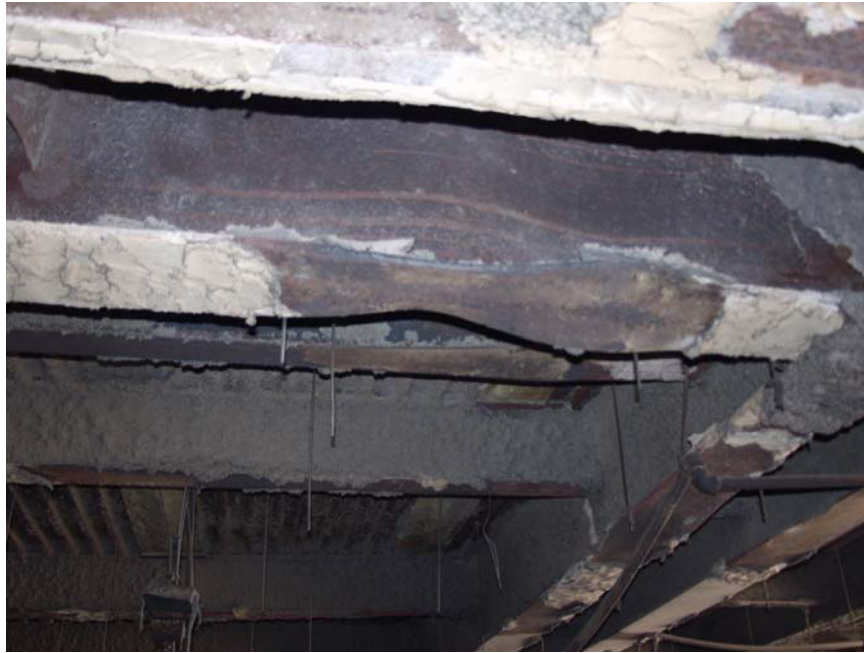
In contrast to these floor slabs, Figure 9 shows one floor area of WTC 5. WTC 5 was one of the modern office buildings in the plaza that was damaged by fire. Notice the significant warping of the framing due to the heat. Fireproofing is charred and flaked off. The older building with the masonry floor slabs and fireproofing performed better.

Figure 9 - Floor framing damage from fire in WTC 5

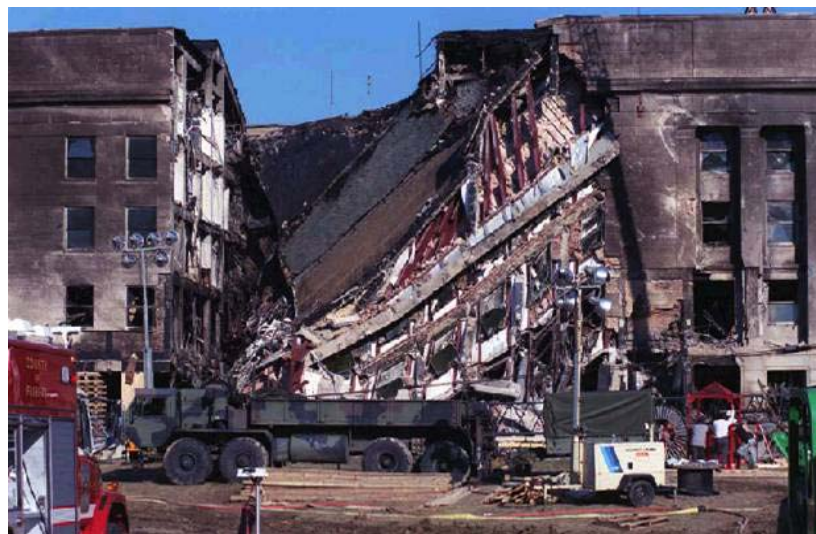
The impact area was approximately 36.6m along the exterior wall. There was relatively limited impact damage to the second floor. Fire damage occurred throughout. Approximately 20 minutes after the attack, the exterior wall partially collapsed because of the loss of first floor columns (Figure 10).

Figure 10 – Collapsed front wall at impact

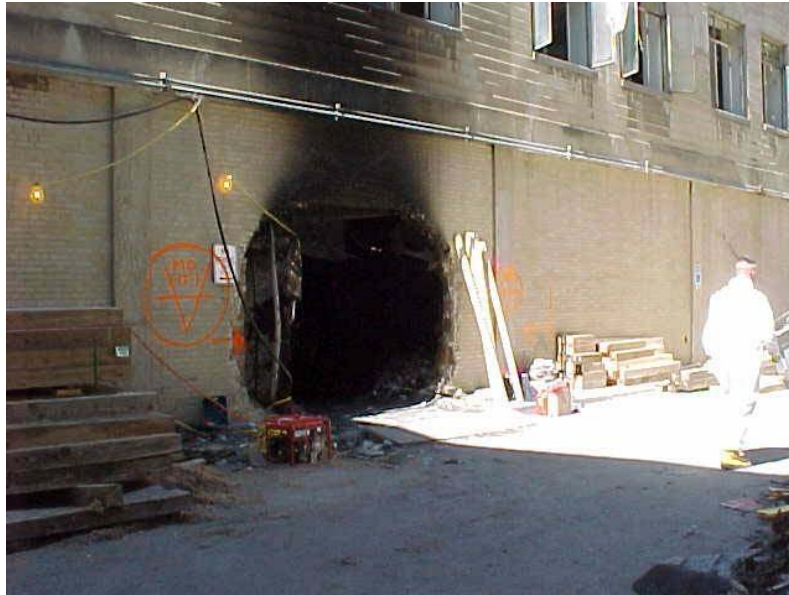
3. Following the crash, the structural system redistributed the weight of the building and its contents among the columns left standing, thereby limiting the collapse of floors above the point of impact. The beneficial system included short spans between structural supports; redundant and alternate load paths; and substantial continuity of steel floor reinforcement through the supports.
4. The masonry infill provided structural redundancy for the exterior walls. Figure 11 shows the arching action of masonry preventing collapse of the frame.
5. Upgraded walls performed very well.

Figure 11 – Masonry infill
