PERFORMANCE OF EARTHQUAKE STRENGTHENED URM BUILDINGS IN THE 2010/2011 CHRISTCHURCH EARTHQUAKE SEQUENCE

Ingham, Jason M¹; Dizhur, Dmytro²; Moon, Lisa M³; Griffith, Michael C⁴

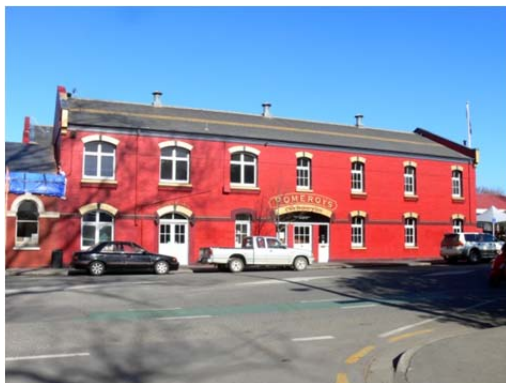
(a) Damage classification - Insignificant
Damage level – A
(292 Kilmore Street)

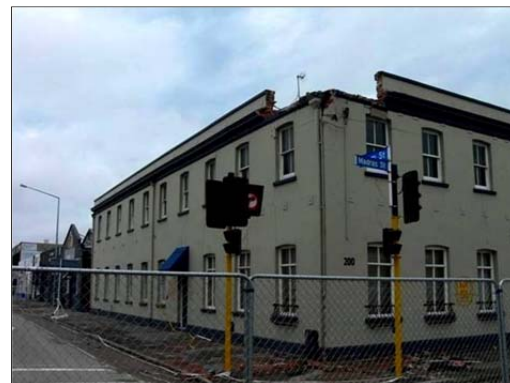
(b) Damage classification - Moderate
Damage level – B
(200 Madras Street)

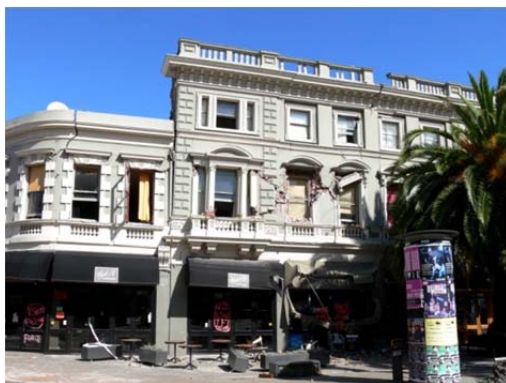
(c) Damage classification - Heavy
Damage level – C
(120 Manchester Street)

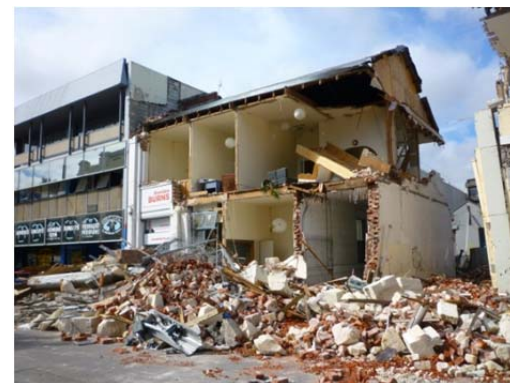
(d) Damage classification - Destroyed
Damage level – D
(202 Hereford Street)
