Remedial interventions for structural problems caused by fire in a historical building

Basak Ipekoglu and Mine Hamamcioglu

Izmir Institute of Technology, Department of Architectural Restoration, Izmir, Turkey

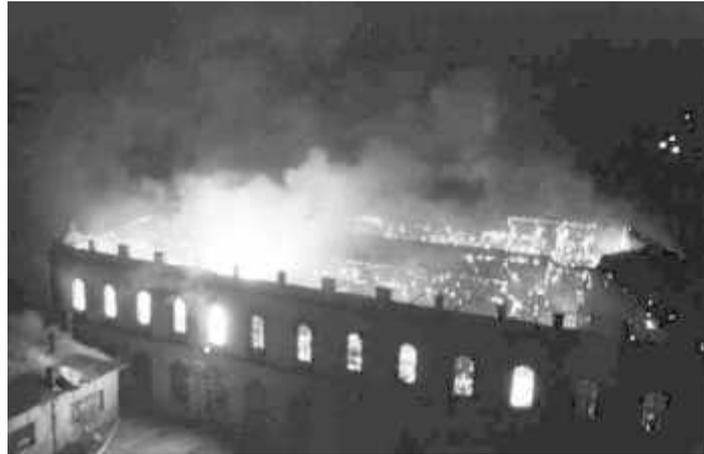
The superstructure of Izmir Mithatpasa High School Building was completely demolished after the fire it had undergone on March 31st, 1997. The absence of the roofing necessitated an urgent restoration work (Figure 1). The local office of the government, which was in charge of the building, asked Izmir Institute of Technology Faculty of Architecture to prepare the restoration project and to provide consultation during the following application phase. (Project Coordinator: Prof.Dr. Ahmet EYÜCE, Team Responsible of the Project: Assoc.Prof.Dr. Basak IPEKOGLU, Dr. Mine HAMAMCIOGLU) Yapi Merkezi, a construction firm experienced in restoration work, carried out the applications. The analysis of the structural system and the detailing of structural aspects of the project were carried out with the technical support of the Chamber of Civil Engineers in Izmir (Civil engineers in charge of the work: Muzaffer TUNÇAG and Necati UZAKGÖREN). Central Laboratories for Restoration and Conservation in Istanbul carried out the analysis of materials (Material Scientists in charge of the work: Prof.Dr. Ahmet ERSEN and Assist.Prof.Dr. Ahmet GÜLEÇ). Since the budget of the restoration phase was very limited, all types of project and consultation was provided without any financial payment.

Figure 1 : The building after the fire.

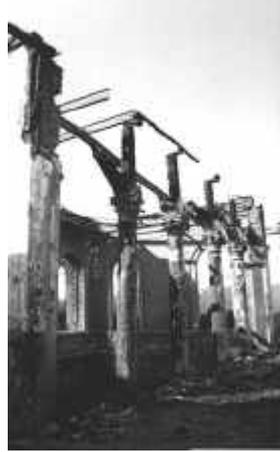
- Severe structural damages in the first floor: At the first floor, timber elements and stone-brick filling material of the walls were partially burnt. Consequently, metal connections in the walls were damaged. Plasters have split off the wall surfaces because of the extensive amount of heat. Timber skeleton walls covered with lath and plastering, and timber floor beams and their covering were so damaged that their repair was impossible. Timber doorframes were completely lost, where as the altered iron joinery of the windows were damaged. At the north corridor, the columns and arches defining the border of the monumental staircase were severely damaged. Here, the arches were constructed with timber laths and plastered. Similarly, timber columns

were plastered and whitewashed to create the image of marble surface. Column capitals imitating Corinthian style and stone column bases were all in ruins. At this space, the embellished ceiling was completely lost together with the roof (Figure 4).

Figure 4 : Columns and arches of the monumental staircase.

COLONNADED PARTS IN THE SPACE OF THE MONUMENTAL STAIRCASE: On the upper floor, colonnaded and arched part which formed the north side of the space which possesses the monumental staircase was completely devastated by fire. The thick timber columns together with their stone bases, capitals, original plasters and the arches constructed in wood-lath technique suffered severe damage. This part would be renewed with steel construction however the original formal features would be replicated in cast glass-fiber reinforced concrete.

On the upper floor, the colonnaded and arched part of monumental staircase was renewed with steel construction. This system was covered with cast glass fiber reinforced concrete material reproducing the original formal features. In this part, changes in loads during the implementation of the steel construction system caused an important problem on the marble columns at the ground floor, which were just below the new steel construction system. The surface detachment problem, which was only observed on the south surface before the implementation increased. New diagonal cracks, which were not determined before, occurred. This serious problem appeared before the placement of the pre-stressed concrete slabs over the steel construction. Necessary measures were taken at this phase of the implementation. After the determination of the problem, the structural engineers of the project developed a project, which would support the existing system. The arches were supported by the cradles included steel "false work" that could catch the arch. Then the physico-mechanical properties of the marble columns on the ground floor have been determined by experiments made in the Geology and Rock Mechanics Laboratory of the Faculty of Engineering of Dokuz Eylül University under the leadership of Prof. Dr. Necdet Türk and Geology Engineer Bahadır Yavuz. In the results of the experiments, it was determined that the marble columns lost their bearing capacity and the preservation of them could not be possible. The following decisions were taken for this part:

As a result of this opinion, the existing system was replaced with steel construction system and original formal characteristics were replicated with marble coating (Figure 9). At this phase, the experts of Yapi Merkezi, which was the implementation firm in charge, made significant contribution to the project.

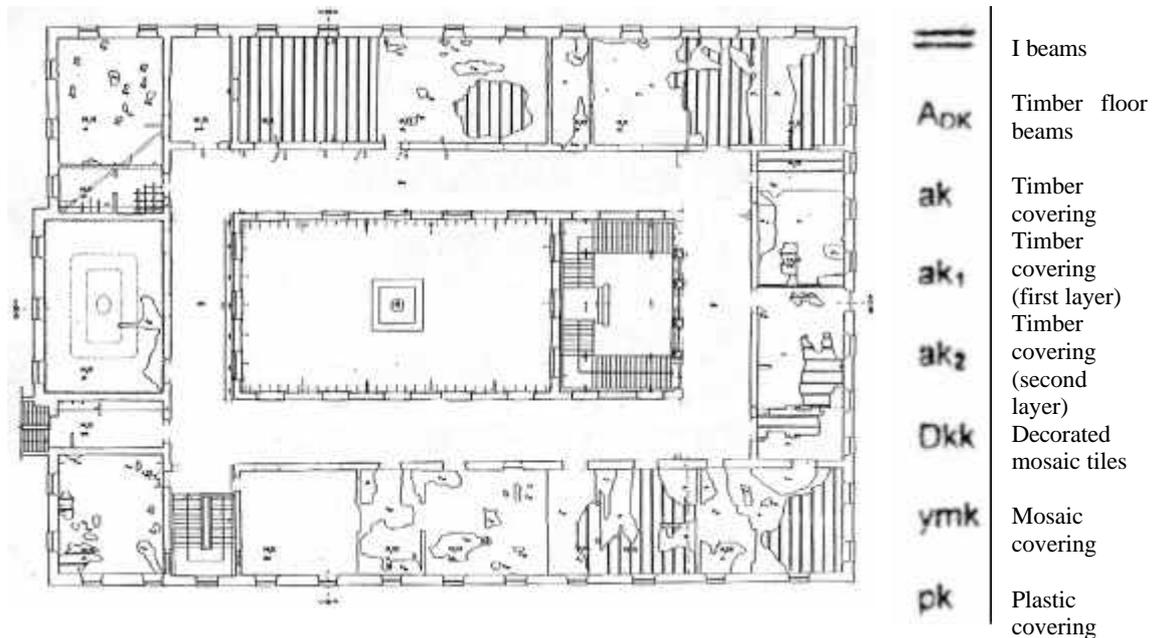
Figure 5 : First floor plan – Analysis of the damages

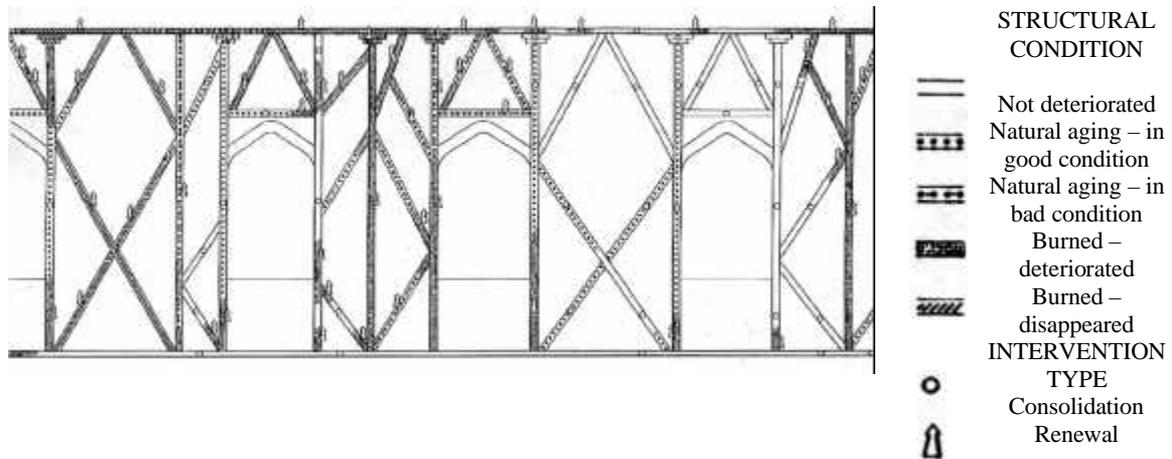
3. Wreckage Removal and Documentation: The burnt plastering on the first floor walls and thoroughly damped plastering on the mezzanine and ground floor walls were removed. After these removals, the damages in the timber elements of the combined walls were documented on the drawings of interior facades. The ruins on all of the four faces in each space were

documented via drawings and photographs. The types of damages and related intervention decisions were illustrated (Figure 6). Material samples were taken from the building.

Figure 6 : Structural analysis of walls with combined constructions and intervention decisions.

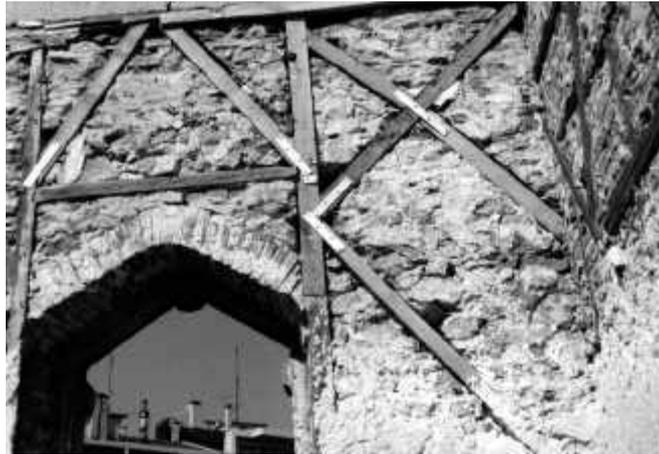
Figure 7 : Interventions on the walls with combined constructions.

The implementation was started with the removal of the plasters, which were not possible to preserve. According to the documentation drawings, which explain the intervention types that would be carried out in the timber skeleton system, the burned elements of the timber skeleton system were partially renewed with the new timber material in the same properties with the original material. However, mostly the original material was preserved and surface consolidation was provided with appropriate chemical composition. Metal clamps in the good condition of the timber skeleton system were preserved while the ones affected by fire were replaced with newly designed ones (Figure 7). The top level of the walls was completed with reinforced concrete beam and the system was strengthened with reinforced concrete beams and steel beams at necessary locations. Then pre-stressed concrete slabs were placed and connected to the concrete beams. Timber skeleton partition walls, which were burned, were reconstructed according to the restoration project (Figure 8).

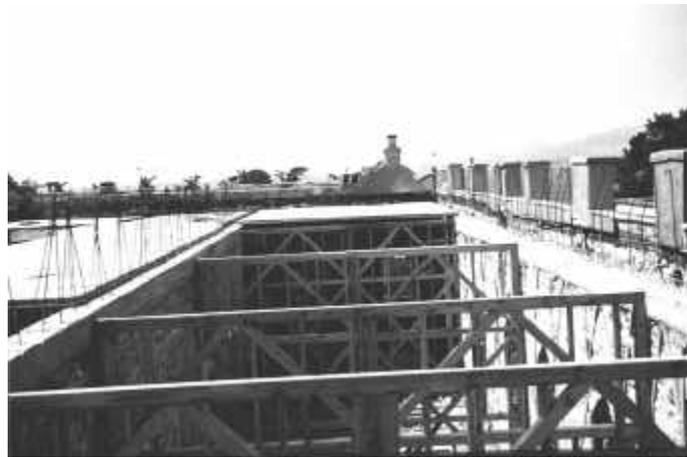
Figure 8 : Pre-stressed concrete slabs and timber skeleton partition walls.

Original partition walls, which were constructed of timber skeleton and covered with wood-lath and plastered, were severely burned and it was not possible to restore them. For this reason, these walls would be reconstructed of timber skeleton with the principle of the continuity of completeness in the historical construction system. They would be covered with fiber sheets for insulation and then with gypsum board. New partition walls which were designed in the restoration project would be made of gypsum board to emphasize that these are new parts belonging to the restoration phase.

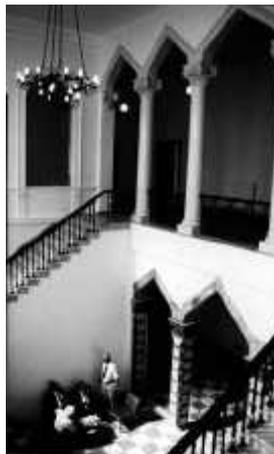
Figure 9 : Monumental staircase after restoration.
