## Restoration of Capela da Nossa Senhora do Monte - Old Goa

S. C. Deshpande

Sandhya Savant

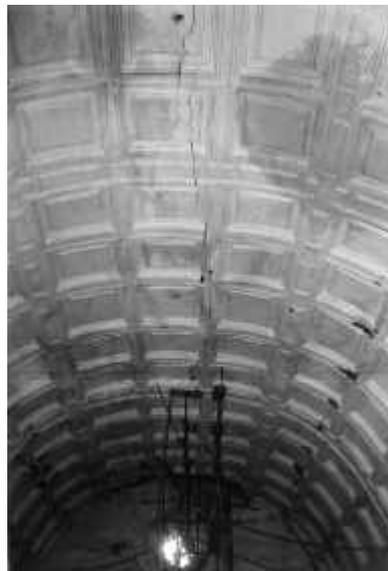
Figure 2: Interior view of the Nave vault – showing the crack

Around 1980 it was noticed that the vault had developed a crack in the longitudinal direction. Over time this crack widened causing dislocation of some of the laterite stones and two or three of them separated and fell to the ground. Timely temporary propping of the vault prevented

further collapse as seen in Fig.2. It was in this condition that the local parish approached the Fundacao Oriente, a Portuguese cultural trust to take up the restoration works. The Fundacao Oriente decided to appoint a team of conservation specialists with Mr Luis Marreiros, from Portugal as the technical director. In turn, locally, conservation architects (Bombay Collaborative) in association with structural engineers (Sewri Consultants) were commissioned to form a complete technical team to plan and execute the restoration work.

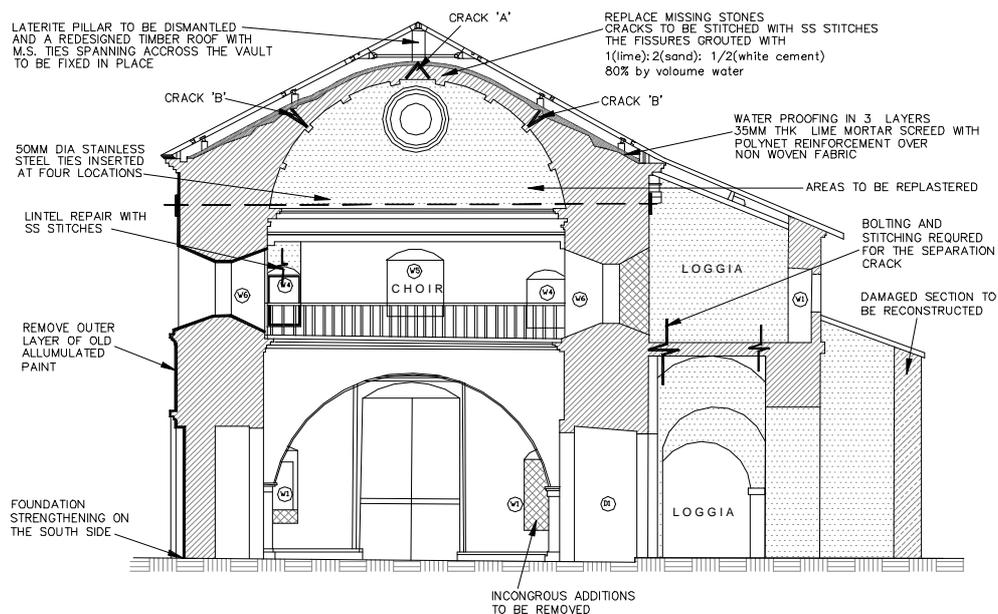
The monument became a topic for discussion and finally a subject for undertaking restoration work when a longitudinal crack (A) as seen in the Fig.3 was noticed. This crack extended longitudinally throughout the length of the vault. The other cracks, at the quarter points of the arch of the vault (B) were also clearly visible. These were seen as hairline cracks from the inner side, whereas the stone had clearly separated at the outer surface, i.e. the barrel arch had developed a central longitudinal crack, where the inner face (intrados) was in tension and outer face (extrados) was in compression. In the case of the longitudinal cracks along the quarter points of the barrel vault, however, the intrados were in compression and the extrados were in tension. As a result of this cracking pattern, the entire vault was in structural distress. Strengthening and rehabilitation of the vault was one of the main structural design problems to be tackled.

Figure 3: Section showing the cracking of vault schematically and all the other Structurally distressed areas

1. It was noticed that the south wall was out of plumb by nearly 100mm.
2. The gable ends on either side of the nave had separated.
3. The lintels of the windows on the west façade had cracked due to a lateral crack running across the façade.
4. The Loggia, which was a later addition, showed signs of separation from the main building.

From all the signs of structural distress it was clear that there had been some movement caused to the foundations. The exact reason why this had occurred could not be ascertained. The reason for this foundation movement could be settlement of foundations, deterioration of laterite rock used as the material of construction in the foundation work over a period of time, or even effects of earthquake tremors. Sliding of the hillock slope as a possible reason was examined but discarded, as no distress was seen in the laterite steps leading to the Chapel. In any case, if such a phenomenon had occurred, the slope of the hill must have achieved its residual angle over a period of the last 450 years. Be that as it may, the wall had lost its plumb for one of the reasons cited above and the vault had consequently opened like a cracked nut. The structural rehabilitation of the vault therefore meant, initially the foundations had to be strengthened, before the other structural restoration works were undertaken.

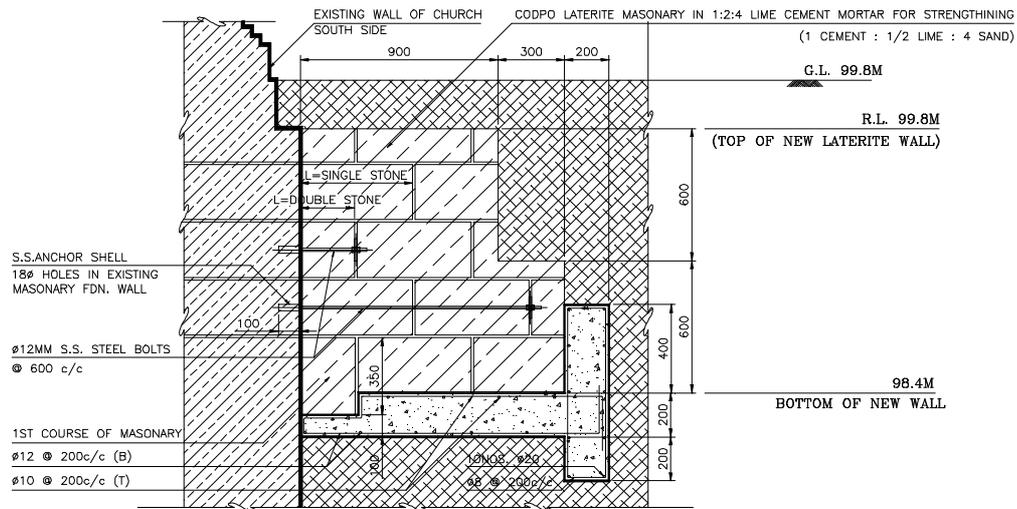
Figure 4: Drawing showing the foundation strengthening detail

The design concept to strengthen and buttress the existing foundations was to add extra mass by the side of the existing foundation, attach the new mass to the old foundation by means of S.S, anchor bolts and ties and create a foundation system, such that the entire foundation does not move laterally. As far as vertical settlement of the Chapel wall is concerned, it was assumed that since the foundation has been constructed on laterite rock of the hillock, vertical settlement is not the main issue and whatever vertical settlement was to take place, has already occurred. Adopting a cautious approach underpinning of the existing foundation was thus not attempted. The original laterite rock, of which the foundation was constructed, appeared to be fairly intact and had not crushed or deteriorated over time. In keeping with this design philosophy, the foundation design system as seen in Fig. 4 was adopted for the south wall. A similar system was adopted for the two buttresses on the north wall.

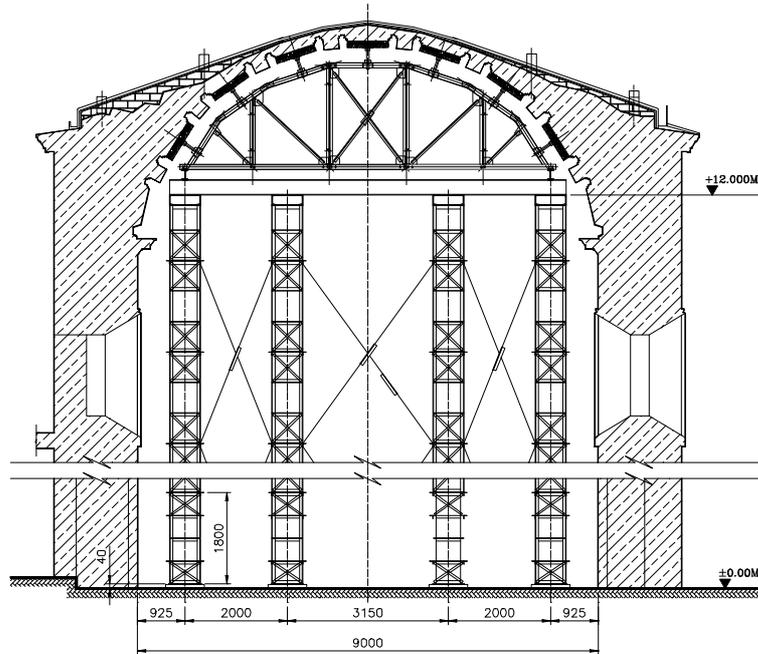
Figure 5: Drawing showing the temporary supporting system

Fig. 5 shows the temporary supporting system designed to support the vault during the process of vault structural consolidation. The system consists of structural steel trestles, on which structural steel arch trusses were erected. The trusses had a provision for attaching, adjustable stirrup head jacks in which timber scantlings, could be placed. These timber scantlings supported plywood formwork plates. Between the vault underface and the plywood formwork plates was sandwiched a layer of 100mm thick foam. The stirrup head jacks were adjusted so that the plywood formwork plates supported the load of the vault surface, with the foam sandwiched in between. The reason for introducing the foam layer, was to ensure that the offsets of the coffers on the underside of the vault, are not damaged.

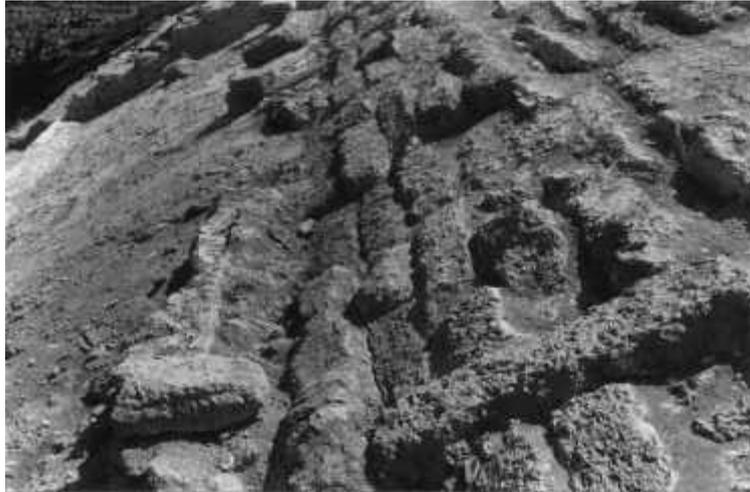
Figure 6: Photograph showing the vault surface when exposed with the timber roof dismantled

With the vault firmly supported, the next step was to grout and stitch the cracks from above. To achieve this, the entire timber roof above the vault was dismantled and the upper surface of the vault exposed as seen in Fig. 6. The exterior surface of the vault was cleaned and the cracks were located and exposed. It was observed that the cracks ranged from 20mm to 50mm in width. The first step was to refix the dislocated stones. Then the cracks in the vault and the portion that had separated from the gable walls were stitched, with the use of stainless steel stitches. (The various types of stainless steel stitches used in this rehabilitation work are described later in the paper.) Subsequently a pointing mix of [1 part lime: 3 parts sand + 5% Acrylic resin] was used to fill the cracks.

Having restored the vault to this extent, further strengthening was carried out by means of general overall grouting of the vault surface / profile by means of drilling holes, fixing an appropriate nipple and attaching a grout feeder pipe to pass the grout into the main body of the vault. Various mixes of the grout were experimented and tested earlier in the laboratory and later verified for site conditions by means of field tests, before being adopted for work at site. The grout mix finally used was [1 part lime: 2 part sand passing 600 microns: ½ part white cement: 80% water by volume (Unit volume = lime + sand + white cement)] The grouting operation was carried out under a very low gravity feed pressure (maximum  $0.1\text{N/mm}^2$ ). The entire vault consumed nearly  $5\text{m}^3$  of grout.

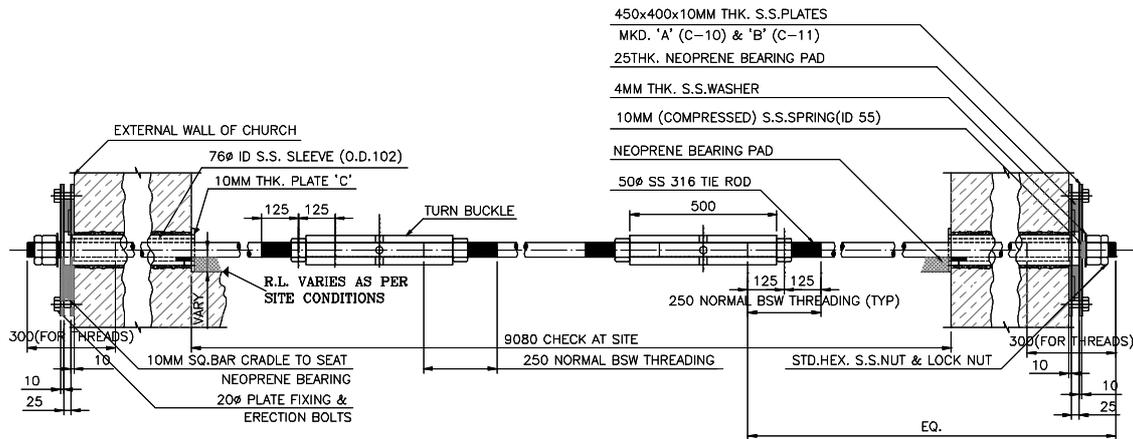
Figure 7: Detail of the ties

While this process was in progress, four horizontal holes were drilled through the 2.7m thick north and south walls exactly opposite each other, to place stainless steel ties as tension members, to prevent any lateral movement of the walls. The detailed design of the S.S. ties is shown in Fig. 7.

The ties mainly consist of a stainless steel bolt SS 316, 50mm in diameter in three parts joined by two intermediate turnbuckles. The holes drilled, were lined by a stainless steel pipe 6mm thick as a liner. The ends of the ties abutted against the wall face by means of two stainless steel plates 8mm thick, with neoprene bearing pads as a sandwich layer. The neoprene pads were placed to permit slight movement in the system / bolt, that might occur due to difference in temperature, or lateral forces like earthquake tremors etc. The end of the bolt was anchored by means of a hexagonal nut, tightened till refusal and followed by a lock nut. The entire bolt / tie assembly is as erected and placed under the vault is shown in detail in Fig. 8.

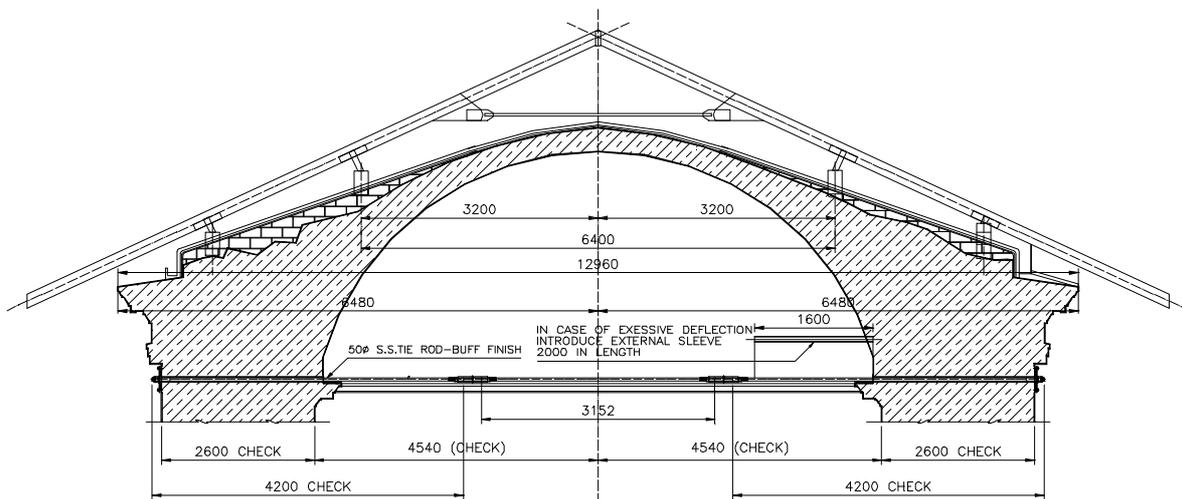
Figure 8: Entire S.S. Tie Assembly as erected and placed under the vault

pedestals on the crown of the vault were eliminated and instead, a horizontal mild steel tie was introduced to span across. Thus the wind load is transmitted to the sidewalls of the Chapel which are about 2.7m thick. The barrel of the vault, hence, is protected from unnecessary vibratory loads. All nails and screws piercing the timber, are of S.S. 316 grade, to avoid any splitting of the timber due to corrosion. Fig. 8 also shows the arrangement of the timber truss forming the new roof design.

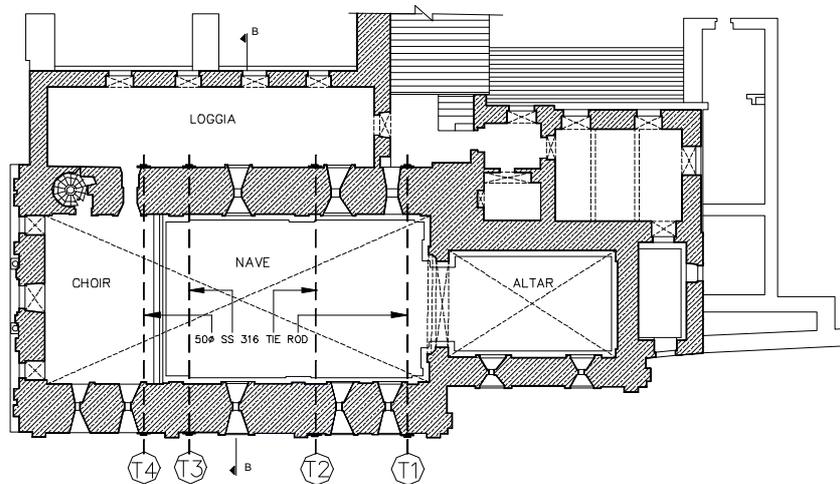
Figure 9: Key plan showing location of the ties

Four such ties were placed in the entire vault, at convenient locations as seen in the key diagram as shown in Fig. 9.

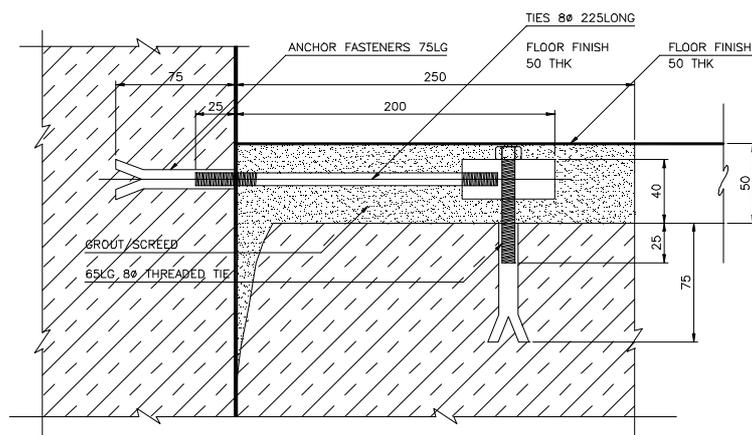
Figure 10: Detail of Stitch between a vertical wall and the Horizontal plane

Different stitches were designed for appropriate locations, as required. The stitch as shown in Fig. 10 was necessary where the vertical walls and the horizontal planes of the vault or the floor slab had separated. This had occurred where later additions like the loggia had separated from

the main Chapel. Due to the movement in the foundations the gable walls showed signs of separating from the vault profile.

To describe the stitch, an anchor fastener is placed in a vertical wall and a tie is screwed in to it. The end of the tie has a flat plate with an eyehole drilled into it. An anchor fastener is then drilled in to the horizontal surface in alignment with the eyehole of the flat plate. A vertical tie is now threaded through the eyehole and a nut is tightened on the faceplate by means of a hexagonal nut. Thus a vertical surface gets anchored to a horizontal surface.
