The Grand-Place of Brussels

Paula Cordeiro

City of Brussels, Historical Heritage Department

ABSTRACT: The Grand-Place of Brussels has been on the UNESCO's world heritage list since December 1998.

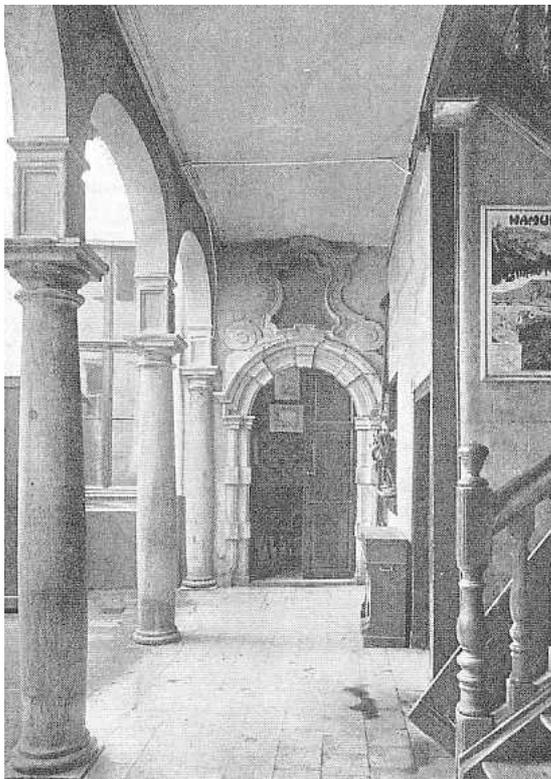
Figure 3 - Brussels City Archive, "Comité du Vieux Bruxelles." 1905.

Taken in 1905, this old picture shows the access to the building in the back of the parcel. The staircase to the floors is on the left and a series of arcades are open to the courtyard. Despite its important architectural value this space was destroyed in 1926.

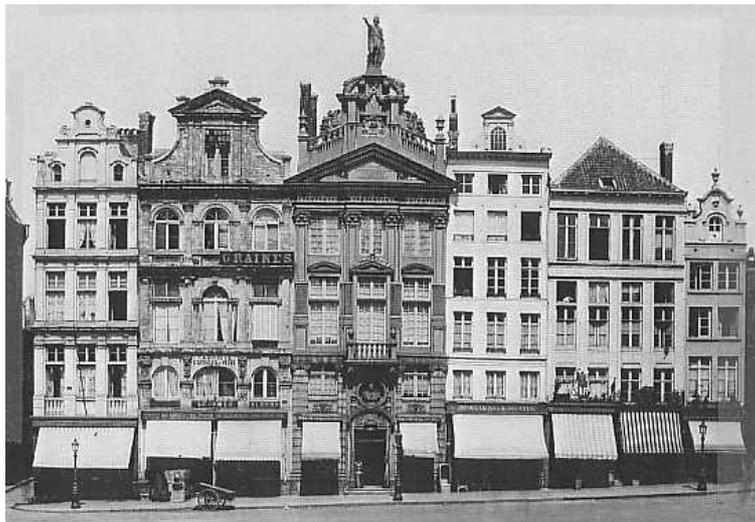
Block of houses n° 20-28

Figure 5 - Picture around 1895 showing the situation before the 19th century works.

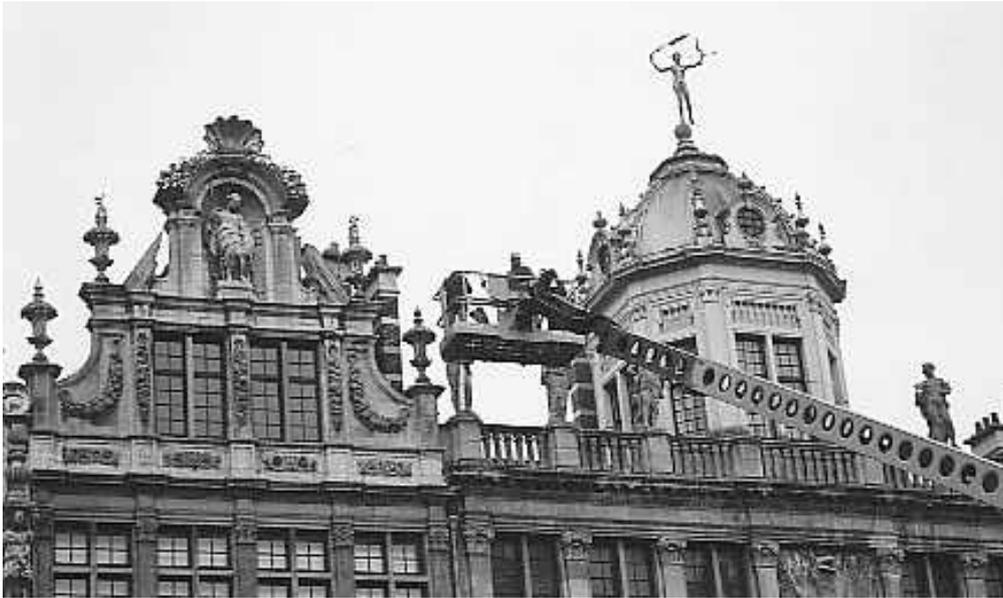
Figure 7 - Inspection carried out in 2000 to evaluate the state of conservation of the façades.
© Historical Heritage Department. 2000.

In order to evaluate the state of conservation of the façades a visual inspection was carried out during June 2000.

The pathologies affecting the façades were identified, documented and indicated on the drawing.

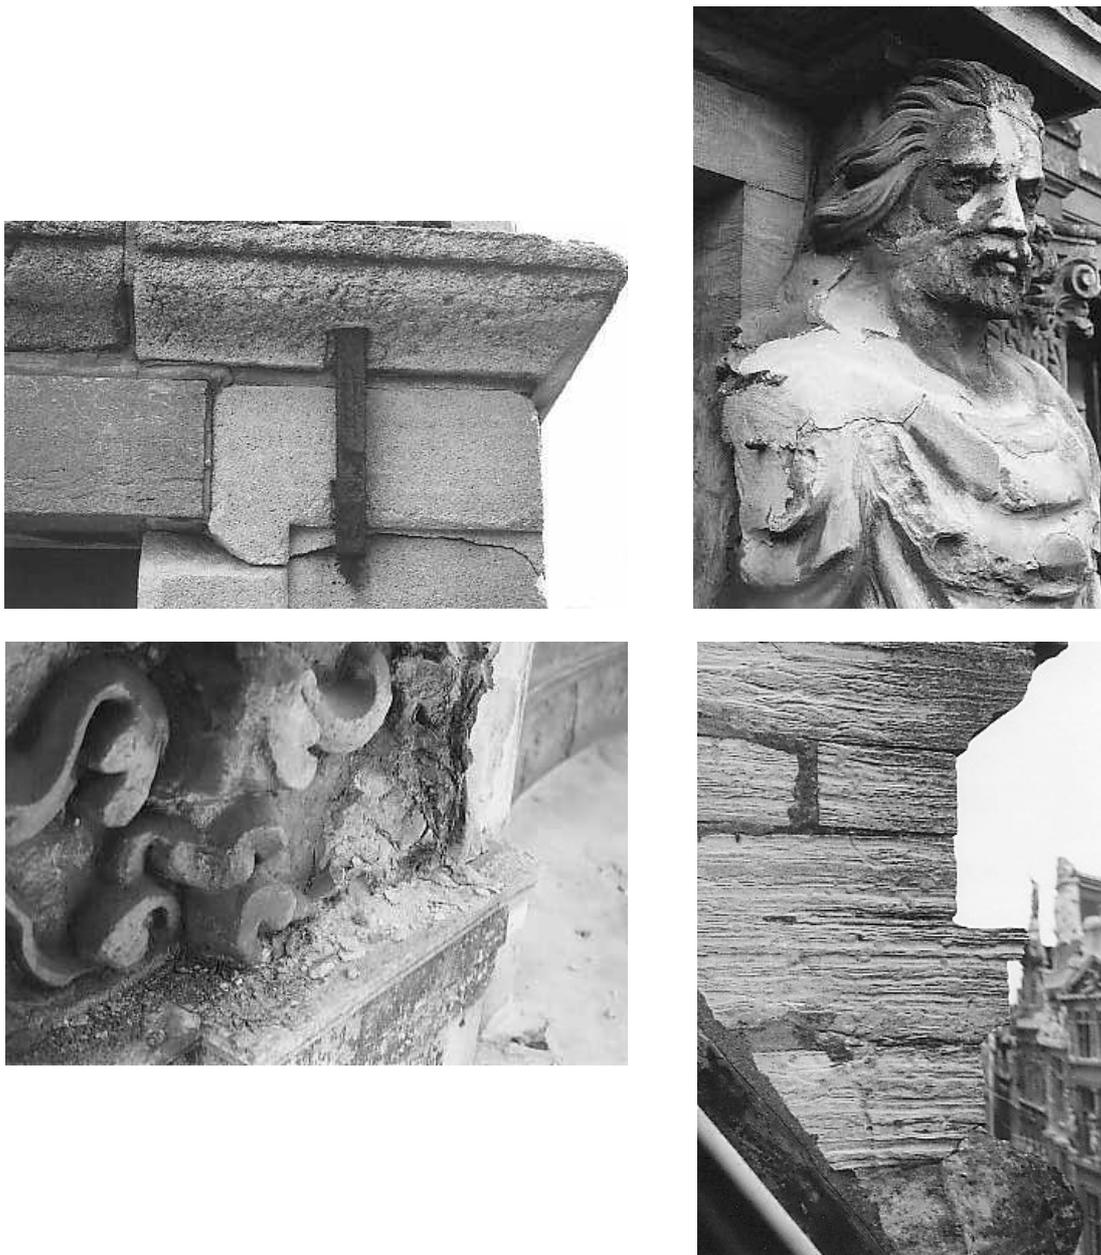
During the survey at least four different types of stone were identified (e. g. Baelegem, Gobertange, Euville and pierre bleue). Over the years these stones were subjected to several kinds of alteration. These alterations are mainly due to the effect of natural weathering, including air pollution.

In general, the façades present an advanced state of degradation. The Baelegem stone is difficult to recognise due to several layers of cement. The Gobertange stone has been attacked by atmospheric pollution agents. The surface directly exposed to the rain is constantly washed leading to a faster degradation. The Euville stone is prone to deep degradation, the outer surface is deteriorating into powder.

The main deterioration patterns found are black crusts, flaking, scaling, exfoliation, sugaring and powdering, fissures and fractures.

The materials used during the 19th century restoration led to serious degradation. The façades were restored and rebuilt partially or in whole and the interior was conserved. Metallic supports were used to support the existing floors, being incorporated into the stone façade.

Since then, due to water infiltration, these metallic elements have corroded and have cause serious problems: elements out of line, fractures and fissures in the stones.

Figure 8 - Examples of deterioration and alteration.

The project only addresses the cleaning and conservation of the existing masonry. The study carried out in 2000 provided information for the development of the restoration project. A first list of work was drawn: removal of biological colonisation; cleaning; removal of non – functional and/or unesthetic mortars, repointing of joints and micro-filling of surface

discontinuities; fixing of surface scales by injection with fluid mortar; treatment of iron elements; resetting, stabilisation and anchoring of the gable.
