## Rehabilitation of the Minho line's Areosa and Afife masonry railway bridges

**ABSTRACT:** The Areosa and Afife Bridges, sited respectively at PKs° 85.619 and 91.487 of the Minho Line, are two of that Line's most beautiful and emblematic Bridges of this kind. Built in 1890, they are two masonry structures made of stone elements, forming an abated arch vault with an approximate span of 14 and 12 metres respectively.

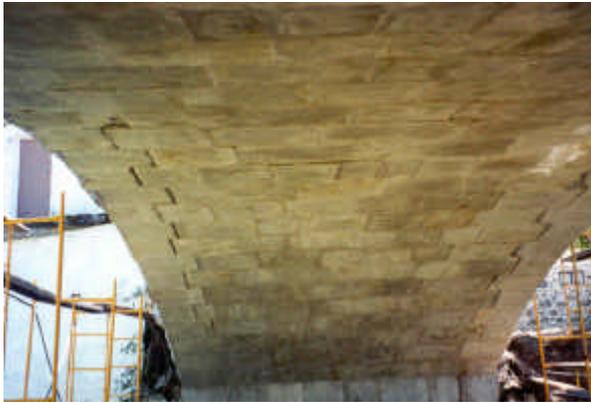
Both structures showed evident signs of degradation with cracks in all of the intrados of the vault, standing out two greater sized cracks that followed the structure in a longitudinal direction causing the detachment of the frames. Even thus, the masonry elements of those lateral faces were perfectly levelled between themselves. In the Areosa Bridge, the one showing greater damage, a slight subsiding of the inside of the vault could be seen, with some individually displaced stones.

The gradual subsiding of the inside of the vault was a consequence of the detachment of the frames, in its place caused by the dragging of fine coating material from the interior of the strongbox outwards.

Figure 3: Areosa Bridge – Frame detachment

These abnormalities derived not only from the antiquity of the structures and the action of rain water over the years, which progressively degraded the masonry joints, but also from the low height of the existing ballast, which led to a greater dynamic aggression on the part of the passing rolling stock.

In this way, considering the observed degraded state of both Bridges, and in order to stop the existing restraints that were harming normal railway traffic, the rehabilitation of both structures was carried out.

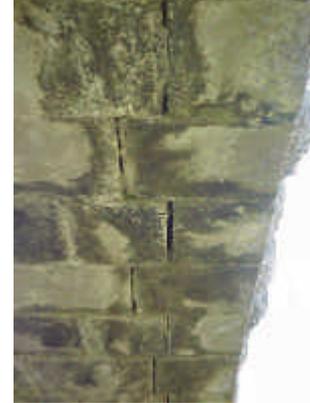
Figure 4: Detail of the crack

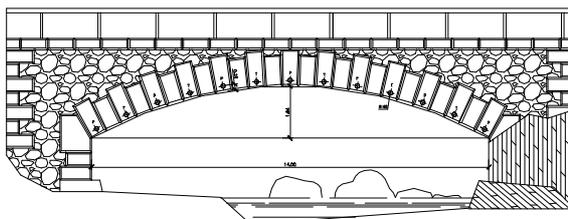
Figure 5: Solution type – Trussed beams and pegs

Of all received proposals the S.T.A.P., *Reparação, Construção e Modificação de Estruturas* (Repair, Construction and Structure Modification) SA company was selected, which accompanied by the Engineering and Services Cabinet. Their solution foresaw the use of trussed beams and pegs placed transversally to the railway line, to be later sealed with a cement solution.

The project developed for the improvement of the Areosa Bridge consisted basically of globally increasing the stability of the elements that compose it, namely the masonry structure of resistant stone, on its transversal plane.

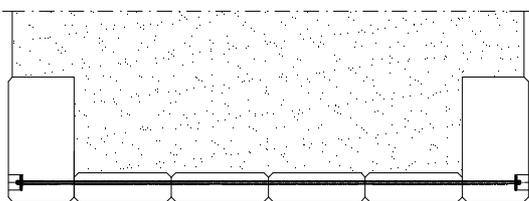
Figure 7: Trussed beams

Thus, the stopping mechanisms consisted in the placement of trussed beams, alternately applied with 1.5 meter long pegs (latches) being placed in the greater sized stones, totalling 6 beams and 7 pegs on each side of the Bridge.

The rods used on the beams and pegs were made of A400 NR steel, with a diameter of 25 millimetres, threaded at M20 at the tops and endowed with both a nut and a lock-nut. In the anchorage and distribution plates S235 JR steel was used with  $\text{Ø} 150 \times 10$  mm, which were set over cushions of retraction-free mortar. All these metallic elements were subjected to an anti-corrosion protection treatment that included mechanic scouring at the degree of AS two and a half, and the application of a coating of zinc dust rich primary epoxy – 100 microns.

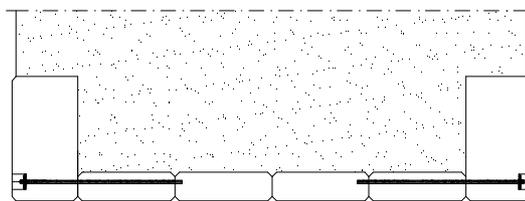
Figure 8: Pegs

The application of the latches worked as a complement to the beams which had the goal of establishing a proper connection between the lateral faces of the Bridge and the rest of the structure, acting in a cutting and traction way, thus stopping any relative movements.

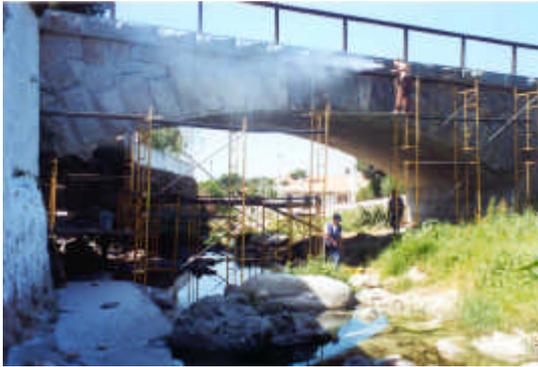
Figure 9: Areosa Bridge – Cleaning

Work began with the cleaning and repair of all masonry joints. Those that showed degradation or looseness were properly pricked, washed and blown with the care needed not to damage the stone. In the same way, those that had been colonised by grass, algae or lichens, were given a biocidal product, being their removal carried out with the least possible damage to the masonry. The mortar that was strongly connected and consolidated to the stones was left untouched, as it was “healthy”. In general, the joints were exposed to a depth of about twice their width.

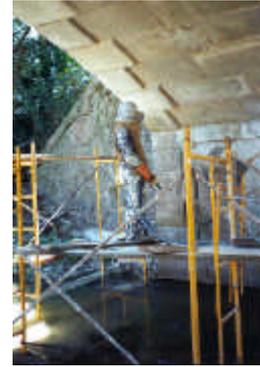
Figure 10: Afife Bridge Cleaning

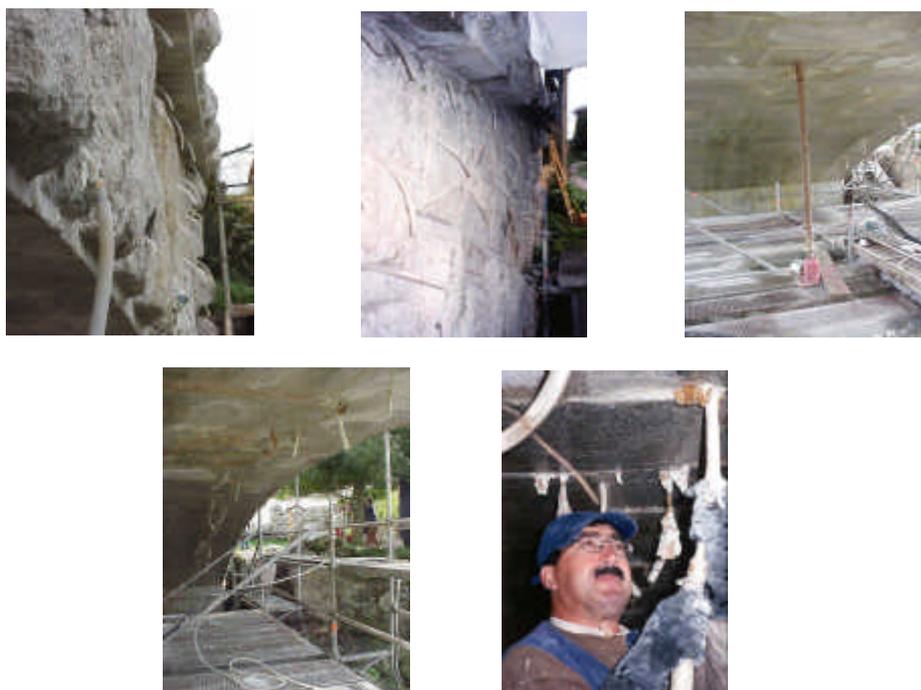
Figures 14, 15, 16, 17 and 18: Injection of the Bridge's strongboxes

After the accomplishment of the re-closure of the masonry joints with mortar, so as to allow them to function with an impervious lateral curtain, the injection of the cement solution was started in order to fill up empty spaces and to consolidate the filling material of the Bridge's strongboxes.

This injection was carried out, whenever possible, from the bottom to the top, at low pressure, from previously executed holes that crossed the covering stones. These rigorously made holes were made with a mallet and small beams following a network set in staggered on both sides of the Bridge and also on the inside of the vault 1" tubes were left in these holes that served for both the injection of the solutions and for purges made to verify their level of progression. In this way, the advancement of the solution in height could be controlled, making sure that the area would be perfectly filled up and thus consolidated.

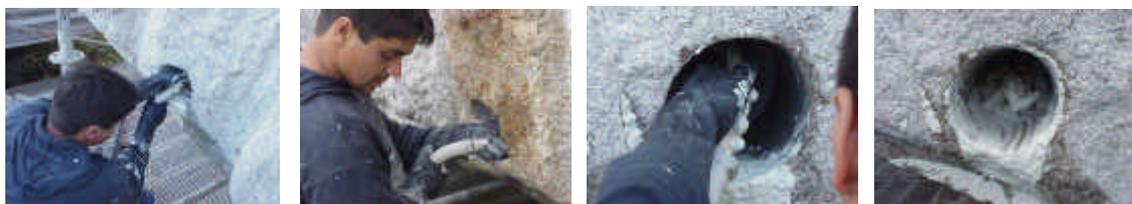
Figures 19, 20, 21 and 22: Injection of the beams and pegs

This operation was carried out simultaneously with the injection of the be60ams and pegs and finished after all tubes had been conveniently sealed.

The solution was made with a product consisting of special cement and additives, of great fluidity, easiness of pumping, lacking retraction or exudation and of adequate mechanic resistance to the surrounding masonry. It was prepared with appropriate equipment, with an initial induction of 80 % of the total amount of water required, followed by the application of the cement-based product in a quick and continuous way until a plastic and homogeneous mixture was obtained. Later, the remaining 20 % of water were added.

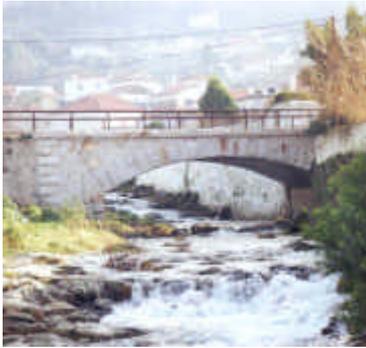
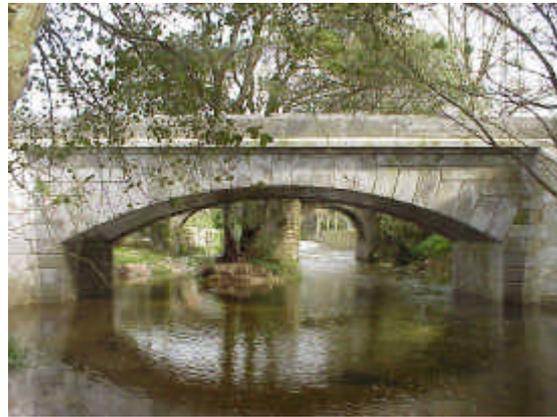
Figure 23 and 24: Areosa and Afife Bridges – Final look

Finally, after verifying that the nuts were properly screwed, all injection tubes were removed and the plugging of negatives was carried out. These had been previously opened to make the beams and pegs using the same stone mould which was meanwhile reused and disguised with mortar so as to try to “imitate” the texture of the stone.
