Actions implanted to promote the restoration of emperor D. Pedro II's Palace in the city of Itapura - S.P. - Brazil

3 RESTORATION AND REFORM OF "THE EMPEROR'S PALACE"

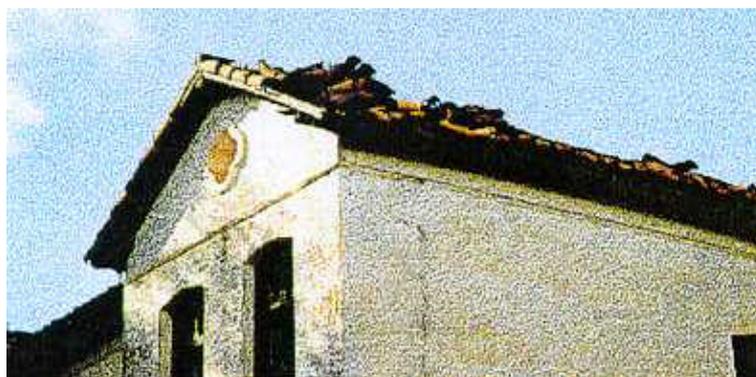
Figure 3: Detail of the Roof

The roofing is constituted of tiles of earthenware and wood structure. It is quite damaged presenting several points without roofing, exposing the woodwork and compromising the whole structure.

The whole woodwork of the existent roofing should be repaired or substituted, with the purpose of eliminating current problems of the action of insects and the deterioration by humidity.

About 80% of the roofing tiles should be substituted, for another of same type, material and dimensions and the remaining tiles will be submitted to a cleaning process.

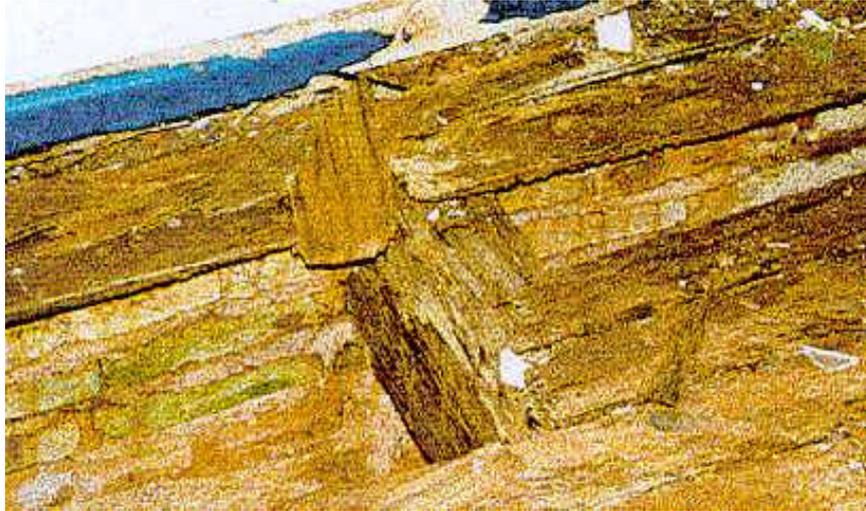
The floors of the two pavements are compromised, implicating the replacement of the elements that it will not be reutilized. After the substitution, the floors will be sanded, caulked and later all the floors should receive application of protecting resin.

Figure 4: Detail of the compromising of the floor and of their supports.

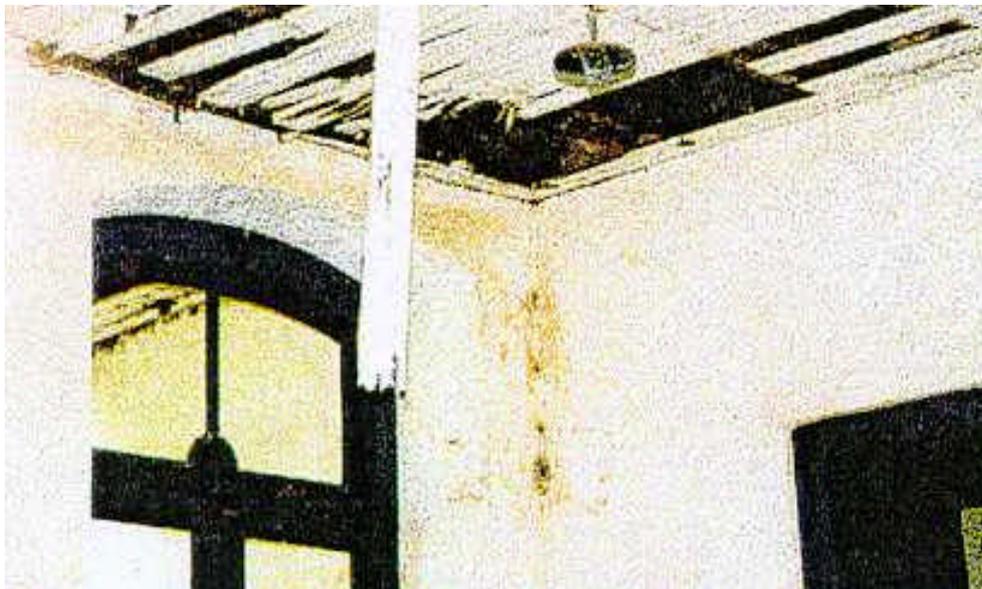
Figure 5: Detail of the ceiling.

The building possesses internally as well as over the balcony wood ceiling installed in a simple way. Due to very bad conservation state, it will be completely substituted by equivalent material or following specifications resulting of research.

The edges of a roof will have the ceiling recomposed according to the original. Afterwards the ceiling and the edges of the roof will receive coatings with appropriate varnish paint.

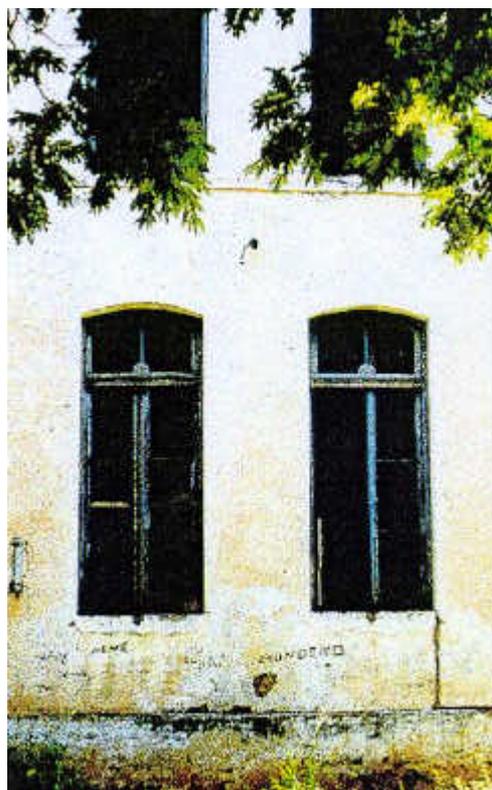
Figure 7: Window-sashes.

The window-sashes in general are in reasonable state, seeming to have been recently fixed. However, due to the continuous vandalism and the inadequate finishing, they are in need of urgent repairing. Therefore, they should have the movable parts replaced and the static parts treated with appropriate varnish.

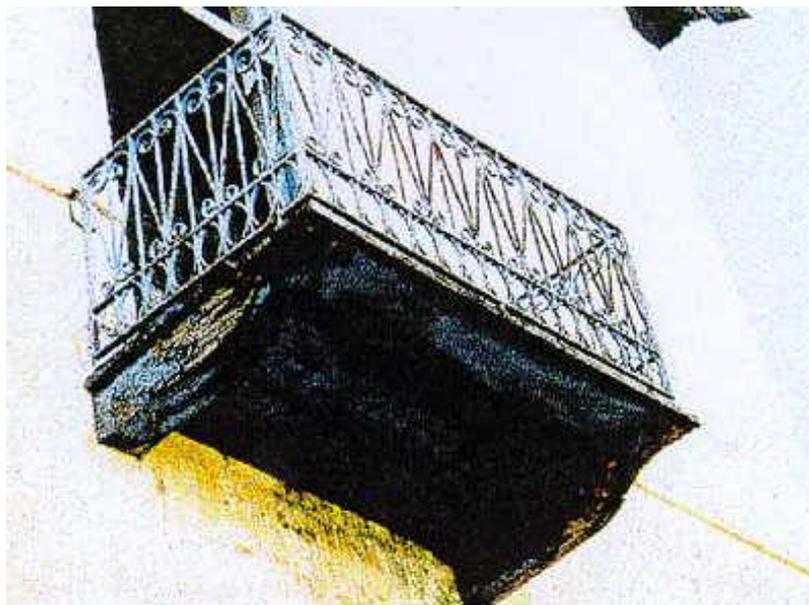
Figure 9 : Detail of the balcony of in superior pavement

The damage to the facades seems to be restricted to some small repairing and superficial fissures covering, besides the walls whitewash wearing.

As a general guide to the restoration of the building, there exists a serious concern in the attempt to returning the facades to their original conception. For that, an effective cleaning and subsequent rebuilding of parts will be performed, followed by whitewash application in color defined after careful research.
