## Study, diagnosis and rehabilitation of the wooden slabs of two palace houses in Seville

C. Rodríguez Liñan, P. Rubio de Hita, J.C. Gómez de Cózar

*University of Seville, Technical School of Architecture, Department of Architectonic Constructions, Seville, Spain*

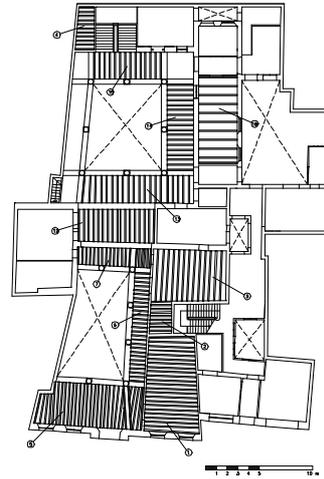
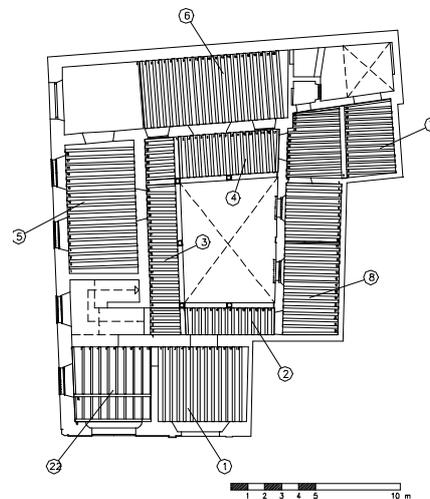
The beams of the wooden slabs have been represented in the ground plan (Fig. 2 and 4) with the rooms numbered. The beams that have been studied are in bold. There are four types of wooden slabs.

between the 10 and 20% of the total) which showed more traces of damage. These beams are in bold in the ground plans (Fig. 2 and 4) and all the slabs studied are also numbered to be easily spotted.

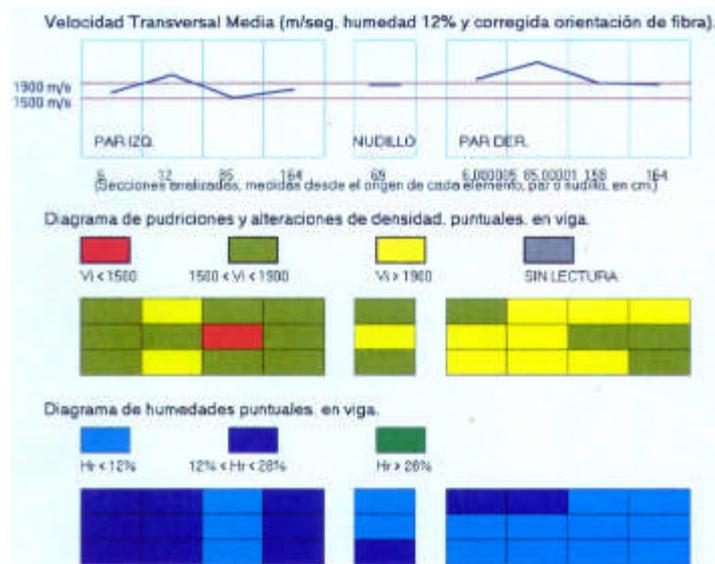
Figure 8: Record card of a beam (Águilas)

The results of the test obtained in situ were recorded in record cards to be later processed by the program Ultramad 1. The data are processed in this program in order to be corrected following the correcting coefficients of the direction of the fibre as well as the correction relative to humidity (all the values refer to normal speed, fibre and humidity of 12%) and an individual record card is obtained for each beam studied (Fig. 8) in order to study the degree of damage and loss of density per section by comparison of the values of normal speed obtained with the reference values of sound wood.

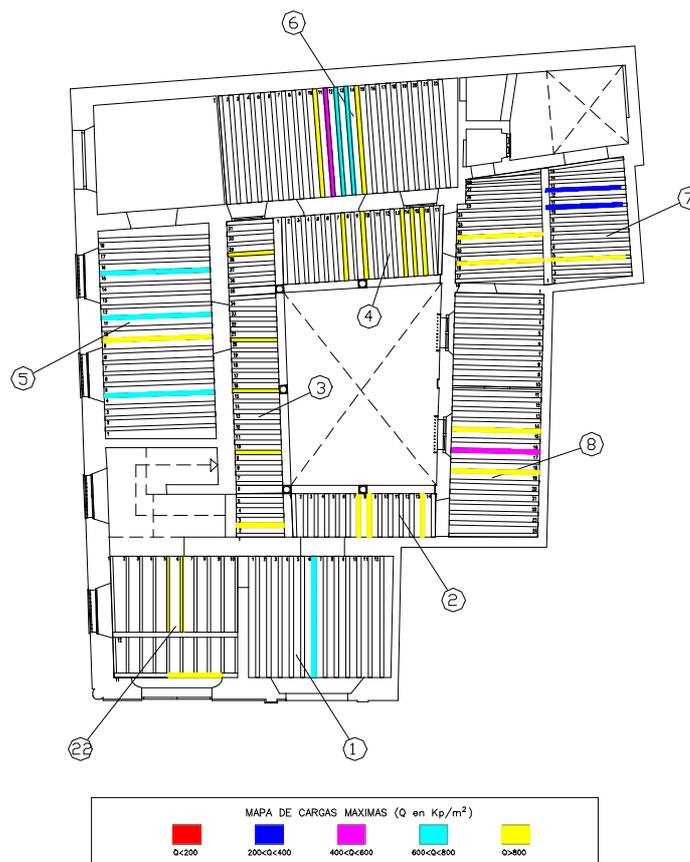
Figure 9: Ground plan with maximum loads (Viejos)

And last, by applying the equations obtained which relate the normal speed of wood to the resistance to flexion of the same wood, the resistance of the wood in the different sections of the beam studied is obtained. The analysis of the group of sections in relation to the momentum gained for a uniformly distributed and continuous load on a beam with two supporting elements allows us to determine the following values: the maximum continuous load for each beam and the maximum superficial load the slab is able to bear. These results are depicted by means of maps where the different values obtained are represented by colour codes: humidity content, degree of damage per sections of each beam, and maximum load. One of these maps is represented in figure 9 that corresponds to the maximum load obtained for the beams studied in the house of Viejos street.
