Palazzo Cittadini-Stampa: role of stratigraphy and cinematic analysis in the knowledge of a masonry building

S. Bortolotto, C. Colla, D. Mirandola & A. Sponchioni

Politecnico di Milano, Milan, Italy

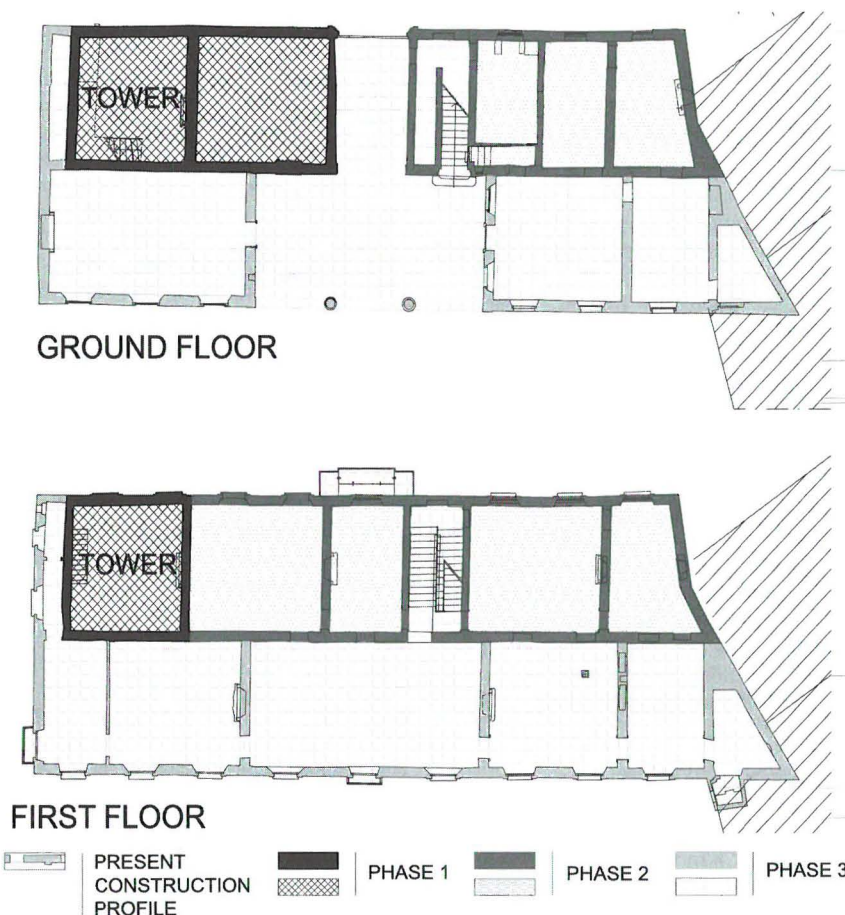
Figure 5. Building evolution as dated from its historic masonry.

The main data have been summed up through simplified graphic schemes showing the different construction phases (Fig. 5).

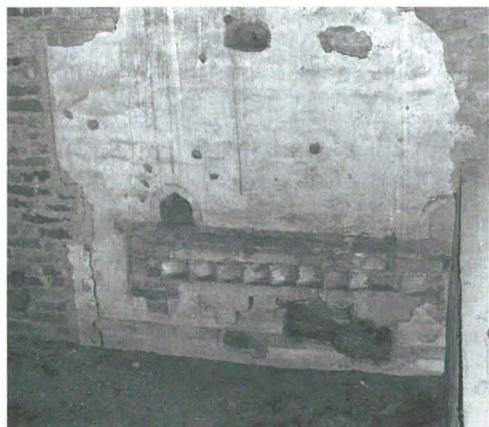
- a tower-house in the north-western portion of the present building. The "house" consisted solely of a ground-floor and reached as far as the present entry-hall, whilst the quadrangular "tower" had two storeys above the ground level. Two of its corners are still detectable in the North front and in the longitudinal spine bearing wall of the present building. On the top floor – which now corresponds to a garret – the tower had a projecting brick decoration, probably a windowsill for pigeons (Fig. 6);

Figure 6. External projecting brick decoration of the ancient tower (visible in the garret of the present building).

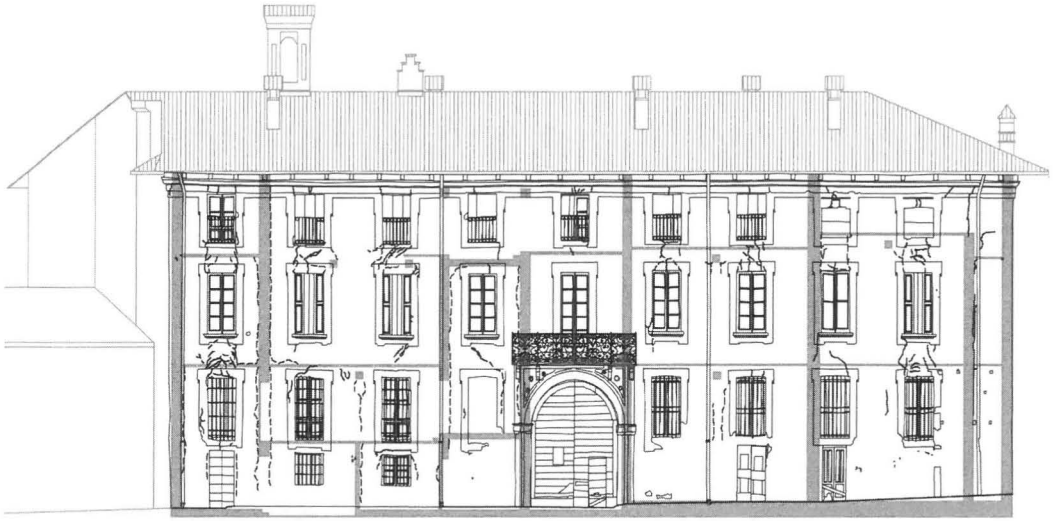
Figure 7. Crack pattern of the main elevation (North) overlapped to that of the inner façade with projection of bracing walls.

and some fissures which actually appear to be flaws in the plastering (i.e. several craquelure-like patterns in the coating). The most relevant fissure pattern involves the north-front external masonry. A visual survey of the crack pattern in this portion of the building

has been carried out along with a specular one on the inside of the same wall. The graphical output from both sides have been overlapped to obtain a more complete interpretation of discontinuities and structural damage (Fig. 7). Some axonometric projections are also

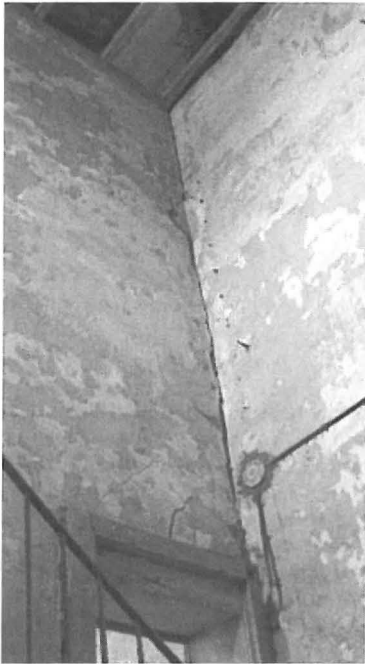
Figure 8. Crack running vertically at the corner between bracing wall and longitudinal wall in the staircase.

The cracks at the junction between transversal and longitudinal walls indicate the lack or loss of masonry “toothings”, which may produced a cinematic

mechanism. This construction defect is related to the multiple construction phases, as well as to the many doors, located in the orthogonal walls but too close to the north front wall (some of these doors were later walled up although with too thin masonry). In the third development phase, along with the walling up of some of these older doors, demolitions have taken place to open new doors in the same bracing walls, but this time too close to the longitudinal wall. These operations have further weakened the masonry.

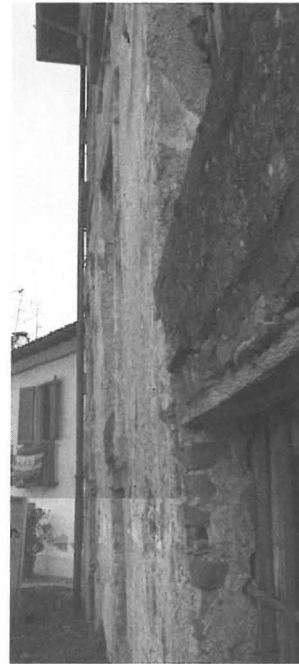
Figure 9. Vista of the left portion of the North elevation with spalling of wall.

Close examination of the crack patterns on the outer and inner faces of the north front revealed that a cinematic mechanism has taken place, limited to the portion to the east of the main entrance (Fig. 9).

A number of factors seem to have concurred to this situation, starting from the presence of the “void” created by the entrance-hall and the porch, continuing with the lack of connection between the walls built in second phase and the tower-house; as well as the new large windows added in the third phase; finally the thrust added by the orthogonal walls of the new structure built in third phase onto the northern walls.

The generated cracks run diagonally on the façade, along lines which, observed together, seem to draw an arch. This “arched” pattern clearly indicates a vertical translation in this portion of the façade (Mastrodicasa 2002).

To these cinematic mechanisms is to be added the outward rotation of that same wall, which can be attributed mainly to the above mentioned collapsing of the ceiling between the first floor and the garret – and consequent loss of a constraint – and further to the thrust of the rafters of the new roofing built in 1982. This thrust is unevenly distributed by the new concrete ring beam, which is not completely closed and, moreover, increases the load on the wall (Fig. 13). Therefore, this portion of the façade can be described as a “slender” wall, loaded on its extreme points, and outwards-bulging. To this wall remain two bonds: the corner wall to the East and the foundations which anchor it to the ground (Mastrodicasa 2002).

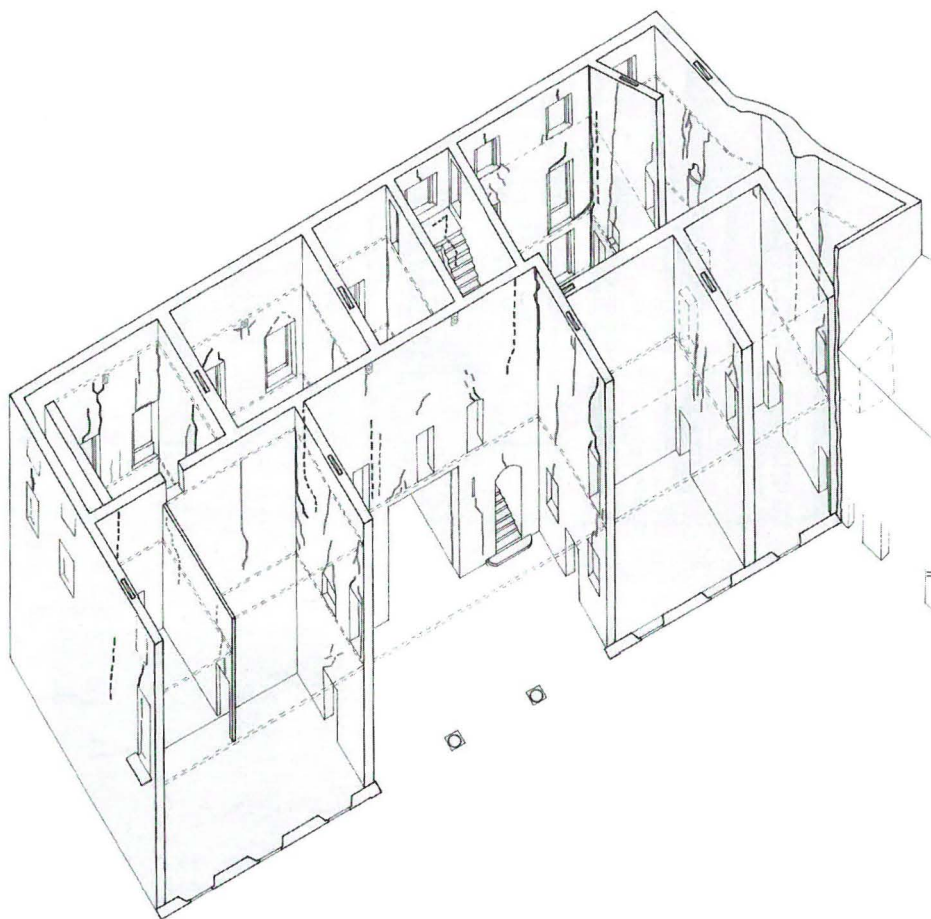
Figure 10. Axonometric projection of the crack pattern.

represented in Figures 10 and 11. As a result of this procedure and way of crack plotting, a three-dimensional reading of the decay phenomena in the building could be modelled and hence compared with the results of stratigraphy analysis in order to spot all "critical areas". Indeed the results from both disciplines may be combined to enhance interpretation.

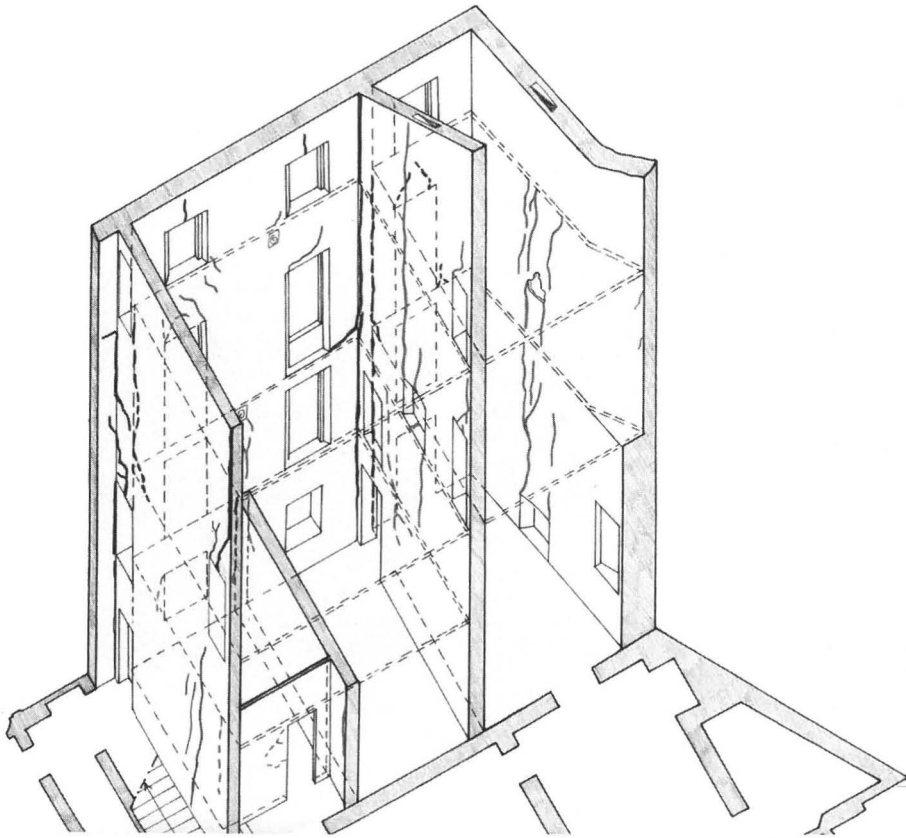
Figure 11. Detail of axonometric projection of the crack pattern with the crack running vertically the whole height between a transversal wall and the longitudinal North façade.

Alterations made in the bearing walls, such as those mentioned above, have jeopardized the structural stability along the years. In the northeastern part of the building some large cracks have been spotted at the junction between North front wall and bracing walls, signalling a possible cinematic mechanism in the North wall. The most critical area is on the first floor where the wooden ceiling previously connecting the bearing masonry members is almost totally missing in one large room. Its collapse followed years of water leakage through the roof, caused by lack of maintenance and consequent material decay.

Therefore it is recommended to set up a monitoring systems over a significant period of time (18 months) in order to ascertain any changes in the crack patterns detected, as well as possible active cinematic mechanisms – translations, rotations, collapses – concerning structural macro-elements such as walls, openings, roofing, foundations etc. It would also be advisable to check the stress distribution and strength of the walls, for instance through diagnostic tests with flat-jacks both single and double (Binda 1979).

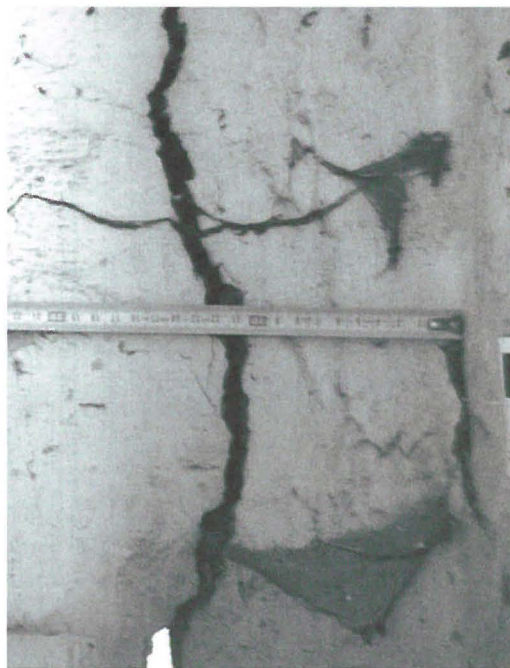
Figure 12. A detail of the crack of Figure 11.

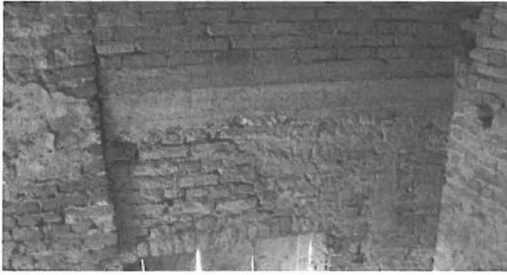
Figure 13. A detail of the ring concrete beam in the attic.

- closure of the reinforced concrete ring beam (Fig. 13),
- installation of metal ties both to contain the thrust of the roof and, at the ceilings, the walls’ relative movements,
- consolidation and partial substitution of the wooden ceilings to improve their bearing capacity,
- verify the existence of a basement with the possible aid of geo-radar technique or focused digging, in order to assess the actual depth of the foundations.
