Preliminary Study and Proposal for Restoring A Jesuit College at Saragossa, Spain

Rosa Bustamante, Benito Lauret, Juan Monjo and J.M. Valero
School of Architecture, Polytechnic University of Madrid, Spain

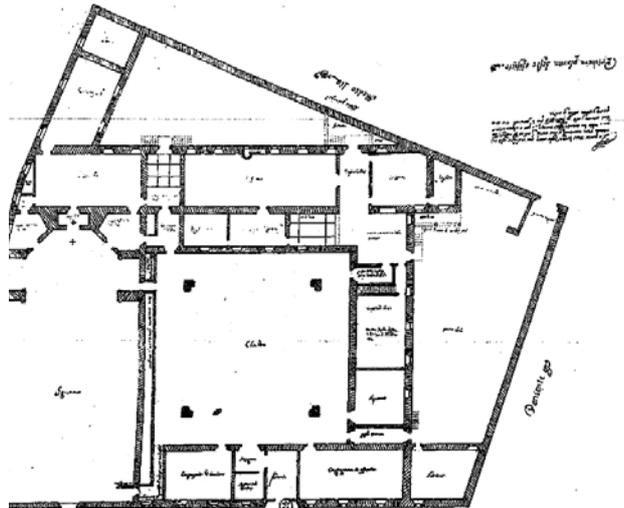
Figure 1 : First storey of San Carlos College, Saragossa, c. 1600 (Valléry-Radot), published in Saragossa at the time (Baltasar Gracián: 2001). Legend: 0 entrance; 1 Congregation of Knights; 2 Congregation of Schools; 3 latrines; 4 regular door; 5 pantry; 6 parlour; 7 refectory; 8 sacristy; 9 area “the way out to say mass”; 10 antesacristy; 11 latrines; 12 kitchen; 13 washroom; 14 stairway; 15 *de profundis*; 16 vegetable garden.

- the absence of side chapels, and therefore of columns and buttresses, confirms the preceding hypothesis (the dimensions given on the drawing in Aragonese yards are similar to the size of the present church, with a span between supports of approximately 21 m);

- as the two chapels at the head of the church form a transept, symmetry was maintained in the church design by creating polygonal areas, two antesacristies “*the way out to say mass*”;

- while the drawing shows the sacristy perpendicular to the centreline of the church, it is actually perpendicular to San Jorge Street (Fig. 2); the explanation for this digression from the Jesuit model may be found in that the present sacristy, a vaulted polychrome nave with arch ribs, was built in part of a former Jewish castle, where, to make the most of the existing structure, the Jesuit monogram had to be tilted. And indeed, the oldest remains in the compound are located behind the church apse (Valero 2005), as attested for instance, by part of a walled-up ogee arch visible on the southeast buttress at the head of the church;

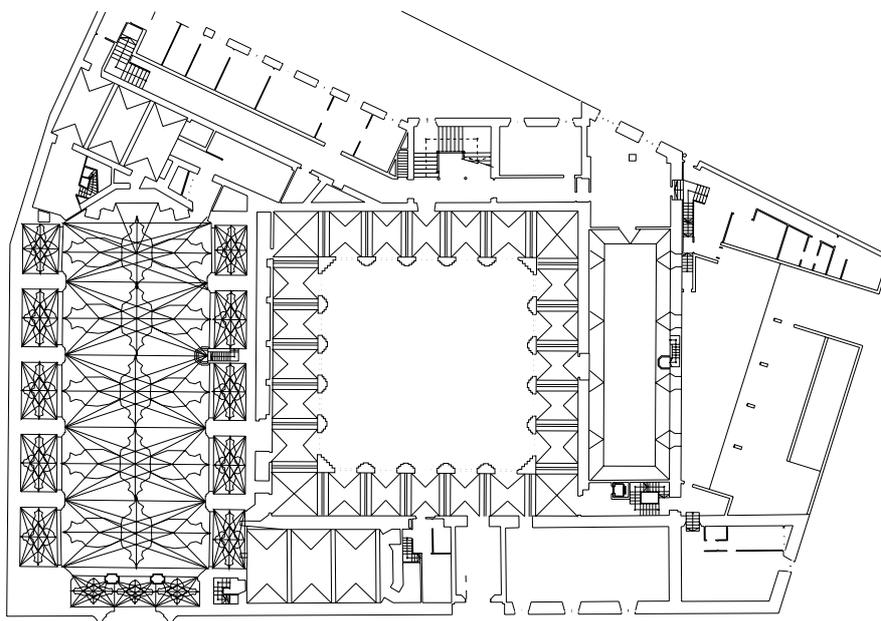
- the corridor to the upper choir confirms the inclusion of this element, but not of the portico at the entrance;
- due to the separation between the epistle (south) side and the cloister for men’s and women’s confessionals, the vaults over the latter had to be braced by columns detached from the epistle wall (see Fig. 2).

Figure 2 : Present plan view of San Carlos College at Saragossa. Church on one side of the block (San Jorge Street), cloister in the middle and other ancillary buildings to the south of the church.

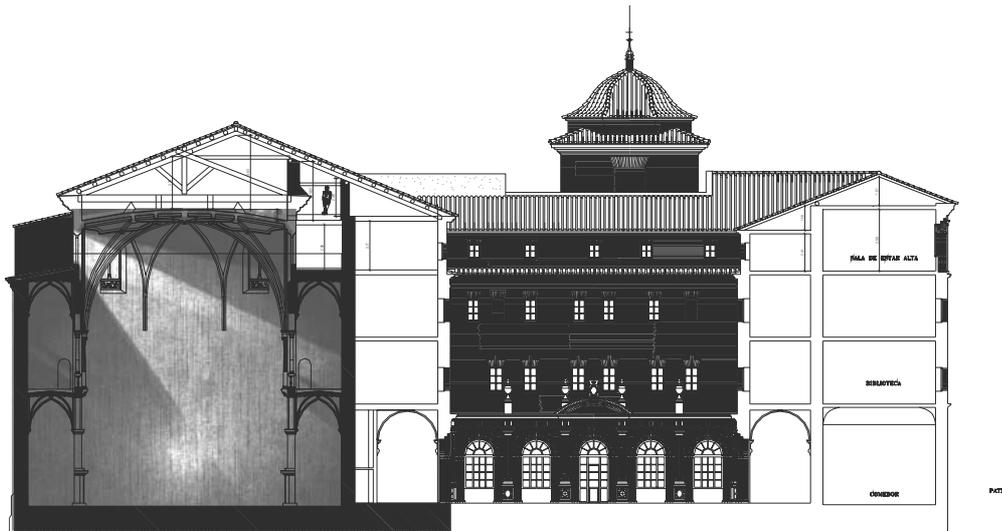
Figure 3 : Cross-section of the compound. Detail of the enlargement of the original roof and present state of interior lighting

On the occasion of the third storey enlargement, brick posts had to be erected on the original cornice (see Fig. 3), which is presently concealed by the roof, to support the extension of the roof over the south side of the central nave. Measuring 1 m high, this cornice, is similar to the one in the apse. From bottom up it consists of a quarter round, a cyma-recta, triglyphs alternating with tiny arches and another cyma-recta, all made of gauged brick and topped with two corbelled courses of brick.

The central nave of San Carlos Church presently receives very little natural light as a result of the enlargement built, depending on the source, either in the nineteenth (Torralba) or the twentieth (Boloqui) century. In any event, it has deprived the church of its lighting.

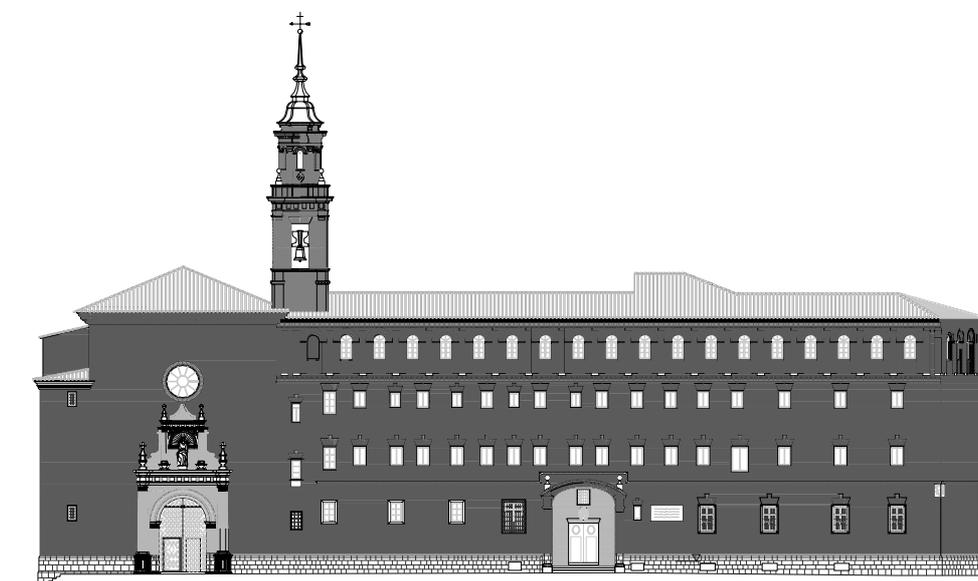
initiated by Brother Pablo Diego de Lacarre in 1723, in which the lustre on the vividly coloured stucco walls and the gilding on the wood reredos were extended to all the other constructional and decorative elements. Brother Lacarre's lavish interiors contrast with the austerity of the facade (Fig. 4).

Figure 4 : Church frontispiece and proposed restitution of the original roof.
To the right facade of the third storey enlargement to San Carlos Square.

After the survey conducted and in keeping with a philosophy that places a premium on essential aspects such as recovery of church roof symmetry and the upper windows for natural lighting, both of which are sufficiently documented to be original features, the approach chosen is to eliminate subsequent additions of questionable value that contradict and detract from fundamental characteristics of the monument's architecture (Figs 4 and 5).

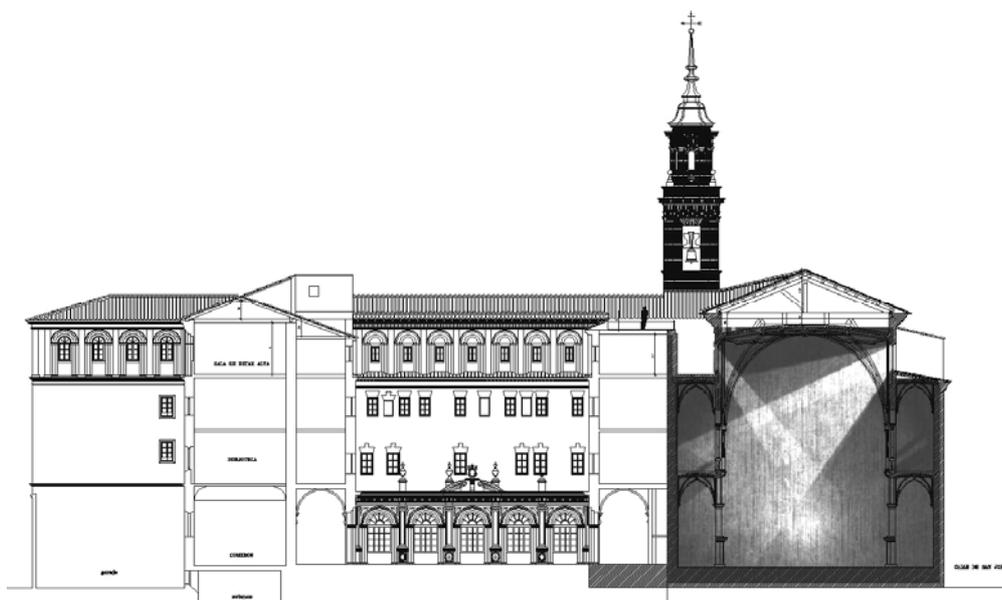
Figure 5 : Proposal for restitution of the natural lighting inside the church by rehabilitating the windows on the south or epistle side.

The solution proposed consists in restoring the roof to its original configuration, i.e., eliminating the enlargement that affected the two parts of the roof described above. This will leave part of the building, namely the presently usable chamber, unroofed. The most reasonable element for the area would appear to be a flat roof, to conserve the visibility of the cornice from the cloister.

Such a tactic also provides natural lighting for the central nave of the church by exposing the upper windows in this area, presently concealed underneath the existing roof. To this end, skylights or an "English basement"-type arrangement will be used to eliminate any obstacle preventing daylight from reaching these windows (Fig. 5).
