The Reconstruction of the Timber Roof of the “Pieve” in Cavalese

M. Piazza and M. Riggio

University of Trento, Department of Mechanical and Structural Engineering, Trento, Italy

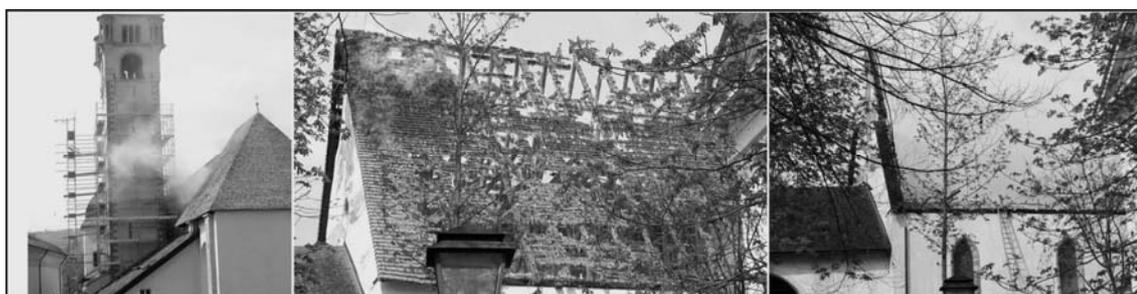
A fire on March 29th 2003 destroyed the most of the timber roofs of the Pieve.

All the phases of the fire are reported by a series of pictures shot from the very beginning of the ignition (Fig. 2). The fire started in the roof of the nave, just under the bell tower, that was surrounded by the scaffolding built during the roofing maintenance works.

Once the fire was extinguished the destruction of the roofs was complete. All that could be salvaged from the wreckage were some burned wall plates and some portions of timber elements inserted in the masonry walls (consequently protected from direct exposure to fire). The only roofs that have lain untouched are the one of the porch and the belfry, lying at significantly different heights from the burned roofs.

Figure 2 : The fire

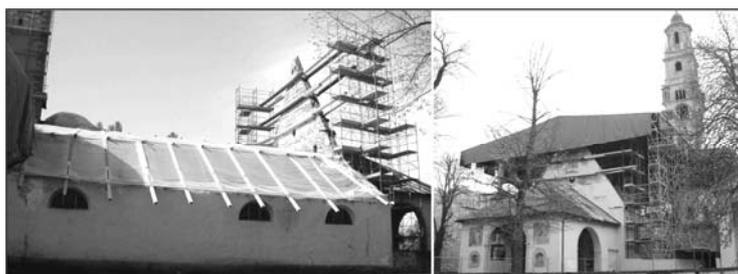
Figure 3 : Provisional emergency actions

A cover for the roofless parts of the building was obviously required. A first cover consisted of PVC sheeting laid on the vaults extrados. Afterwards an external scaffolding was built to bear the temporary metallic roof frame (Fig. 3).

The cover had the task to protect the remaining masonry structure from the weather, to provide an operational platform for the acquaintance and the repair of the masonry vaults as well as for the construction of the new roof.

Moreover, urgent safeguard measures were taken to avoid the collapse of some masonry structures, such as the gable, that suffered stability problems due to the lack of the timber bracing.

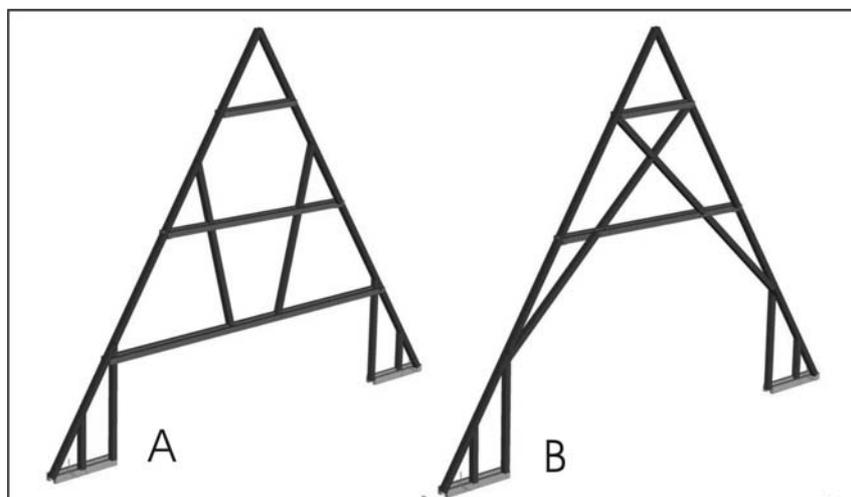
Figure 5 : The “Pieve” in Cavalese. The two truss typologies.

The roof framing of the Pieve in Cavalese consists of two alternating truss typologies (type A and B in Fig. 5). In truss type 'A', three horizontal straining beams connect the rafters at different levels, in order to reduce sagging or spreading of rafters. In addition, diagonal braces connect the lowest horizontal beams to the rafters. The truss type 'B' is a scissor truss. Horizontal beams are also present at two levels. Both truss types bear on the external walls as well as on longitudinal beams. The longitudinal members at the level of the hammer beams, as well as the other bracing longitudinal timbers, at the level of the collars, bear on a complementary transversal frame. Hence, between the series of the two trusses, one complementary frame, bearing on the wall plates and on timber pillars, is interposed (Fig. 6).

The cross-sectional dimension of the members is especially determined by the presence of timbers in compression and lap joints. A two-layer diagonal boarding braces the roof in its plane.

The connections are traditional carpentry joints reinforced by steel connectors (double-threaded screws), in order to maintain the functionality of the joint in adverse and unpredictable conditions, as well as to avoid splitting along the grain in lapped joints.

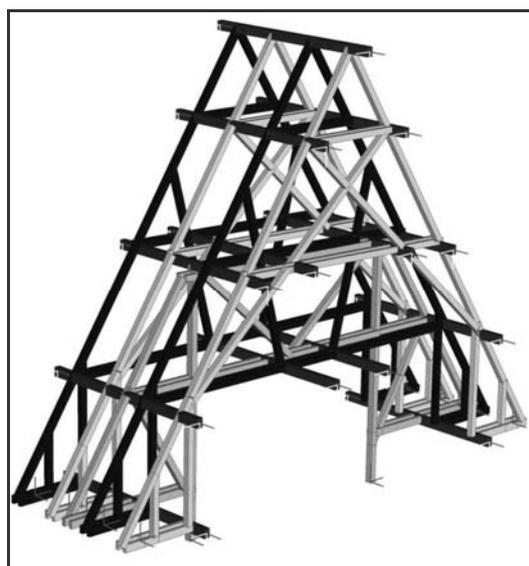
Figure 6 : The “Pieve” in Cavalese. The roof framing ‘modules’.

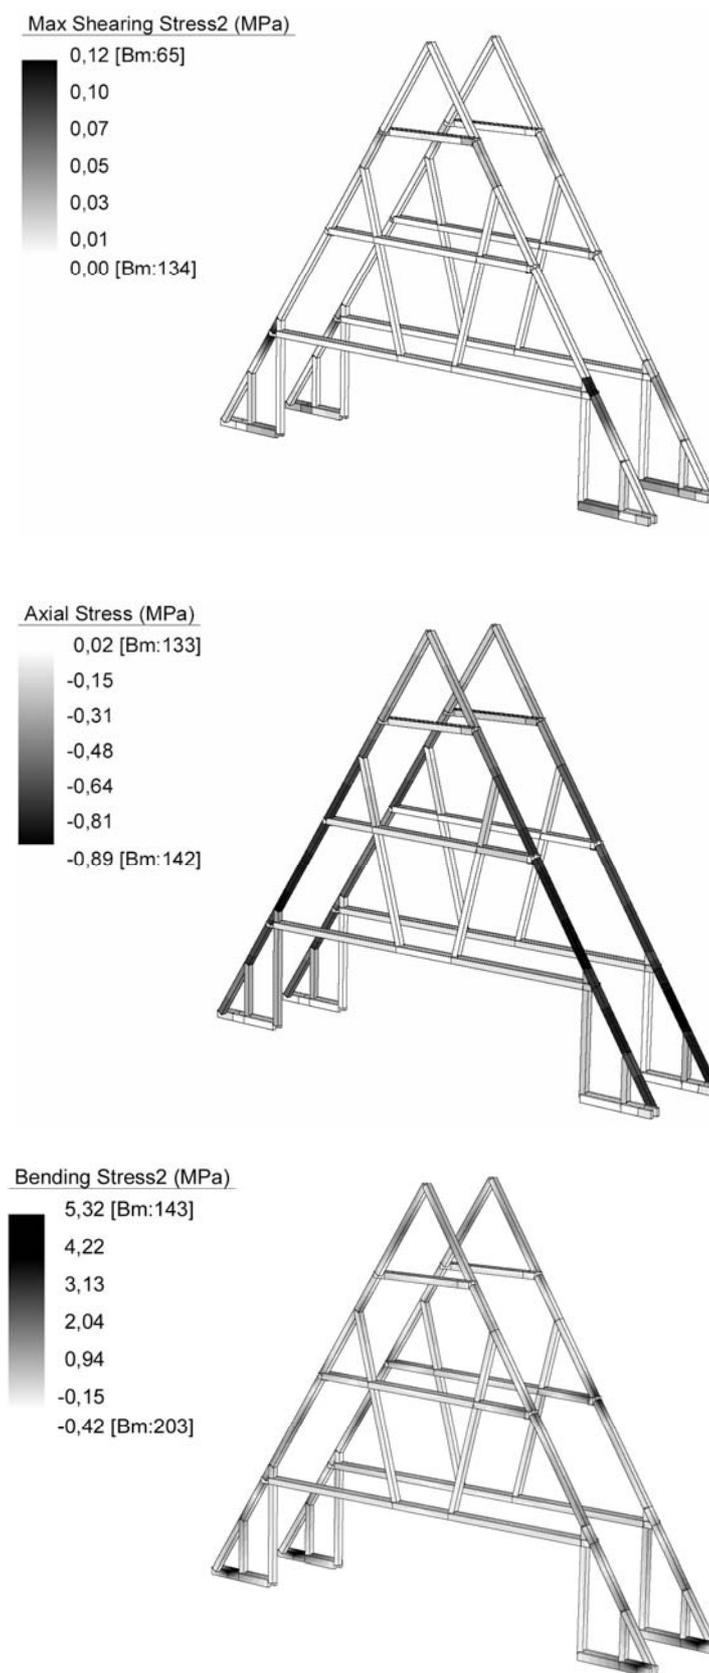
Figure 7 shows the results of the analysis, as regards normal, bending and shear. The reported results highlight the importance of 3D analyses for the study of complex timber structures. Indeed it is shown the state of stress of two trusses, typologically identical but in two different positions in the roof (either adjacent to the transversal bearing frame, or at ca. 1,00 m. from it). The stiffness of the trusses supports varies along the span of the longitudinal beams and of course is higher at the transversal frame, where the beams rest. Therefore, the resulting stress distribution couldn't be highlighted by the 2D analysis of a single truss.

The value of shear stresses is punctually higher (approx. 6÷8%) than the allowable stresses. However, the latter can be up 25% for a load condition that considers wind loads (according to DIN 1052 standard), thus satisfying the strength verification. For all other normal stresses parallel to the grain, the values in each element are sufficiently small: this is clearly the consequence of the particular typologies of carpentry joints adopted

Figure 7 : Axial, bending and shear stresses in the trusses
