## The Use of X-ray Images for the Assessment of the State of Preservation of Strengthening Interventions on Wooden Structures

Manuela Mattone

*Politecnico di Torino, 2nd School of Architecture, Home-City Department*

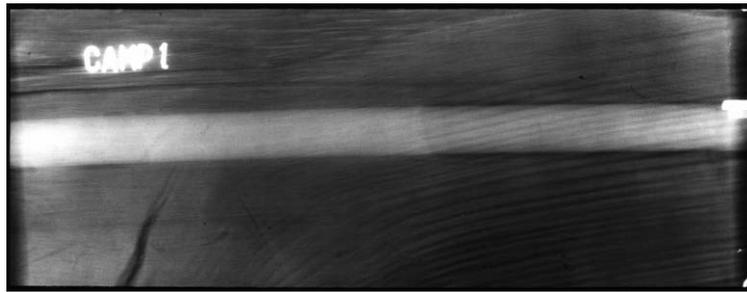
In order to evidence the presence of detachments, different methods have been evaluated by performing numerous tests on specimens with known characteristics. Ultrasound and thermographic tests proved unable to provide interesting results. Conversely, images produced by X-rays – a technique widely adopted to assess the state of preservation of metal elements and welded joints – were able to discern bars of different sizes in the wood and to identify the discontinuities along the bar/wood connections. The reduced absorption capacity of the air compared to the other materials, in fact, makes it possible to identify any discontinuities as may be present along the bar/wood connection: they are revealed by the presence of dark-colored zones adjacent to the unbounded bar portions, as observed in the X-rays taken on specimens specially prepared to this end.

Figure 1 : X-ray image of the specimen with fibreglass bar.

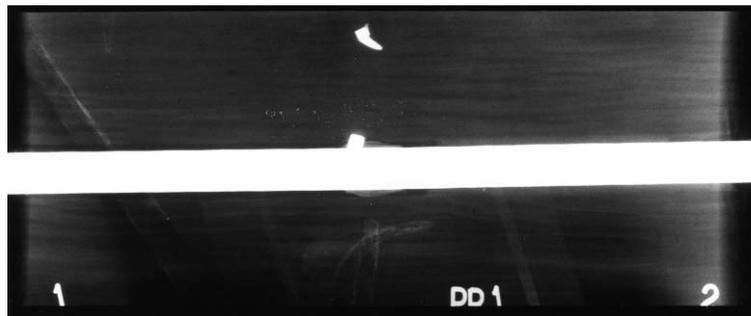
Figure 2 : X-ray image of the specimen with steel bar.

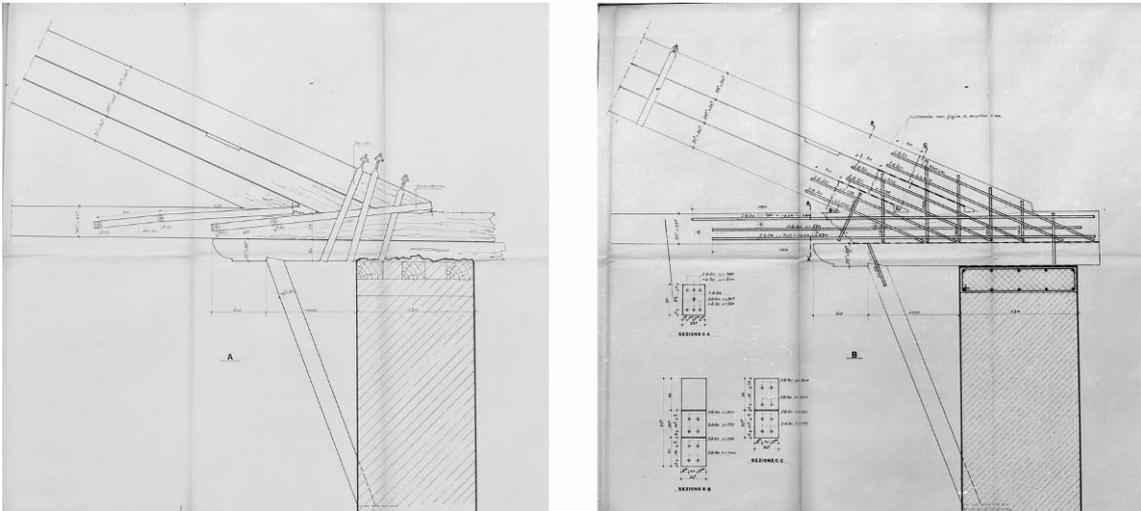
tions, were subjected to strengthening works prompted by the observation of significant deterioration conditions at one of the rafter-ridge beam nodes, due to the joint effects of humidity, moulds and wood-eating insects. Damaged wooden parts were removed and replaced with epoxy-based concrete prostheses and quartz aggregates, which were connected to the rafter-ridge beam node by means of fiberglass bars (20 mm in diameter) made integral with the wood by means of a 5 mm layer of epoxy paste.

Figure 4 : Farnese Theatre, Parma. The strengthening intervention project (Architects Mariella De Cristofaro, Delio Fois).

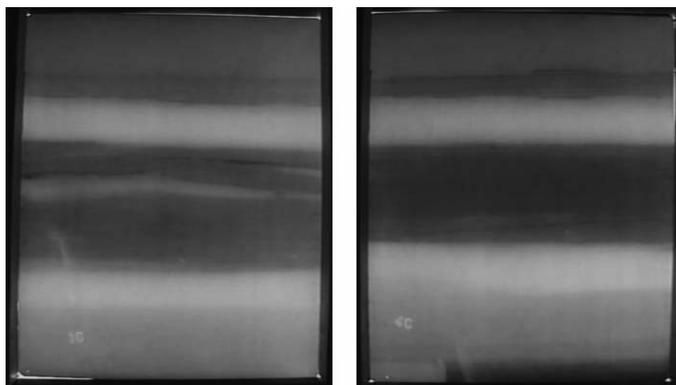
From an examination of the radiographic images it proved possible to identify the positions of the fibreglass bars and to verify gluing conditions. In some cases, situations of discontinuity were observed in the connections between the bars and the wood, which – in all probability – should be ascribed to a non perfect execution of the strengthening intervention, whose static validity, however, was not impaired.

Figure 8 : Castle of Racconigi (CN). X-ray images of the portion of the ridge beam that has been subjected to the strengthening intervention. The darks areas around the upper bar evidence the presence of discontinuities between the bars and the wood.

The tests conducted so far have made it possible to ascertain the applicability and effectiveness of this testing method. The results obtained in the course of the testing campaign also suggest the wisdom of conducting these tests *in itinere* – during the installation of the prostheses – in order to verify the correct execution of the strengthening intervention underway.
