Analysis of Pre' Failure State of Historical Wooden Church

Piotr Berkowski, Grzegorz Dmochowski, Maciej Y. Minch and Jerzy P. Szolomicki
Wroclaw University of Technology, Department of Civil Engineering, Wroclaw, Poland

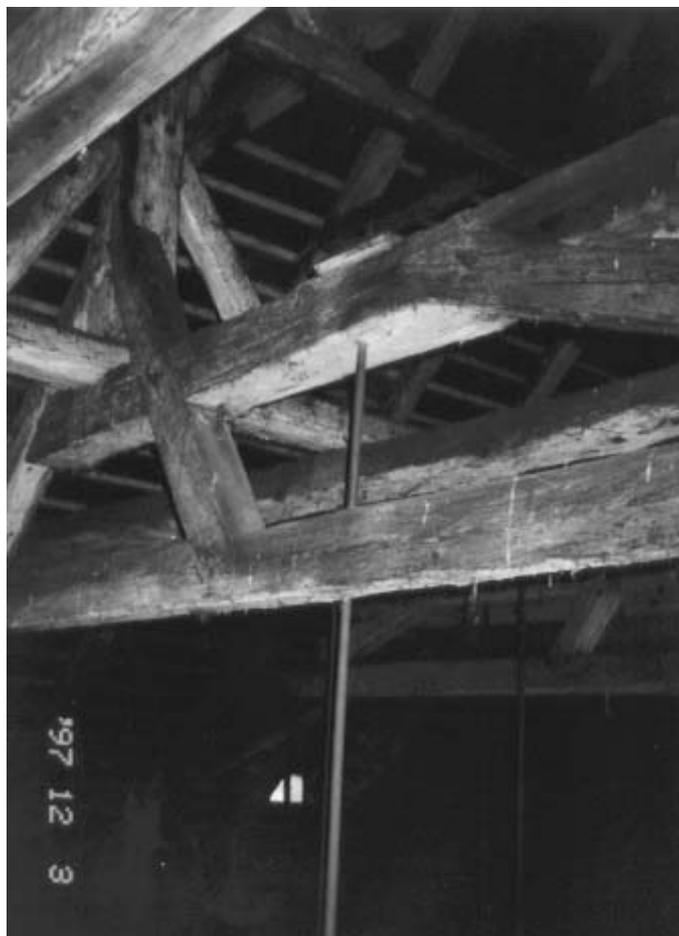
Pre-failure state of church roof and walls stability was detected during executing of routine mycological opinion of elements of timber constructions. Description of biotic damages of rafter roof is typical and do not state here essence of problem, so it was omitted in this paper. In the time of inspection of rafter roof there was observed in its construction existence of secondary elements of steel hangers (steel rods), by means of which floor beams were suspended to roof girder above main nave. Suspensions were executed by two steel rods fixed to lowest (double) collar beam and symmetrically in relations to ridge post (Fig. 4) or one steel rod in axis of ridge post. Secondary elements of steel rods were built in roof construction in planes of main roof girder, only in the places where excessive deflection of floor beam of main nave occurred. Besides, suspension of floor beam to roof girder was not executed by any additional strengthening elements in roof construction. Specification of executed reinforcements is not preserve.

Without detailed analysis it is possible to state that application of suspensions which “save” floor beams above main nave can cause transfer of enlarged strut forces from rafter roof onto walls and in consequence their parting. It can end with loss of stability of the whole construction. Therefore in the time of inspection of building it a special attention was paid to the possibility of damage of timber bearing elements and timber lining elements caused by horizontal forces and enlarged horizontal deformation. In the Fig. 5 there is shown an exemplary effect of enlarged force struts of rafter roof as several centimeters separations between timber lining of angle braces under floor beam of main nave and walls construction. Damages with similar character occurred in all fields of floor beam of main nave where additional steel hangers were applied.

Figure 4 : View of the construction of suspended floor beams to roof girder.

Each strengthening of construction by changing a statical model demands realization of detailed computational analysis, because assurance of safety of one element can cause failure of others. In objective case it sufficed to assure self-equable schema of strengthening, i.e. take over additional strut forces from roof by, for example, steel rods what was recommended (for assumption that allowable stresses are not exceeded after increase of forces in rods from additional loads of floor beam). Besides the use of steel rods, the authors recommended also an inspection of all girder nodes and realization of strengthening for damage nodes. Applied methods of strengthening as well as fungicidal and insectidal impregnations of timber constructions were assumed as generally well known from technical literature. Therefore details of those solutions were omitted in this paper. Nowadays, there is being prepared a final design of repair, protection and strengthening of church building. At this stage there are also considering possibilities of strengthening of damage nodes by using of newer techniques, for example by means of sticking.

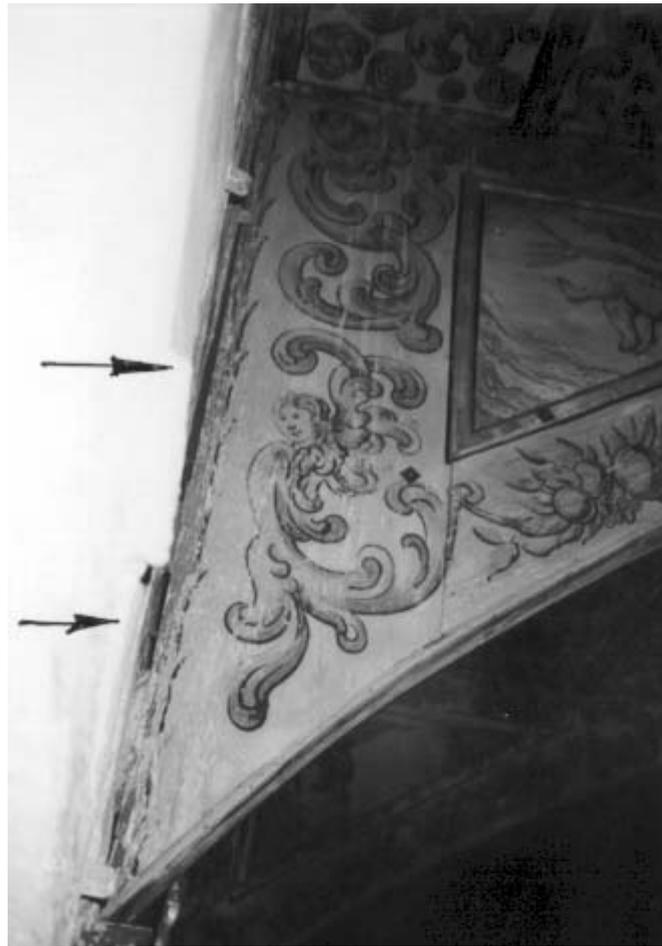
In Table 1 chosen results of calculations are presented. On the basis of assumed schemas of calculations it was noted that suspension of floor beam to roof girder caused almost double increase of displacements of construction (for variant without steel rod) and adequately two-three times increase of internal forces in bars. Floor beams above main nave were weakened by biotic corrosion on supports as well as in the bays and moreover performing function of braces which take over strut forces from roof girder. They were not in condition to transfer the whole of additional tensile forces. It caused excessive deformations of walls as well as timber lining and separation of walls of church building. Maximum horizontal displacements were calculated for assumption that in consequence of exceed of pressure stresses or shearing stresses in supported node of floor beam, steel rod break off carrying out tensile forces. Calculated values of displacements and damages of construction permitted to affirm, that it is in pre' failure state.

Figure 5 : Exemplary effect of enlarged force struts of rafter roof.

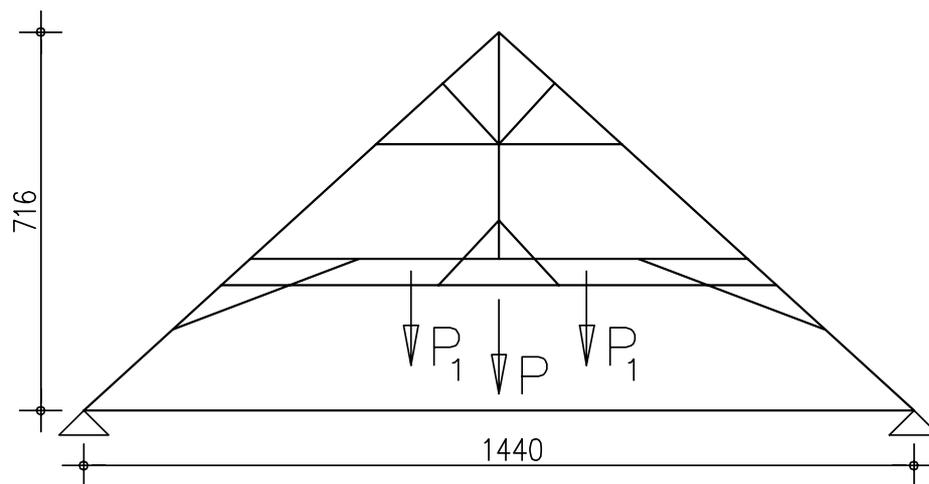
Change of statical schema of roof required checking calculations. In consideration of difficulty in estimating of real stiffness of spatial skeletal construction (compliance of nodes, biotic paralysis, damaged and strained carpenter joints etc.), values of internal forces in main girders were checked for different statical schemas. Geometry of roof girder and its loading were assumed on basis of cataloguing. Statical schema of roof girder is presented in Fig. 6 (forces P and P_1 denote loading due to weight of suspended floor beam of main nave).

Figure 6 : Statical model of roof girder.
