Analysis, Intervention and Repair of Timber Structures

C. Rodríguez Liñán, P. Rubio de Hita, J.C. Gómez de Cózar and F. Pérez Gálvez
*University of Seville, Technical School of Architecture, Department of Architectonic Constructions,
Seville, Spai*

The aim of this paper is to get the state of damage and the bending strength capacity of the timber roof of the Monastery of Santa Clara's dining room in Carmona (Seville) by using this technology.

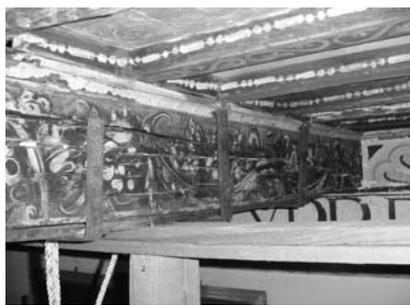
Figure 5 : Beams strengthened by metal sheets

First visit showed the roof's bad conditions. It had big deflection and several beams had been strengthened by inserting thin metal sheets (Fig. 5).

Half of the roof was propped up.

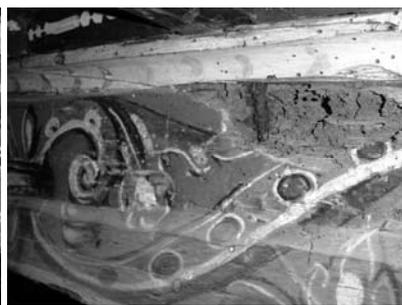
After the visual inspection, we could say that damages were: first, all beams had deflection visible to the naked eye and longitudinal cracks. Regarding to xilophagous agents, there was a generalized attack of little woodworms in all beams plus and brown rotting (Fig.7).

Figure 7 : Woodworms attack and brown rotting

On the other side, brown rotting attack strengthen little woodworm (*Anobium Punctatum*) action because if these ones, at first, only attack wood perimetral whitens, rotting fungi make easy woodworm's *duramen* digestion so depth of penetration of woodworms' attack is higher. It stands to reason that these facts had produced loss of material and density that deeply affected beam's carrying capacity which caused blending breakage in some cases.

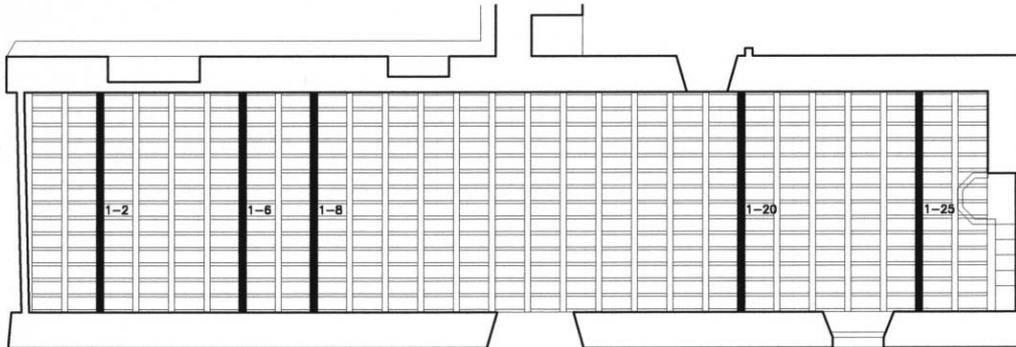
Figure 8 : Studied beams

Five beams from the timber roof have been tested. They appear in the ground plan numbered as 1-2, 1-6, 1-8, 1-20, y 1-25 (Fig. 8).

Selection criterion has been obtaining data from some beams apparently in better conditions and data from those which are apparently more damaged. Two areas have been tested, the most damaged (the one propped up) to which beams number 2, 6 and 8 belong to and the least apparently damaged area to which beams number 20 and 25 belong to.

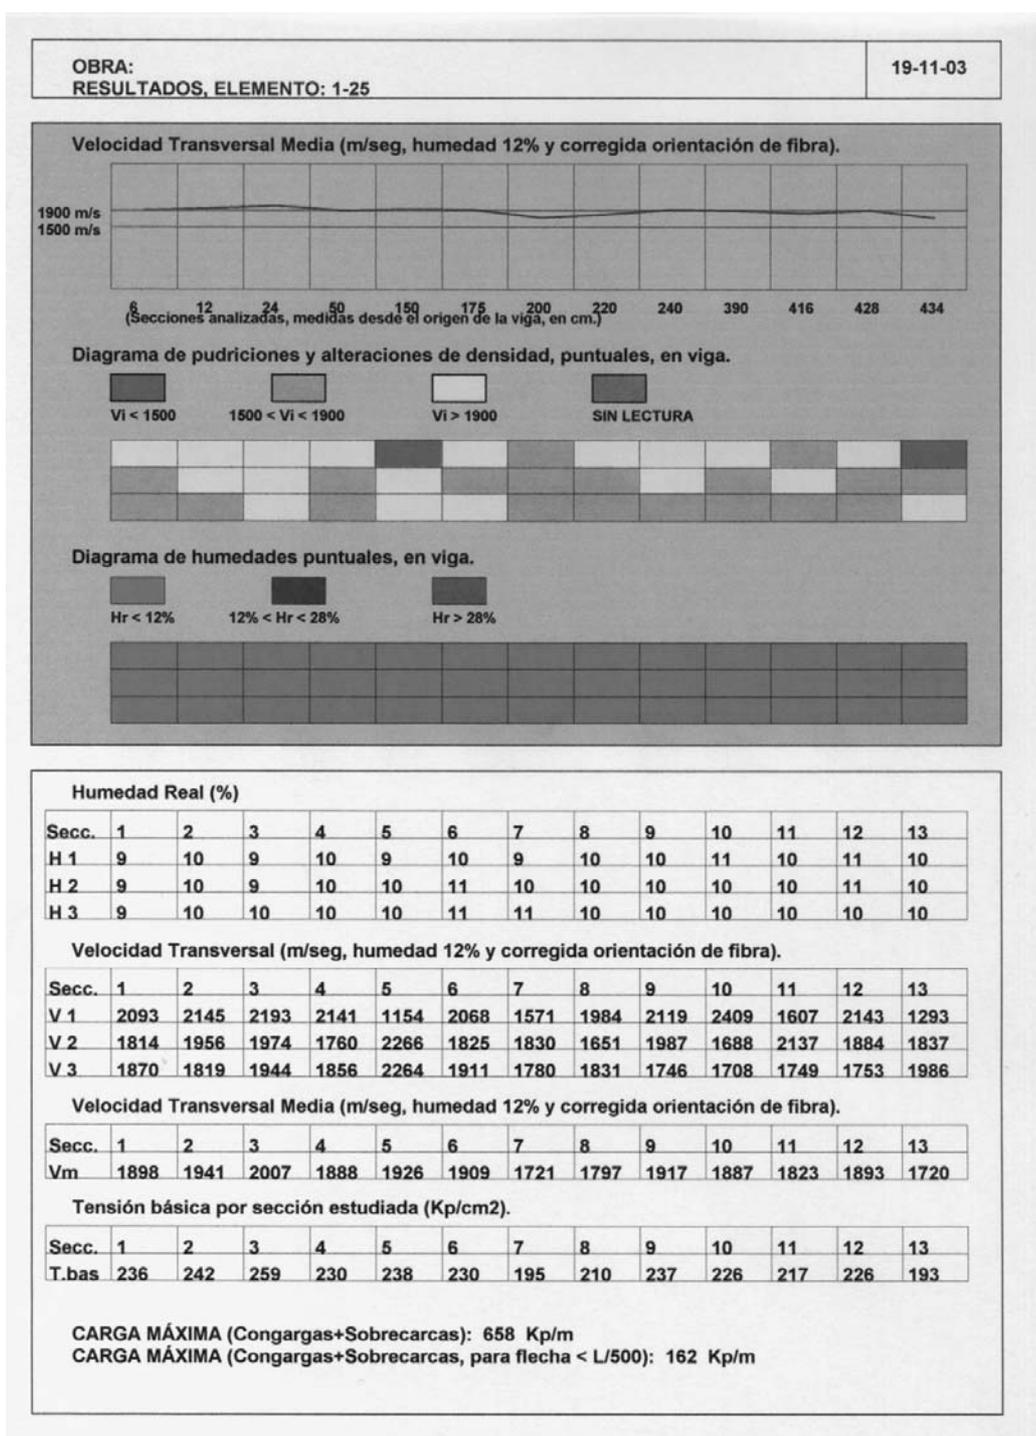
For each beam, some results cards are obtained where are represented the measuring that have been made: ultrasonic velocity, humidity content and maximum load's values (Fig. 10).

Figure 10 : Photo of one beam's results card

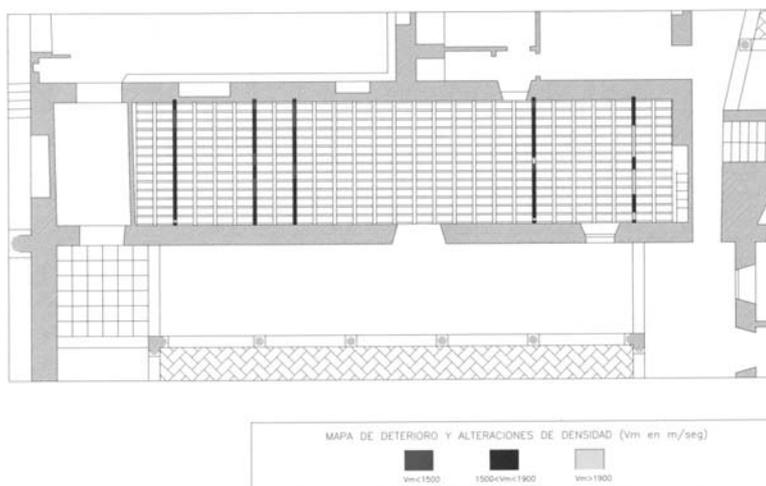
The map of degree of damage (Fig. 11) shows loss of density of wood. It is generated by interpreting ultrasonic velocity by means of the criterion of section 2.1.

For the studied roof we obtained the following results: 1-2, 1-6 and 1-8 beams (which are located in the propped up area) are in blue or red colour. This means that none has sound wood as blue colour means beginning of damage and red colour big damage. 1-20 and 1-25 beams (in no propped up area) are softly damaged, less than previous beams where some areas appear without damage so are in yellow colour.

Figure 11 : Map of degree of damage

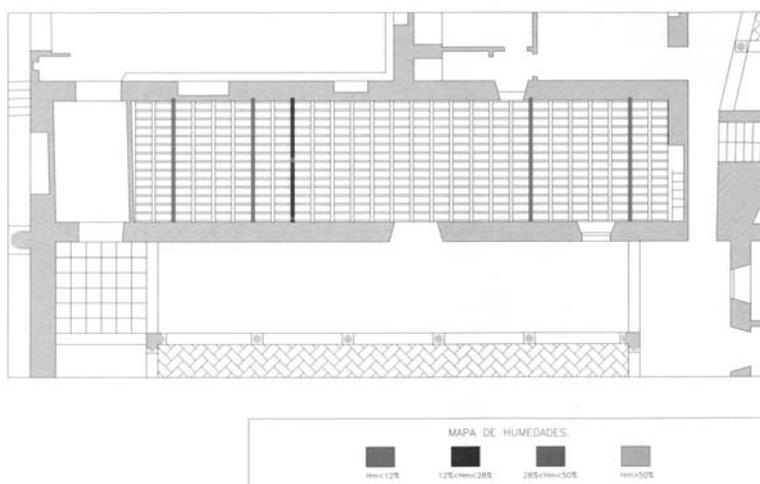
The map of humidity content (Fig. 12) shows data obtained by means of resistance hygrometer are low values in general for all beams ($\leq 12\%$) except for 1-8 beam, where soft high value is obtained.

These results are not compatibles with conditions needed to reach the degree of damage saw in the wood. They are justified taking into account when doing tests, some interventions were done in the building to avoid water filtrations trough the roof. So this damage were produced before, degree of humidity was higher than the ones obtained in tests.

Figure 12 : Map of humidity content

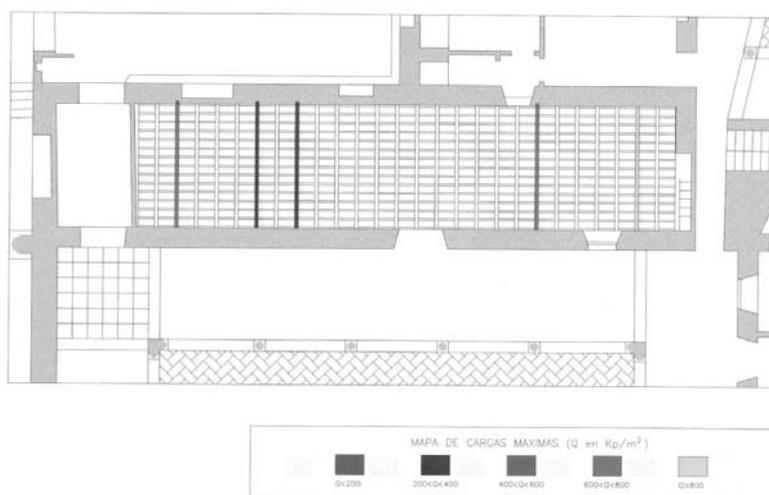
The map of maximum load (Fig. 13) shows maximum allowable loads for each beam obtained by means of ultrasonic tests we use section 2.3 equations.

Although some beams can support load values higher than 7 KN/m², maximum load of the roof is determined by the most damaged beam's values (2.2 KN/m²).

Figure 13 : Map of maximum loads

The results confirm the following thing: There are some beams which can not support overloads produced by using the room for temporary public exhibition ($3\text{--}4\text{ KN/m}^2$), other beams could not support its own weight so even less could support new pavement.

Now, it is possible to say the timber roof can not support with enough security the new use that has been proposed.

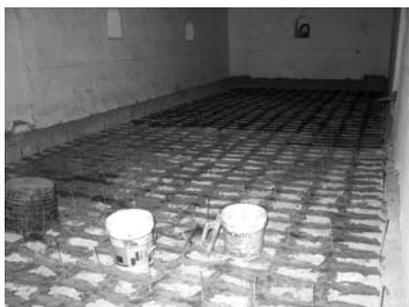
Figure 16 : Roof with bolts and extruded polyester sheet.

While concrete flagstone construction and to avoid timber roof receiving more loads than foreseen, in necessary not to take propping-ups off until concrete flagstone will had reached appropriate resistance to support its own weight and all of the other loads, even it is recommended to prop up areas which are not propped up yet. Figs. 15-17 show the construction process.

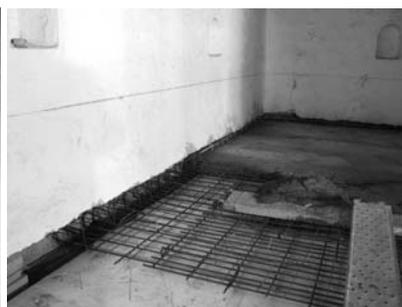
Figure 17 : Steel framework of concrete flagstone.
