Dynamic Identification of Detachment Conditions on Prehispanic Mural Paintings in Central Mexico

Juan Carlos Araiza Garaygordóbil, Hermann Rocha Escalante, Agustín Orduña Bustamante
University of Colima, Civil Engineering School México.

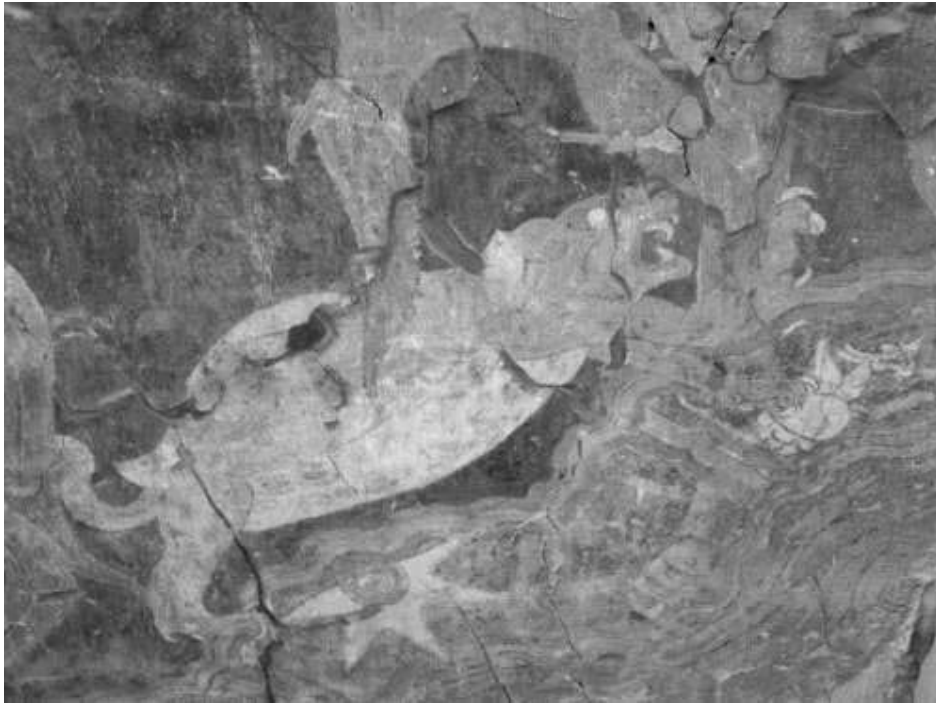
In this process of renovation, some decorated buildings were covered with filling, and the mural painting inside were relatively well preserved for eleven to fourteen centuries. However, on the last few decades, some of the paintings were reopened to atmospheric aggression and a serious deterioration process has been recorded (Fig. 1). The mural paintings are a thin plaster layer directly supported on an adobe wall. The main damage is associated to a differential strain between the constitutive materials (adobe and plaster) generating detachments and local collapses of the decorated surface (Fig. 2).

Figure 1 : Typical damage in one of the murals.

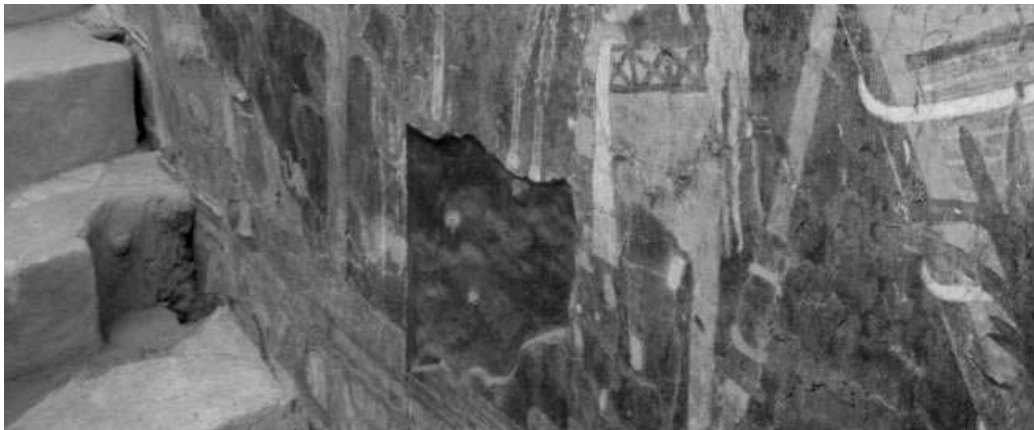
Figure 2 : Typical detachment of a segment.

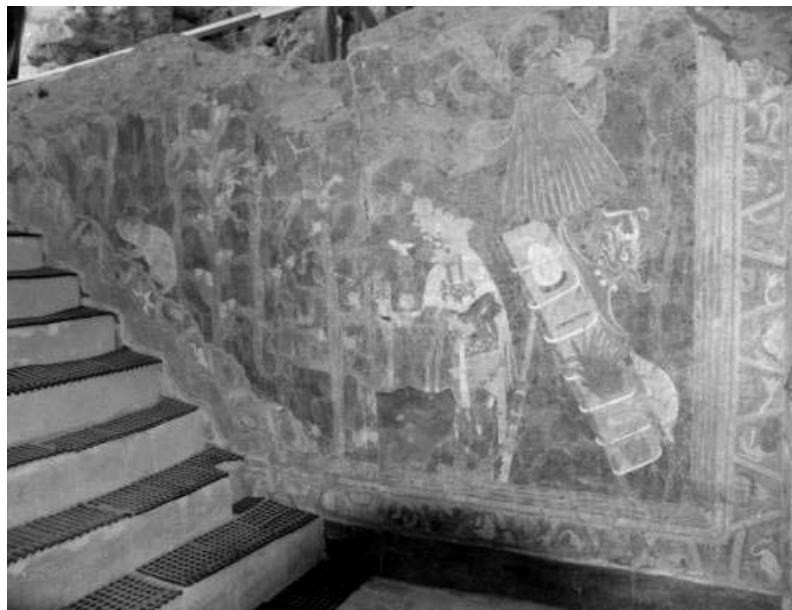
Figure 5 : General view of the *Rojo* mural.

For the particular case of the mural known as *Rojo*, there is a patter of detachments mainly in the region next to the stairs (Fig. 5) and in the upper part, were the differential movements of the Adobe seem to be more important.

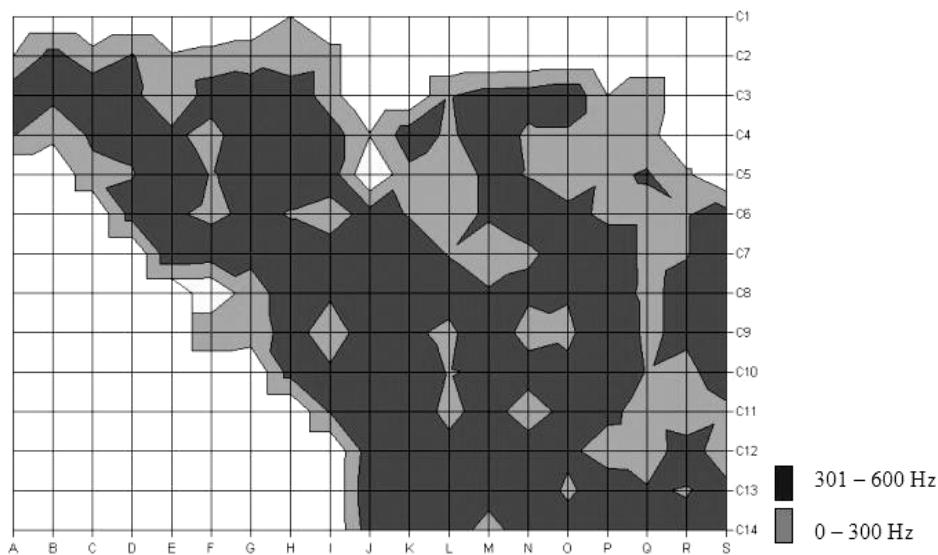
A contour diagram of iso-frequencies was created to identify the trends and to create an hypotheses of the location of detachments. It was expected that for a low frequency certain level of detachment could be expected. Actually, a clear trend was observed, for segments that showed either high or low frequencies. A group of segment showed a first natural frequency between 180-250 Hz and were considered detached. Anther group of segments presented a first natural frequency greater than 350 Hz, and was considered as attached. In Figs. 6 and 8, the lighter color represents lower frequencies and probably detached conditions. Darker color shows a higher frequency and likely a better attachment level.

Figure 6 : Iso-frequency contour diagram of the *Rojo* mural.

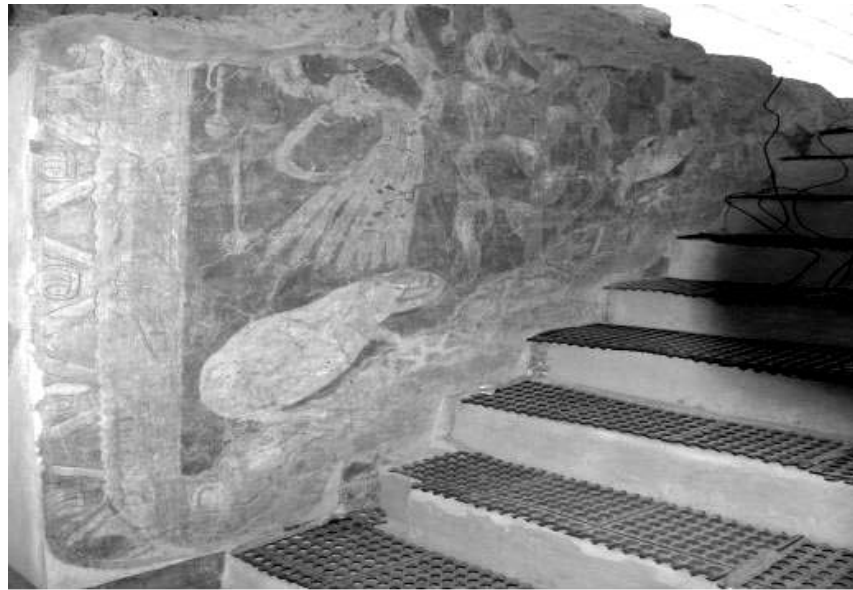
Figure 7 : General view of the *Ranas* mural.

In the case of the mural known as *Ranas*, the structural condition appears once again with some detachments adjacent to the stairs and to the upper part. It is worth mentioning that the stairs block is independent and shows a constructive joint on the contact with the mural (Fig. 7).

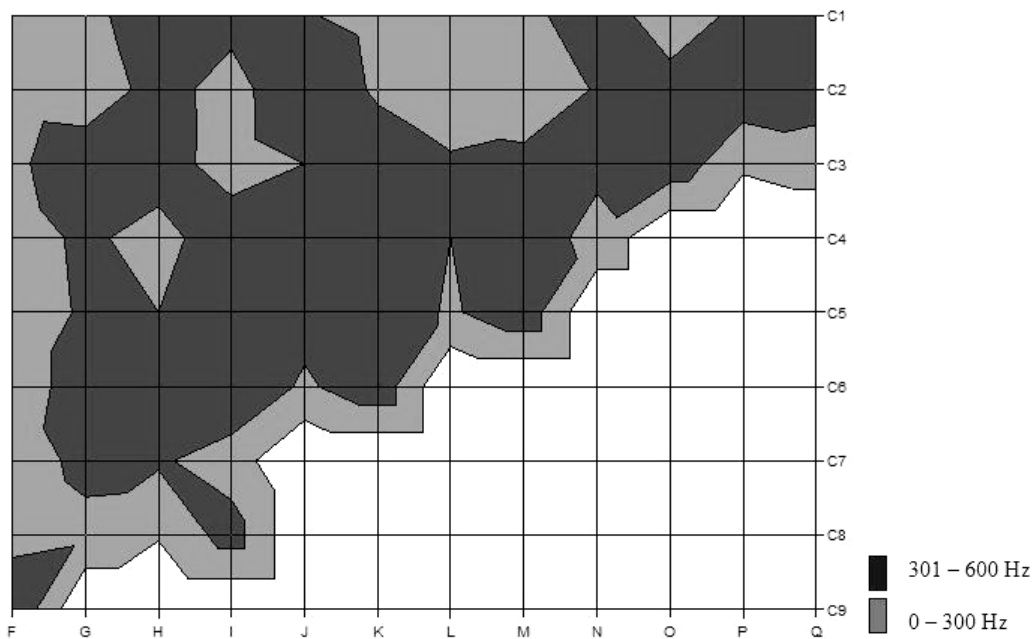
Figure 8 : Iso-frequency contour diagram of the *Ranas* mural.
