## Reinforcement and In Situ Testing of the Upper-Choir of Pópulo Church in Braga, Portugal

**ABSTRACT:** This paper presents the structural intervention on the upper-choir of the Pópulo Church in Braga carried out by DREMN – Regional Directorate for Northern Buildings and Monuments of Portugal, under the technical consultancy of NCREP – Nucleus for the Conservation and Rehabilitation of Buildings and Built Heritage of the Faculty of Engineering of Porto University (FEUP). Besides describing the intervention, it also shows that renovation works to be carried out in old structures, although previously planned and projected according to the available data, may suffer relevant modifications during the preparation and implementation process, which must be regarded as part of the intervention process. In particular, this work involved the in situ testing of the upper-choir structure to evaluate its vertical loading capacity.

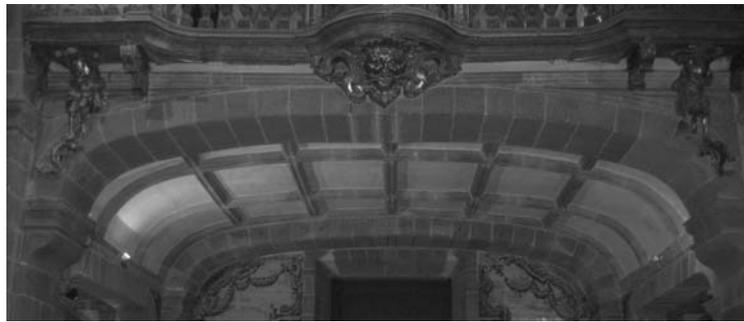
During the restoration works that were carried out at the Pópulo Church, important deformations on the upper-choir vault characterized by joints opening that were visible from the vault's inner face, Fig. 2, were observed. These deformations were located between the arch above the main entrance and the ending arch below the upper-choir balustrade.

Figure 2 : Upper-choir vault.

In terms of damage, arch A exhibit vertical deformations with openings of joints at the key-stone. The upper-choir vault exhibits also vertical deformations, surface warping with double inverted curvature, with openings of joints reaching almost 10mm width. The arches B, C and D did not exhibit any deformation. Conclusions from the inspection and diagnosis that were carried out concerning arches C and D can be found elsewhere (Costa, 2000).

Finally, the joints that were opened were closed using non retractile mortar compatible to the vault masonry (Luxan, 2002) in order to seal them. In the future, this procedure would also allow controlling further displacements that would occur at the vaults.

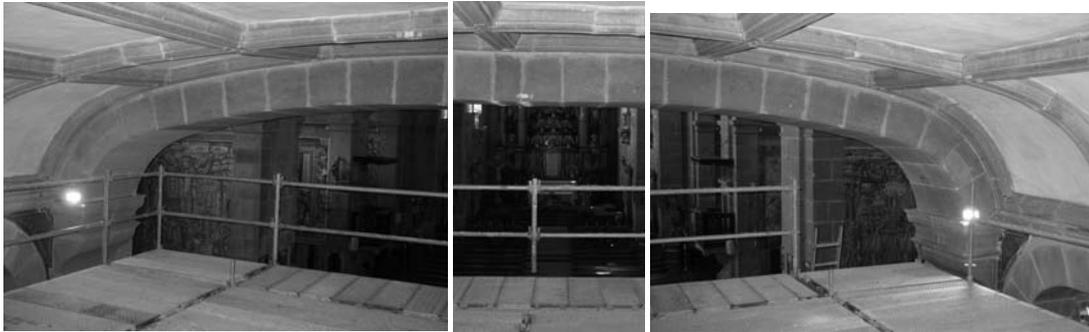
Figure 3 : Façade of arch A.

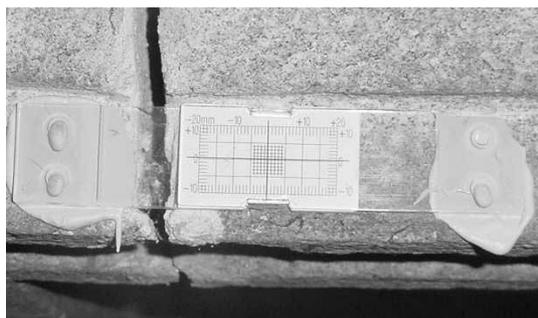
During the first stage of the restoration works, both the vault and arch A were monitored using crack meters, Fig. 5, in order to detect possible displacements of the upper-choir structure, checking, if deformations were still occurring or had stabilised. Simultaneously, the distances between arches A and B (5.62m) and C and D (9.98m), as well as the vertical distance of several pre-defined points along the medium transverse line of the vault, were measured using a laser distance-meter, with respect to a fixed reference structure.

This monitoring campaign was carried out during a year and a half period without any relevant changes on the monitored values. This data is always crucial to decide on any structural intervention, since damage corrections, strengthening or consolidation procedures should not be applied to while structural deformations are still occurring.

Figure 5 : Crack meter on a stone frame of the vault.

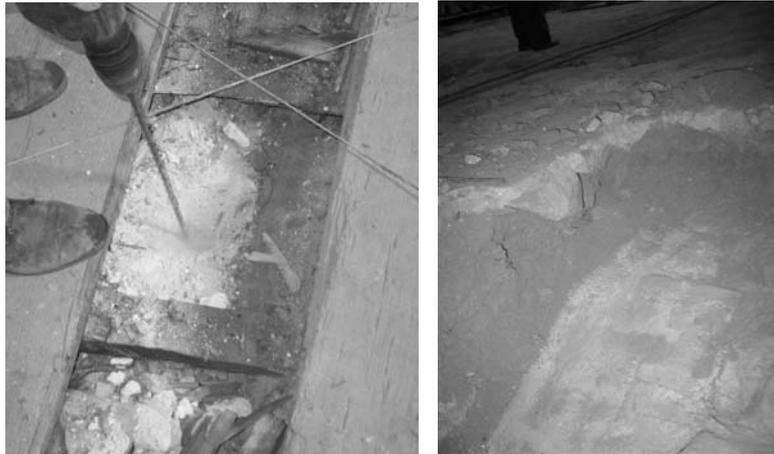
An inspection of the vault inside the stone masonry frames allowed estimating a 30cm thickness shell and confirming that it was made of redbrick elements, Fig. 6. These and other preliminary actions allowed identifying the geometrical and material characteristics of the structure. After analysing this data, it was decided to design a steel structure to be set above the vault and under the wooden floor, to suspend the vault through vertical ties anchored with plumb on the crossing points of the stone masonry frames, Fig. 7. The structure would be tied up to the upper-choir side walls and would sustain vertical displacements that might occur, putting at risk the structural stability of the vault (Costa, 2004).

Figure 6 : Inspection to the inside of the vault.

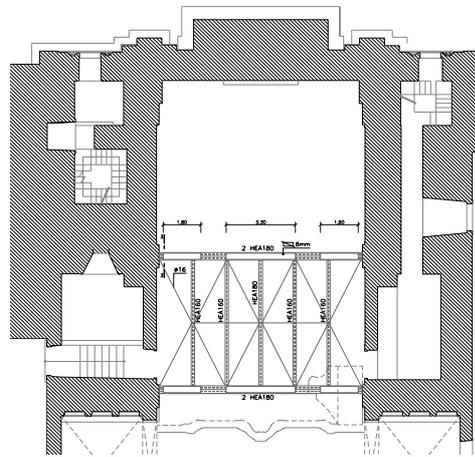
Figure 7 : Upper-choir plan; reinforcement steel structure.

Although this procedure seemed reversible and little intrusive, some physical limitations had to be overcome. In particular the steel structure introduced major forces at the anchorage points on the walls, demanding a good mechanical and structural characterisation of these areas in order to ensure the necessary capacity to sustain the anchorage forces. Although, apparently these areas corresponded to good quality regular masonry zones, in other parts of the church with similar appearance, the regular stone masonry was only used for covering masonry of inferior quality, Fig. 8. Hence, a visual inspection would not be sufficient to assess the strengthening capacity of these areas, and in situ tests had to be carried out (Roque, 2003).

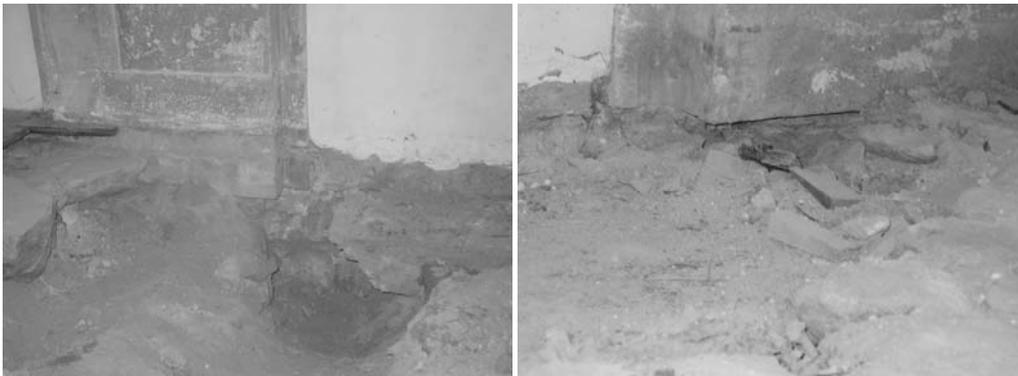
Figure 8 : Faked regular stone masonry column at the upper-choir level.

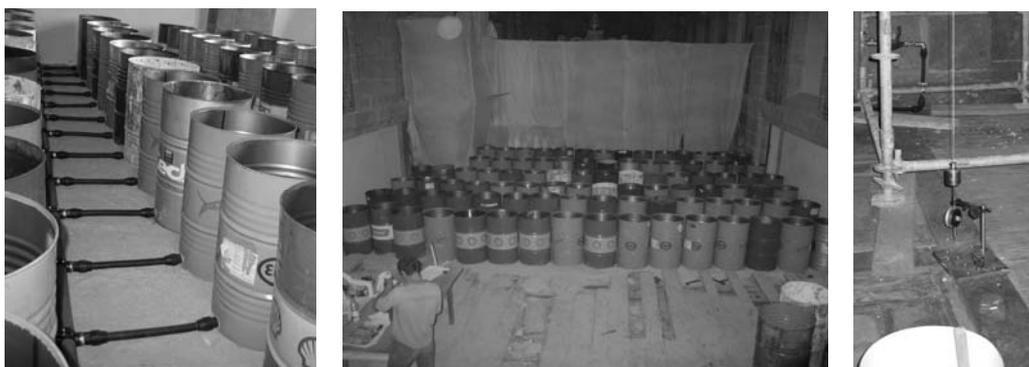
During the tests, the load was applied by filling up with water 92 metal tanks with an average inner diameter of 58cm and an average inner height of 86cm, aligned on the upper-choir floor, Fig. 9.

Figure 9 : Hydraulic network, tanks positioning and measurement equipment.

To make the process easier and guarantee a homogeneous load distribution over the floor, the tanks were linked at the bottom using a hydraulic network, connected to the municipal water supply system. A valve and a counter were set at the entrance of the piping system to control and record the input water i.e., the actual load on the vault. To empty the tanks efficiently, the network was connected to 2 pipes with valves, discharging directly into a rainwater collector at the square in front of the church main entrance. During the tests the vault was monitored using digital and analogical comparing equipment measuring the vertical displacements, Fig. 10, and the crack meters previously installed to control the openings of the joints. The control of the vertical displacements was performed at the knots of the vault masonry frames. To proceed with this, steel threads were tied up to these points and kept straight through weights that were set against the cursors of the comparing devices fixed on the nave floor using heavy bases. This procedure allowed transmitting the vertical movements of the vault to the comparing devices that recorded the displacements.

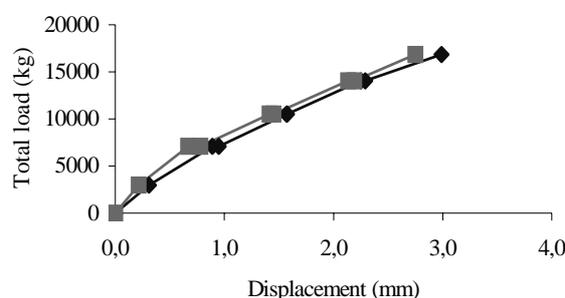
The outcome analysis and particularly the installed force versus measured vertical displacement curves at two central points - the most significant registered points - show an almost linear performance, with an insignificant loss of stiffness without evidence of imminent failure trend, Fig. 10. In this analysis, the possible occurrence of an immediate failure without any “plastic deformation” is safeguarded. On the other hand, the small vertical displacements registered, associated with the non visible openings at the monitored joints, confirmed that the structural capacity is within the acceptable safety limits. Considering this new outcome, the strengthening solution proposed on section 3.2. was abandoned, and the intervention was reformulated.

Figure 10 : Load versus vertical displacement curve.

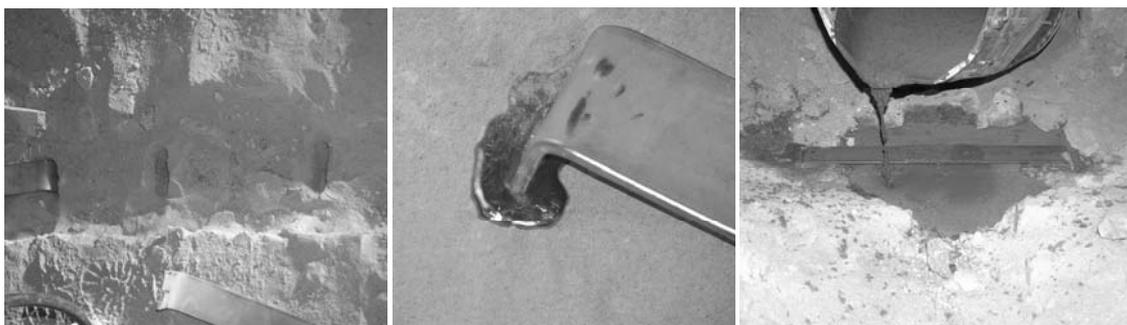
Figure 11 : Stainless steel plates anchored to the stones.

The stones of the masonry frames were linked together with inverted U or E-shaped 50mm width and 5mm thickness stainless steel plates anchored to the stones with a delivery of around 50mm, in order to strengthen the upper face of the stone masonry frames, as shown on Fig. 11. The U-shaped plates were used to connect two stones and the E-shaped to connect three stones, linking one or two joints, respectively. E-shaped plates were used in small-sized stones, where joints were too close. Holes were made on the stones and the plates were anchored by the traditional process of melted lead. Whenever the stones surface was irregular, after the above procedure, a SikaGrout mortar was placed between the plate and the stones, enabling a uniform contact between both elements.

It should be stressed that the reinforcement performed on the upper face will prevent flexural deformation of the vault on the sides, and it will contribute to increase the vaults stiffness and, consequently, to decrease the ability of the structure to deform. On the other hand, by including the strengthening of the vault central area, this procedure provides a more uniform behaviour and, therefore, a better global performance of the structure, fulfilling the purpose of the intervention (ICOMOS, 2001).
