Conservation of a Sandstone Monument at Kanchipuram, Tamilnadu, India

ABSTRACT: Kailasanatha temple, a sandstone monument located at Kanchipuram, Tamilnadu, India built during 674-800 A.D. The sandstone used in the monument has undergone an extensive weathering. The paper deals the reason responsible for the weathering of sandstone. Further the paper deals with stone analysis, forms of weathering occurred on sandstone surfaces which will be useful in future restoration and conservation work.

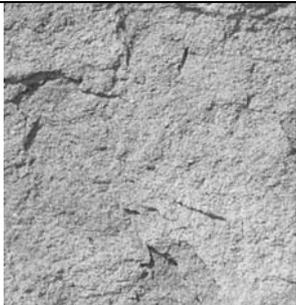
Decay feature	Description	Example
Granular disintegration	Physical damages caused due to lashing rain, wetting and drying cycles and thermal changes. Loss of cohesion of minerals causes disintegration and surface loss of material.

Figure 5 : Loss of material on the external surface of the wall.

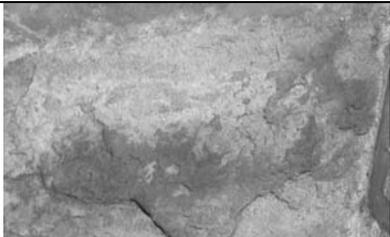
Decay feature	Description	Example
Efflorescence	White patches on the surface of material cause unsightly appearance due to crystallization of salts on the material surface. The phenomenon mainly occurs in interior surfaces or sheltered areas of structures with low rate of evaporation or high humid environment.

<p>Figure 10 Presence of salt as white patches on the under side of the roof slab.</p>
Rock meal	The salts which originate from the soil or atmosphere seeps into the structure by dampness. While drying, salts are deposited internally resulting in granular disintegration. This is a progressive damage, which renders the material soft and crumbling results in disintegration. Typically granular disintegration produces debris that is a mixture of salt and individual grains that is referred to as a 'Rock meal'. And can often be seen accumulating beneath stone which is actively decaying.

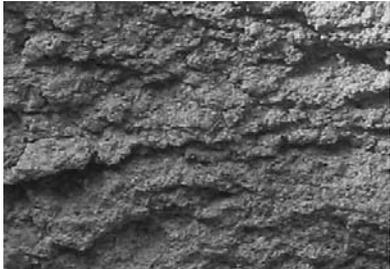
<p>Figure 11 : Sandstone crumbling into powder form.</p>

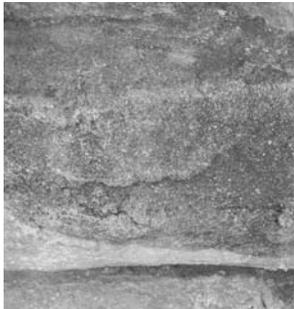
Black crusts	Fungi, algae, Lichen and micro-organisms growing on sandstone surface form a dark crust when dried. The mechanical pressure due to swelling and shrinkage of colloidal bio-film causes physical damage, resulting in weakening of surface grains of stone. Blistering or removal of this film causes partial damage of the surface.

<p>Figure 12 : Micro-organisms growth on the exterior wall surfaces.</p>
Discoloring	The color of the sandstone turns to grey.

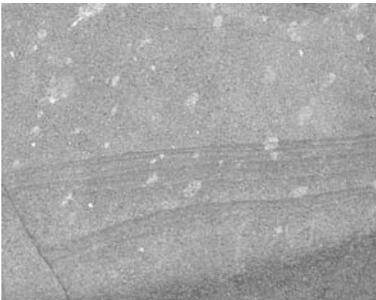
<p>Figure 13 : Discoloring of sandstone.</p>

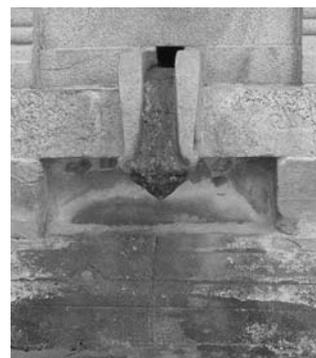
Flowstone The discharge of water and oil from the sanctum stains the stone and promotes the growth of algae and other micro organisms.

Figure 14 : Stains out side the sanctum.

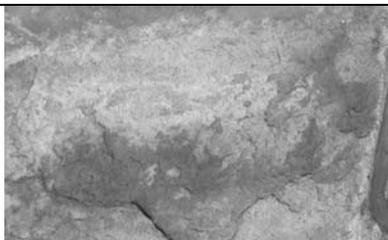
Decay feature	Description	Example
Bio-film Formation	Bio film formation takes place due to dampness. Damp surface of sandstone attracts dust, dirt and other micro organisms. If this is not controlled it will give rise to higher plants. It is green in wet condition and becomes dark in dry condition. The acidic secretion produced by the lichens induces bio- corrosion in sandstone.

Figure 15 Bio-film on the external surface of sanctum wall.

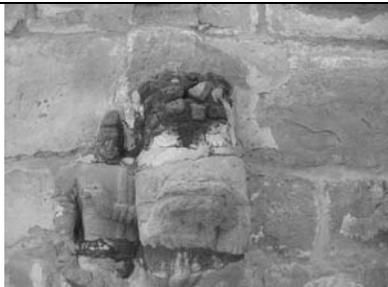
Decay feature	Description	Example
Repair	Repair of sandstone using hard cement mortar and brick. Cement mortar creates a hard rigid boundary around the material. The expansion and shrinkage of the material due to thermal variation cycles within the hard rigid boundary leads to formation of cracks and disintegration of sandstone.

Figure 16 : Restoration of sculpture on the compound wall.

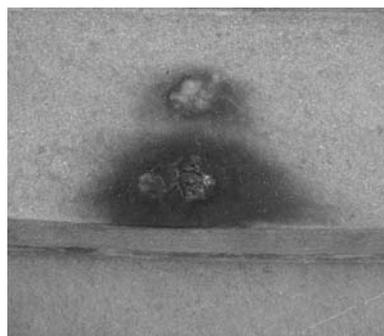
Neglect Stains caused due to burning camphor by the pilgrims create unsightly appearance and damage to the monument.

Figure 18 : Camphor stains at entrance steps.
