Numerical Analysis by FEM for the assessment and the strengthening of the Masonry Vaults of the "Pieve" in Cavalese

M. Piazza and M. Riggio

University of Trento, Department of Mechanical and Structural Engineering, Trento, Italy

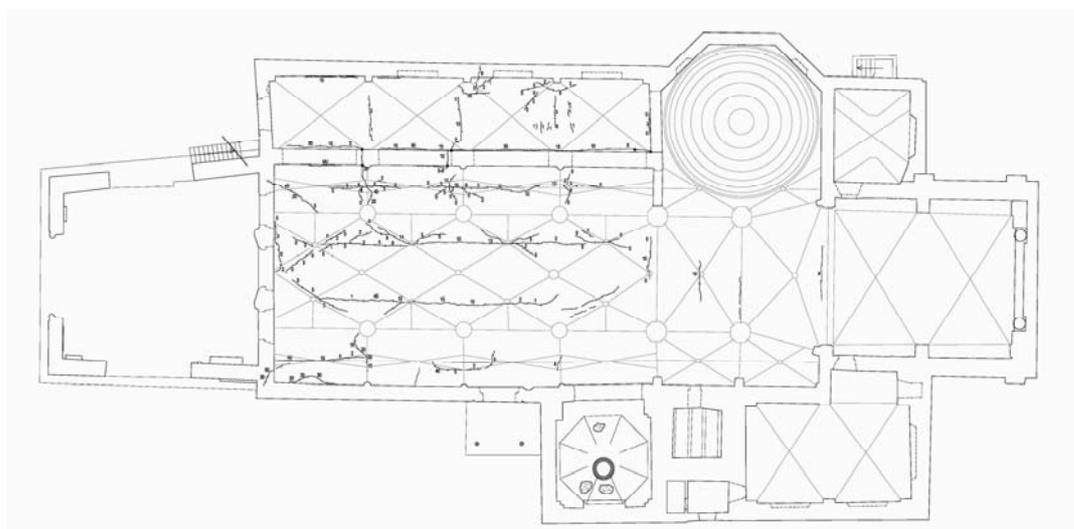
The provisional metallic frames, built into the nave to shore up the vaults, as well as the external one, built to bear the temporary roof, permitted to closely inspect the masonry. Hence, a detailed crack pattern survey both of the extrados and the intrados of the vaults has been carried out (Fig. 5). Cracks have been evaluated as regards their position, direction, length, width and thickness. Extensive internal cracks were present in the extrados of the vaults at the haunches and in the intrados at the crown, according to the typical ‘three-hinged arch’ scheme (Heyman 1996). The analysis of the splits observed along the ribs as well as around the ‘keystones’ of the nave vaults, has led to the conclusion that neither the ribs nor the rose at the keystones are structurally connected to the masonry vaults; ribs rather behave as independent arches. Disconnections between the two systems certainly occurred already in the past, as it is confirmed by the presence of metallic stirrups securing the bosses.

Figure 5 : Crack pattern survey (Plan view)

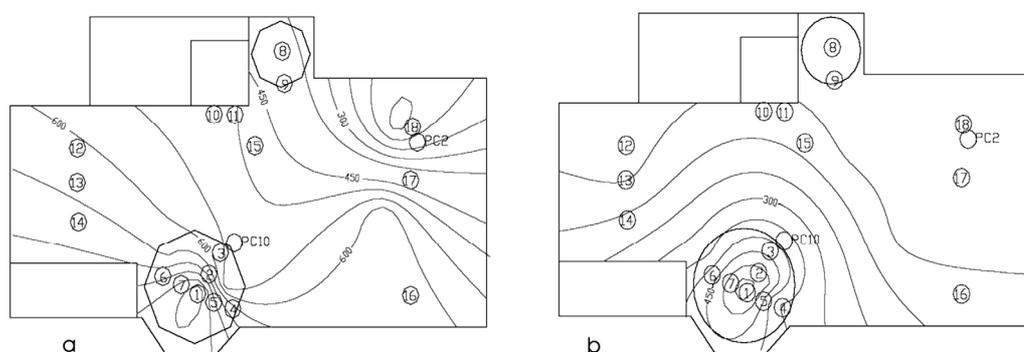
The masonry consists of travertine stone bound with a mortar composed by sand and a magnesic calcium-based binder. Because of the presence of Magnesium salts in the masonry composition, a chemical incompatibility with lime-based grouts, normally used for strengthening interventions, has been highlighted. Thermal analysis has been carried out on masonry vaults, in order to evaluate the effects of high temperatures developed during the fire. A differential scanning calorimeter (DSC) has been used for determining the heat changes occurred during the fire and consequently the range of thermal and chemical transitions in the material. Both the superficial layers (Fig. 6a) and the deeper layers of the samples (at 3 cm from the surface) (Fig. 6b) have been analyzed. The most heated area was the Rosario Chapel dome, where the timber roof frames were very close to the vaults extrados.

Figure 6 : Analysis of the fire effect. Isothermal lines maps (a) superficial samples (b) 3 cm from the surface (RTeknos s.r.l., Zeila lab. s.r.l.)

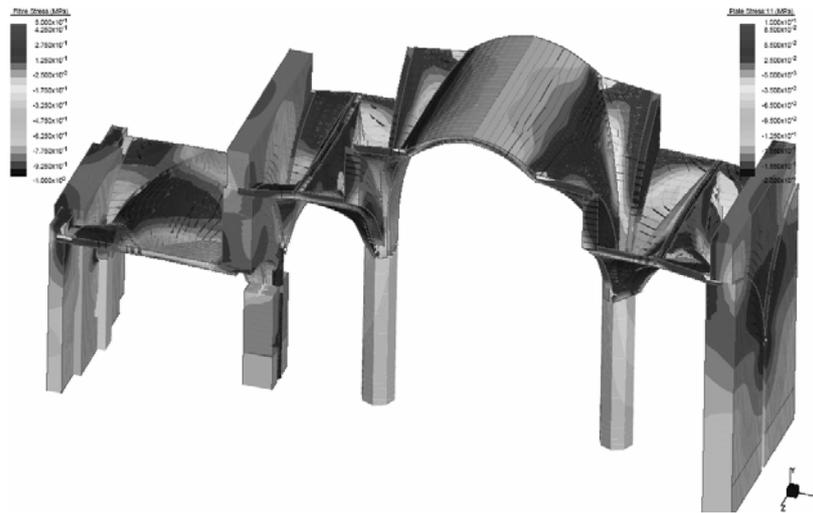
The loading condition associated with the state of the structure after the fire has been modelled. Hence, the only masonry dead loads have been considered, bearing no longer the roof on the underlying structures. The results of the analysis are given in Fig. 7 in terms of maximum axial stresses. Maximum values of the tensile stresses occur at the apex of the intersections of the barrel vault with the lunettes in the nave, at the keystone of the sexpartite vaults in the side aisles and at the crowns, in the areas where the vaults of the aisles meet the walls. The model results are validated by the evidences of damage observed in the masonry structures. Indeed cracks are present at the intersections between lunettes and barrel vault, as well as along the longitudinal ribs of the sexpartite vaults. A further analysis has been carried out adding the dead loads transmitted by the timber roof (Fig. 8). Maximum horizontal displacements referred to the two loading conditions have been compared, in order to highlight contingent dangerous effects of the roof on the stability of the masonry structures. As resulting from the comparative analysis, the presence of the roof doesn't influence significantly the behaviour of the underlying structures. The observed damage is rather to be ascribed to the material quality and the structural shape of the vaults themselves.

Figure 7 : Global model without roof: Axial stresses (hypothesis of hinged supports at the bases)

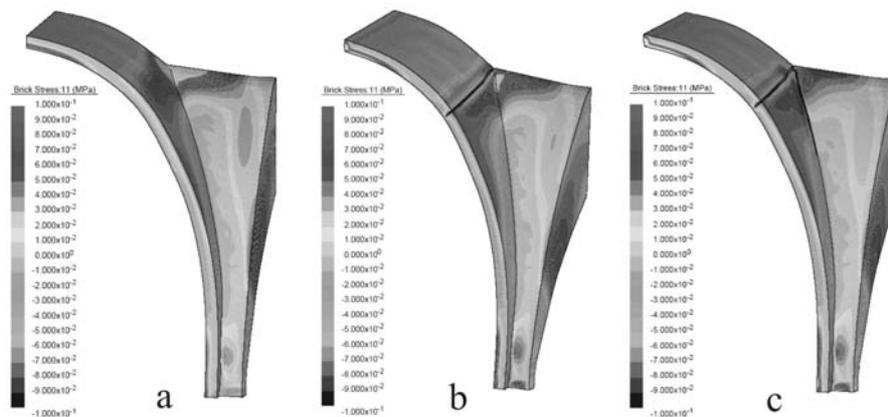
Detailed models of the nave vault have been studied considering them both before and after repairs. Because of its double-symmetry just one quarter of the vaulted bay has been modelled. About 4200 nodes and approximately 33700 brick 8-node hexahedron elements were adopted for the analysis. Different models of increasing complexity have been used to analyse the vault in the unrepaired condition. In particular a first model assumes linear elastic behaviour of the material, whose properties are reported in Table 1. The global modelling demonstrated that the presence of the roof can be neglected, hence, only the masonry dead loads have been considered. The tensile zones, resulting from the first level modelling, highlight the areas of actual and potential cracks (Fig.9a). At a further level, the cracks actually present in the vaults have been introduced in the linear elastic model, disconnecting the elements on either side of the crack. Two different damaged models have been implemented: 1) with longitudinal cracks along the crown at the intrados and tangent to the lunette apex at the extrados (Fig. 9b), 2) with longitudinal cracks and transversal cracks at the intersection between barrel vault and lunette (Fig. 9c). In both cases, the analysis results highlight the presence of residual tensile zones, thus confirming that further local failures could occur. Subsequently, the non linear behaviour of the material has been considered. A no-tension model has been assumed, as represented in the $\sigma - \epsilon$ curve of Figure 10. Loading steps have been applied in order to evaluate the influence of load increments on the behaviour of the structure. Also in this case an undamaged model has been studied at first. The analysis results relative to the 30% of the total load, exhibit critical tensile zones at the crown in the intrados and at the haunches in the extrados (Fig. 11a). A damaged model has been then considered, introducing the longitudinal cracks really existent. In this case maximum tension values occur at the intersection with the lunette (Fig. 11b). A further model that considers also the transversal cracks, exhibits marginal tensile zones (Fig. 11c). The incremental analysis permitted to ascribe the most significant damage to the intrinsic characteristic of the structure, such as dead loads. Indeed at a load step relative to the 40% of the total load, convergence problems occurred, thus confirming the severe static condition of the vaults.

Figure 9 : Detail model of the (unrepaired) nave vault. Linear analysis

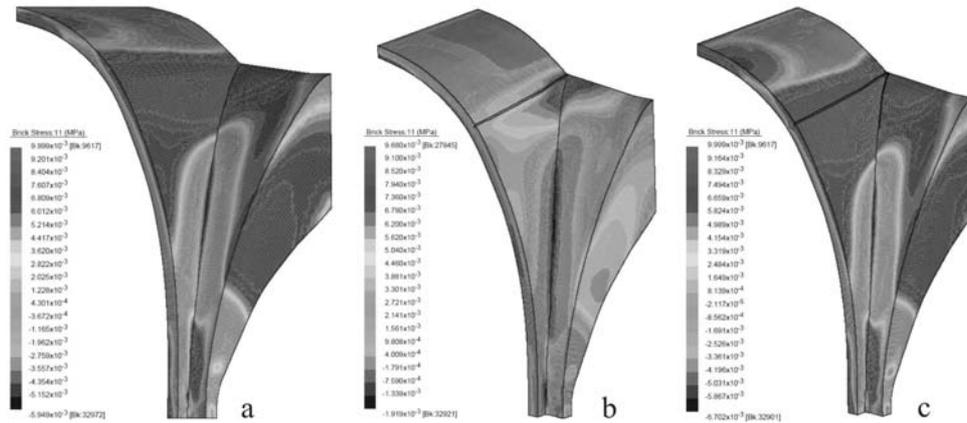
Figure 11 : Detail model of the (unrepaired) nave vault. Non linear analysis; (a) undamaged model (30% dead loads), (b) longitudinal cracks (10% dead loads), (c) initial transversal crack (35% dead loads)

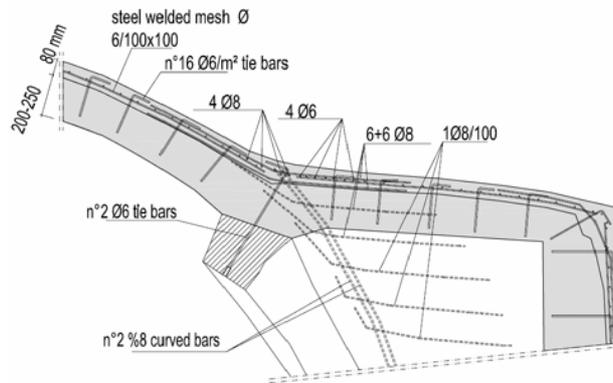
Figure 12 : Strengthening of the nave vault

The structural problems, arising from the visual inspection and confirmed by the structural analysis, required adequate solutions. Fig.12 shows the local interventions on the nave vault.
