Safety Assessment and Strengthening of Existing Steel Frames Containing Semi-Rigid Joints

ABSTRACT: Bund 18 is a historical building at the Bund of Shanghai. The structural system of the building consists of cast in-situ RC slabs, steel beams and columns, which is commonly used in other historical buildings in Shanghai. Through inspection and calculation for Bund 18, the safety state of the building is assessed. Based on the results of safety inspection and assessment, the strengthening and rehabilitation plan is proposed. By renovating some semi-rigid beam-column joints into rigid ones, adding some steel brace struts between the neighbouring columns and strengthening the masonry walls with single or double steel mesh reinforcement and cement mortar, the structural safety are substantially improved. The above strengthening plan is also applicable to other historical buildings which have the similar structural system.

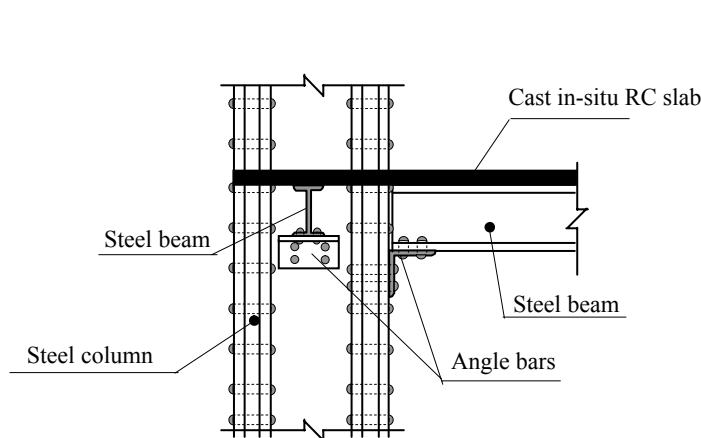
In Fig. 4, steel beams are connected with the steel column only by angle bars. So in this way the beam-column joints can be taken as hinged ones and the structure could be considered as a hinged frame for the analysis.

Provided that the steel beams have perfect connectors with the RC slab, the beam-column joints can also be taken as rigid ones, in such way, the structure could be considered as a rigid frame for the analysis. In fact, there are no connectors between the steel beams and the slab, but

the concrete surrounding the steel beams and that of the slab are cast as a whole. As a result, the interaction between RC slab and steel beams make the structure a semi-rigid frame. Taking the above two extreme situations into consideration, the structural analysis could be carried out according to the rigid frame model and the hinged frame model, while the real situation of the structure may belong to the one between the two extreme situations.

Figure 4 : Beam-column joints

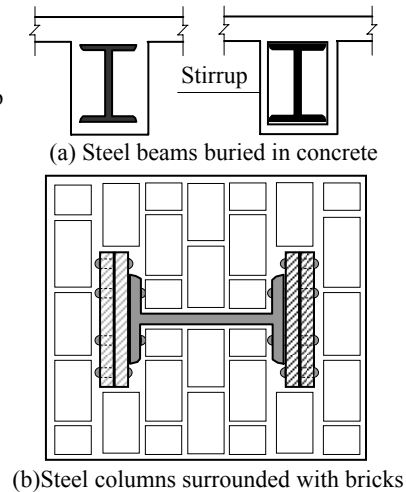
Figure 5 : Steel beams and the typical column

Steel beams are buried in concrete, similar to the composite steel-reinforced concrete beams (Fig. 5a). During the inspection, it has been found that the formed steel sections in the beam are all *I* shape, and the sizes of sections in beams are between 125×305mm~125×380mm, sections in girders are all 150×380mm. As shown in Fig. 5a, some formed steel sections are hooped with stirrups while some are not.

Steel columns are covered with bricks (Fig. 5b). It consists of *I* shape formed steel sections and steel plates, which are clinched together. The thickness of the steel plate is 12.7mm.

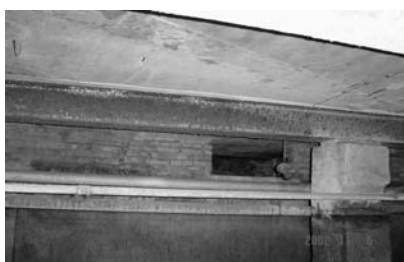
During the inspection, it has been found that some of steel bars and formed steel sections in the building corroded. Because of the loss of protected cover, bars at the bottom of slabs and formed steel sections in the base room, where is humid, corroded severely (Fig. 6a). Due to the same reason, steel bars of the roof in the southeast corner corroded as well as the steel bars inside the stair beams and balcony slabs in the west side of the building (Fig. 6b).

(a) Corroded formed steel sections in the base room

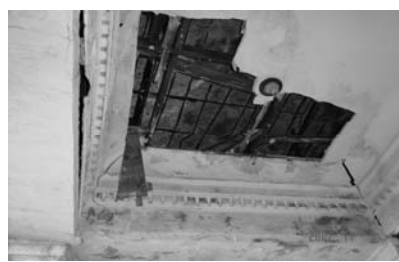
(b) Corroded steel bars in the roof

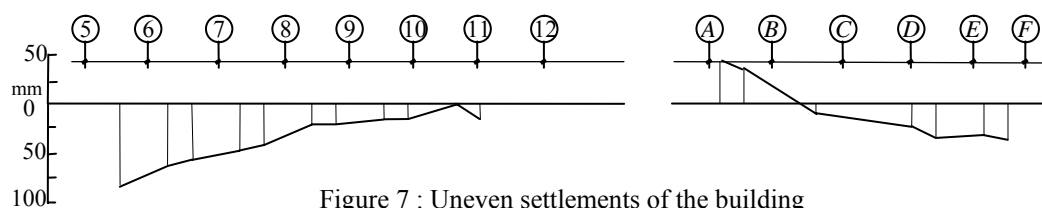
The uneven settlements of the building which were obtained using the SOKKIA C40 high precision level are shown in Fig. 7. The results show that the lowest point is located in the southeast of the building.

Figure 7 : Uneven settlements of the building
