Retrofitting and Reinforcement of a Wire Suspended Bridge in Portugal

ABSTRACT: This paper presents a study made on a particular structure, a pedestrian wire bridge. It describes the work performed by the Nucleus for the Conservation and Rehabilitation of Buildings and Built Heritage (NCREP) of the Faculty of Engineering of University of Porto (FEUP) to respond to the interest of the Association of Municipals of Baixo Tâmega in retrofitting that peculiar bridge located at the North of Portugal. After a brief introduction and illustrating some examples of these type of structures built in Portugal, the paper describes the intervention methodology, which involved *in-situ* inspections and a large experimental campaign for the material and structural characterisation of the bridge. These studies were carried out with the contribution of mechanical and metallurgical specialists and allowed fitting the mechanical properties that were used in the numerical model for the simulation of the bridge

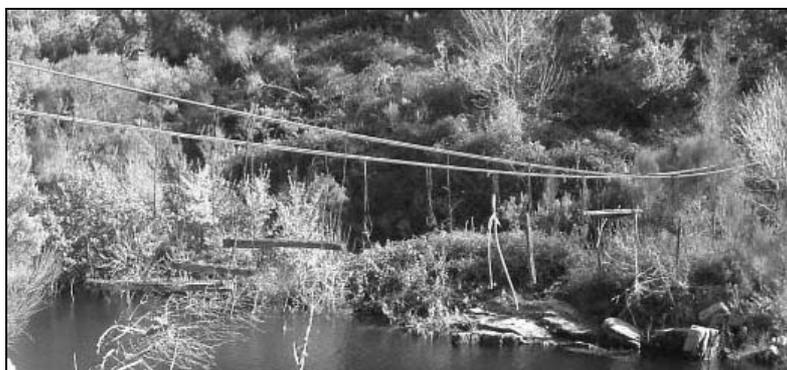
Four of the structures referred to in Table 1 already disappeared or are in a complete state of ruin (bridges: Pensil, Pedraça, Padroselos e Adaúfa). In the case of the Arame bridge, it doesn't present safety conditions that allow it being used. Fig. 2 shows the actual aspect of the Padroselos bridge.

Figure 2 : The example of the Padroselos bridge, destroyed by lack of maintenance.

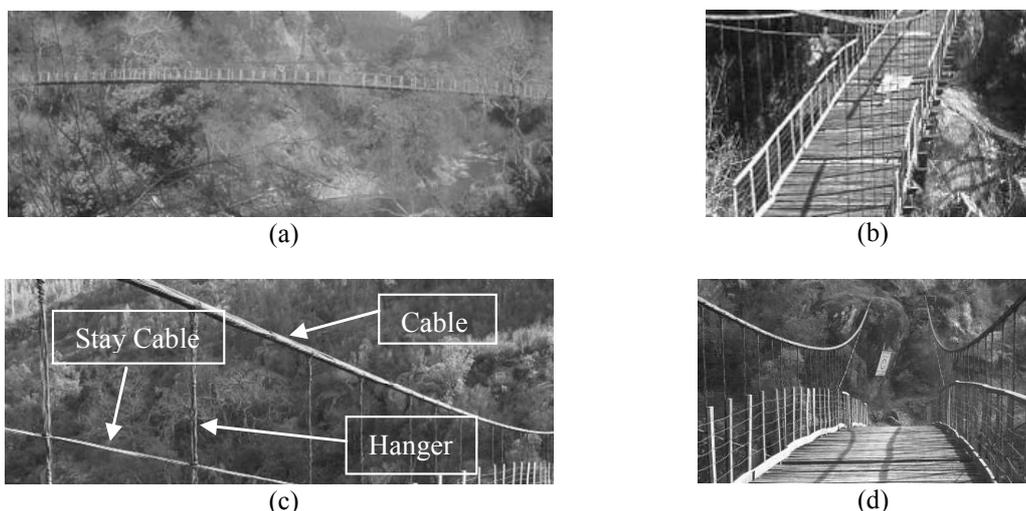
The Arame bridge is 55m long and 2,5m wide; it is sustained by two cables, each one composed by three strand ropes. A cable has, approximately, 220 individual 3mm diameter wires, Fig. 4. The cables are linked to the deck by 104 vertical ties made of 8 individual wires (Costa et al. 2005a).

Figure 4 : (a) Elevation view; (b) Perspective view; (c) Components identification view; (d) Internal view.

Due to the high level of degradation of its components, today the crossing of the bridge is interdict. This decision is based on the fact that the bridge doesn't fulfil the minimum safety conditions for its normal functioning.

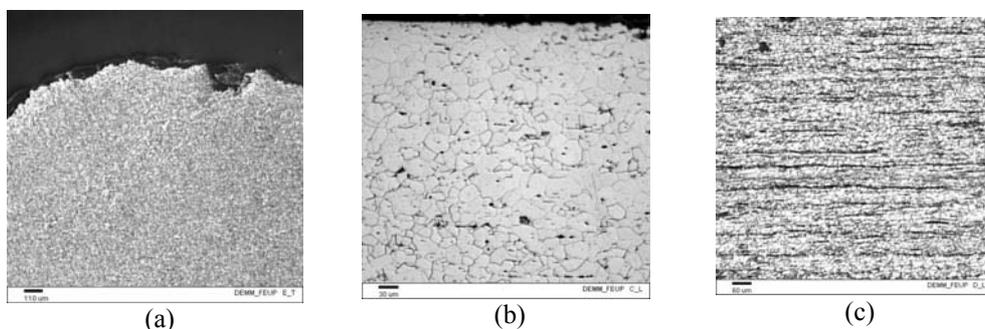
Although it wasn't possible to determine its intensity, it was possible to identify important corrosion phenomena.

A large number of inclusions were observed, denoting a small purity degree of the material. These inclusions weren't found in the same quantities in all samples, giving an idea about the quality control of the production process.

Fig. 5 presents a corroded wire section (5a)), a transversal section (5b)) and a longitudinal section containing several inclusions (5c)).

Figure 5 : (a) Corroded section; (b) Transversal section; (c) Longitudinal section.

- Scanning electronic microscopy (SEM) – the observations allowed determining the amount of corroded section. An average value of about 20% of corroded section was observed and it was used in the numerical analyses.
Two different coatings were identified: an external polymeric one, about $9\mu\text{m}$ thick, suggested by a large amount of carbon observed on the spectrum, and an internal zinc

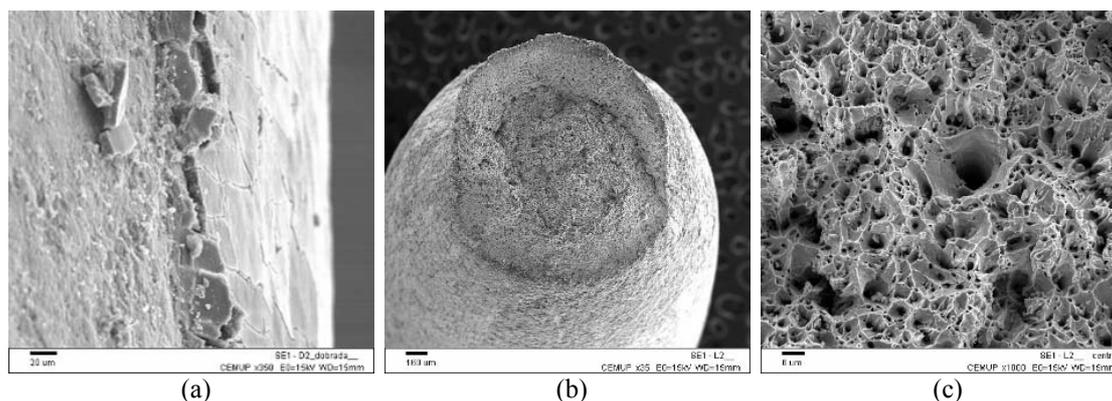
coating. These protections, especially the external one, were cracked. In spite of this, the wires were considered to be relatively well preserved.

Although the uniaxial tensile tests gave, in almost all the cases, a very small ultimate extension, most probably because plastification had already occurred on the wires in previous events (Branco 1985), the observation of the fracture surfaces confirmed the ductility of the material. This confirmation comes from the observed local area reduction and from the micron spherical sockets of the fracture surface (Callister Jr. 2002).

Fig. 6 presents the detachment of the external coating (6a)), a fracture surface (6b)), which is presented more in detail in the Fig. 6c).

Figure 6 : (a) Coating detachment (350x); (b) fracture surface (35x); (c) Detail of the fracture surface – micron spherical sockets (1000x).

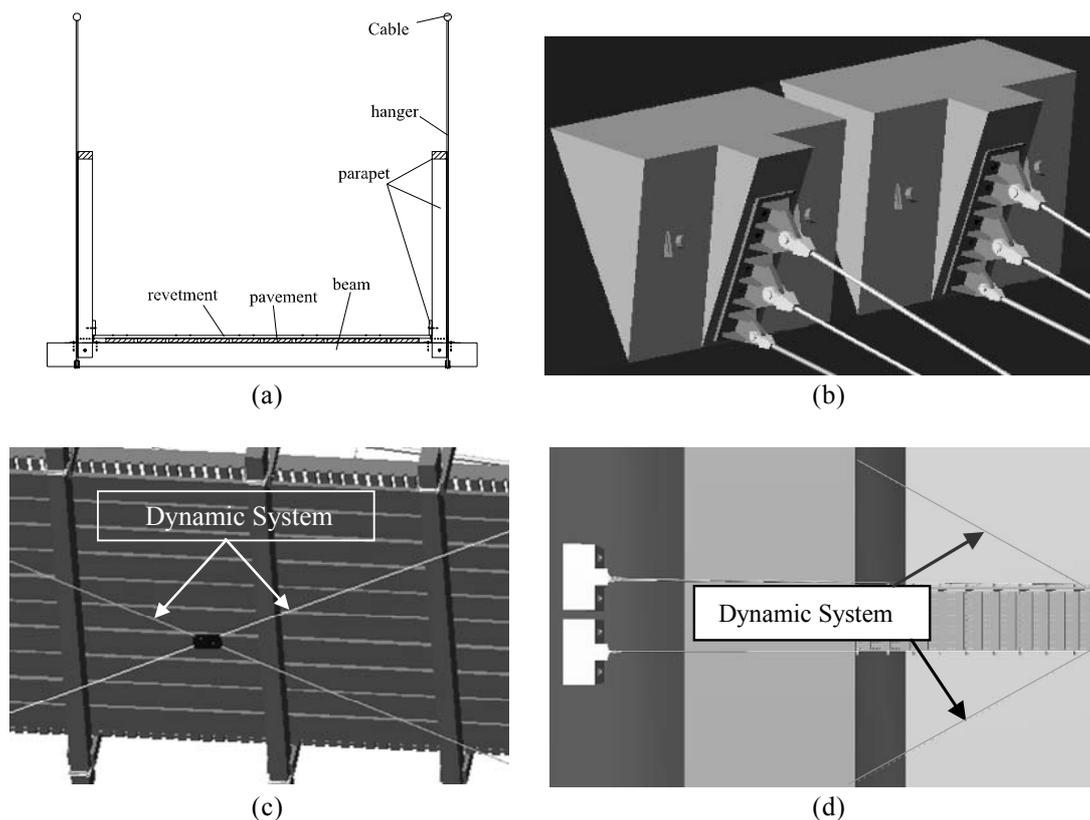
Figure 7 : (a) Transversal section; (b) Reinforced concrete blocks; (c) Dynamic system (3D view under the deck); (d) 3-D Aerial view.

After concluding the previous phase the bridge safety conditions were analysed using the structural numerical software *Robot Millenium*. This analysis allowed verifying that the bridge had no capacity to respond to the nowadays design loads criteria, either in terms of the cables or the deck. Because of this incapacity, the bridge rehabilitation solution foreseen the strengthening of the wire structure with the positioning of new high strength cables. Although the old cables will not be removed and will be preserved as a heritage mark of the old structure, the solution disregarded the capacity of these cables. The new cables will be anchored at reinforced concrete blocks which will be anchored at the mountain rock through pre-stressing anchorages.

Due to the high degradation level of the pavement, as it was already referred to, it will be completely substituted using a higher resistant wood, the IPE. That measure took into account factors like the heritage and economical value of the wood. In fact the historical value of the

bridge isn't on its materials but on its original conception which the rehabilitation strategy didn't intend to modify. Thus, the high flexibility of the bridge will be maintained but without compromising the pedestrian security because this is the main characteristic of this structure, giving authenticity to the retrofitted bridge. However, the dynamic behaviour of the bridge concerning transversal movements was improved with the inclusion of horizontal ties to increase the frequency values of the transversal vibration modes, decreasing significantly the occurrence of this type of vibration. This aspect was taken into account using four horizontal stay cables placed under the deck to increase the transversal stiffness.

Fig. 7 shows a cross section (7a)), the reinforced concrete blocks (7b)), the dynamic system under the deck (7c)) and an aerial view (7d)) (Costa 2005-c).
