Investigations of Historical Structures - A Study of Rational and Irrational Forces

Sanghamitra Basu

Indian Institute of Technology- Kharagpur, Architecture and Regional Planning Department, Kharagpur, India

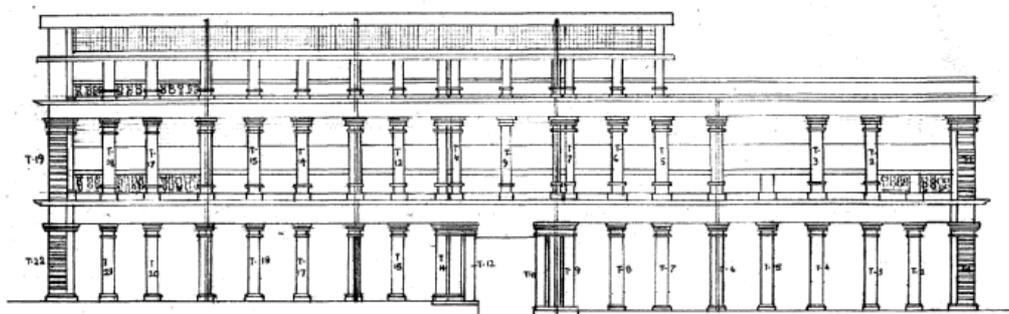
The veranda has a series of freestanding columns in classical style of Greek architecture (Fig. 1). From the moat side, the structure appears to be two to three storied due to the rows of columns on the outer side of the basement and topmost floor. While rest of the building was in sound condition, the columns abutting the veranda were in precarious state with wide cracks on capitals. As far as the documentation is concerned, a partial elevation drawing and some foundation details were made available to the conservation consultants. However, cooperation was extended for investigating the structure and to find out the cause of distress so that appropriate measures could be suggested. Most of the columns were in distressed state with visible settlement and subsequent cracks. It must be mentioned that prior to investigation process, the authority was pondering about demolition of the structure (at least partially) as a probable alternative.

Figure 1 : The veranda from the moat side.

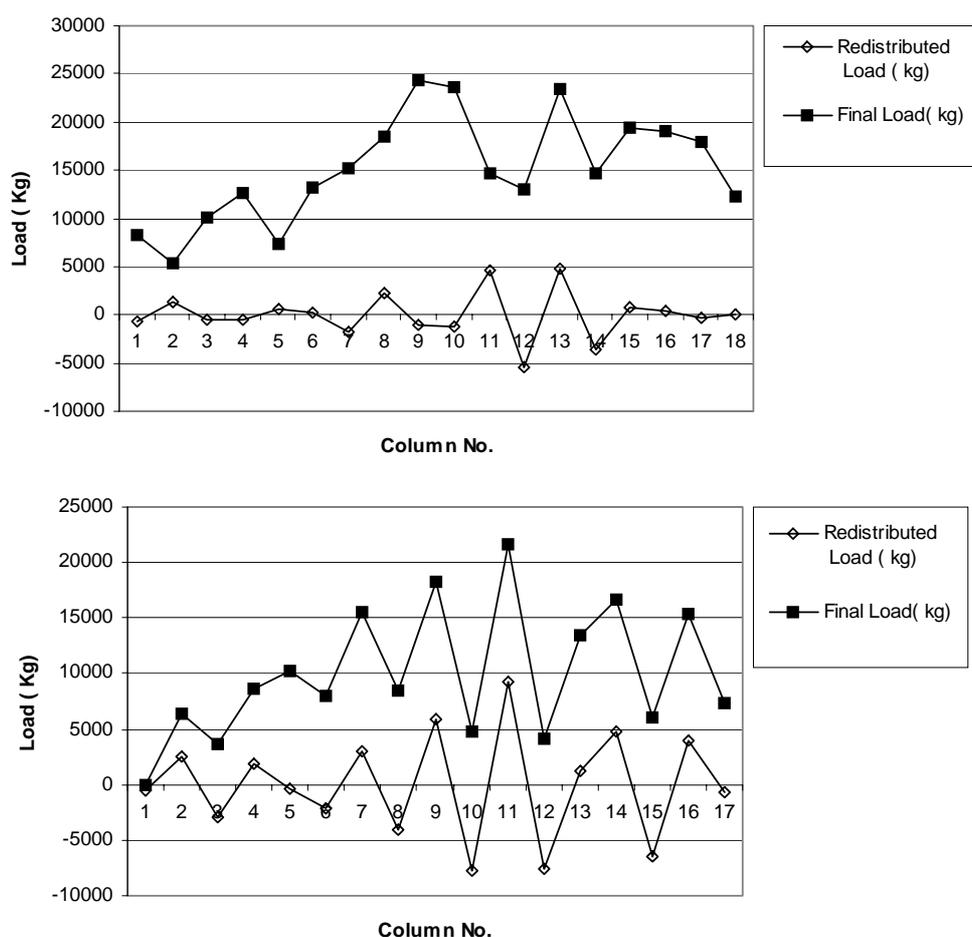
A level survey was carried out to record the relative settlements of the columns. A finite element analysis for settlement gave the changes in the column reactions. The original dead load and the final column reactions were calculated (Fig. 2). Two types of footing cross sections were shown in the drawing. From the drawing it appeared that the type of foundation was not uniform - it was isolated in places and continuous in some areas. Load calculations and a stability analysis were carried out to identify the mode of failure. Investigation pointed towards differential settlement of foundation of columns.

Figure 2 : Expected redistributed loads on columns (ground floor and first floor).

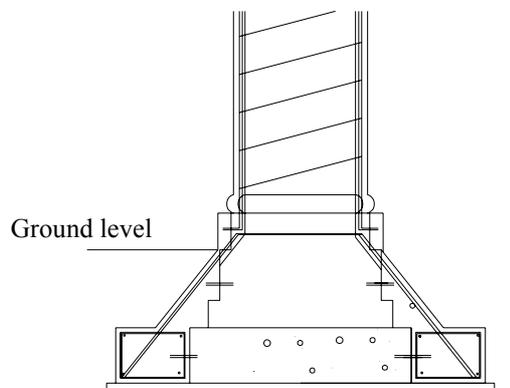
Figure 3 : Section showing jacketing of column and foundation strengthening.

To strengthen the columns and to ward off further deterioration, decision was taken to encase the columns with reinforced concrete jacket. Encasing or jackets extending all the way to the foundation and integrated with the existing footing is expected to provide certain confinement to the brickwork and to stop further cracking and enhance the load carrying capacity of columns (Fig. 3).

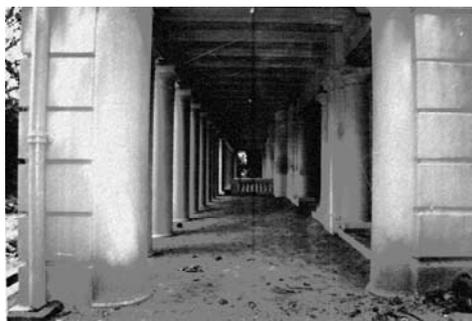
Figure 4 : Ground floor columns after restoration.

Strengthening of the column foundations as well as existing columns required careful designing of temporary support system. Arrangement of supporting columns with jacks and provision of extra ties with main walls of the buildings necessitated careful designing of scaffolding and scheduling of the activities. Each and every step was crucial. With great relieve to all the parties concerned, the building regained its strength and survived a probable demolition threat. The jacketed columns with its enlarged and disproportionate dimensions (Fig. 4) undermine the original artistic appeal – a price for the structure’s survival for posterity.

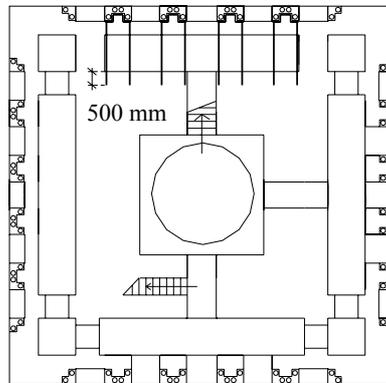
Figure 6 : Section showing the layout of the pinning arrangement at upper level.

Recommended procedure of pinning the damaged portion to the main wall was to take care of the fault. The implementation stage revealed the overriding power of irrational forces in play. The teamwork with all the stakeholders is an interesting learning experience.

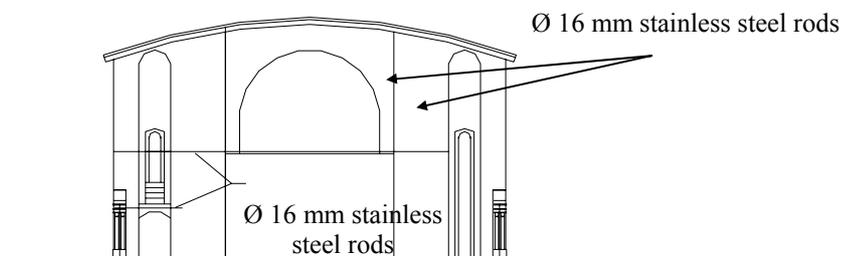
Figure 7 : Section through the sanctum sanctorum showing position of stainless steel rods.

The work started with grouting as per specification. It was just before the drilling process that reservations were expressed by the temple authority regarding probable damage to the structure inflicted during the drilling across the wall section. A compromise was worked by pinning it along the walls within a groove section rather than through the wall section, even though consultants had reservations about the reliability of this method. The owners did not accept even this arrangement and at the last stage the entire process was carried out in a different manner with the pins spanning at a safe distance from the walls. As the structural efficacy of this method is to some extent questionable, consultants had to disassociate themselves from the project. The authority went ahead with the process and completed the pinning in a modified manner. The restoration measure is now complete and quite a few years have passed by. It is necessary to monitor the crack to ensure long-term safety of the structure. But that onus now rests with the trustee members. Officially the building is not a listed one and the local authority do not have clear dictum about its conservation status.

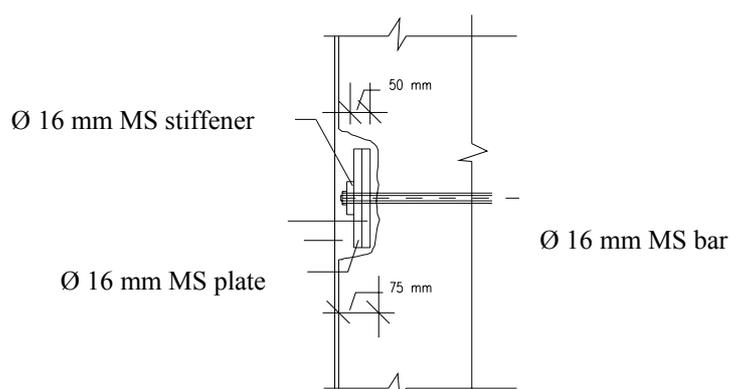
Figure 8 : Details of anchor bar.
