## Restoration of Wood Structures at Federal University of Rio de Janeiro

Marisa Hoirisch and Rosina T.M. Ribeiro

**ABSTRACT:** The University Palace of the Federal University of Rio de Janeiro, a renowned neoclassic style building, was erected between 1842 and 1852 as a tribute to the Emperor Dom Pedro II adulthood. The need to repair the wooden floor structures of the Palace, attacked by a overwhelming termite infestation, required hiring a multidisciplinary technical group including structural engineers, building companies acting in historical buildings restoration and biologists specialized in urban insect infestations. Since this building is protected by the National Institute of Historical and Artistic Landmarks, every stage of the project, as well as, the works for the floor restoration were controlled by the landmark institute.

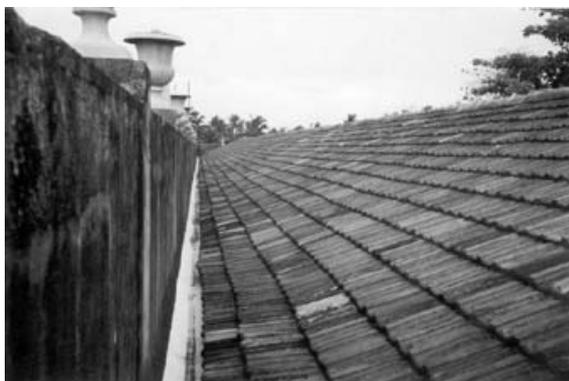
A stimulus to colony growing took place due to alternating dry and wet conditions, triggered by roof flaws, cracked and displaced tiles, gutter debris, unprotected construction joints and water pipe clogging. Furthermore, the replacement of copper water troughs by those in asbestos-cement, about 20 cm higher than the original ones, led to a drastic reduction of the slope of the two last tile rows, turning them flat and inducing water return to the inner section of the building, see Fig. 2.

Figure 2 : Two last tile rows flat at University Palace's roof.

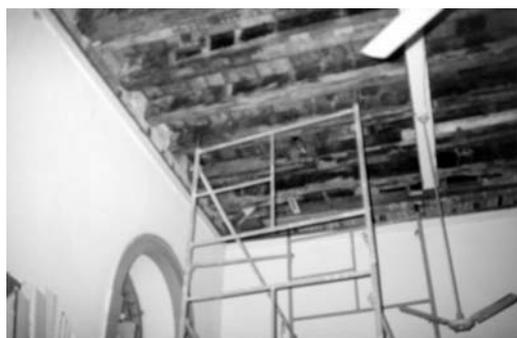
Figure 3a: The boards of the inferior ceiling were removed, 1996

- The boards of the floor and inferior ceiling were removed, see Fig. 3a.
- They were further reutilized after termite treatment.
- Masonry cavity removal in both wall sides to allow the support of new strengthening wooden beams (in this room the affected beams attacked by termites were not removed)
- Termite treatment in the remaining viable beams.
- Supplying and installation of two strengthening beams made of *Manilkara longifolia*. wood with a cross section of 3" x 9" placed on both sides along the partially destroyed wood piece, after previous infestation control, see Fig. 3b.
- Filling of the masonry opening with grout, making sure that each bearing wall would maintain its structural resistance.
- Reinstallation of floor and ceiling skirting boards using a new replacement screw fixation.

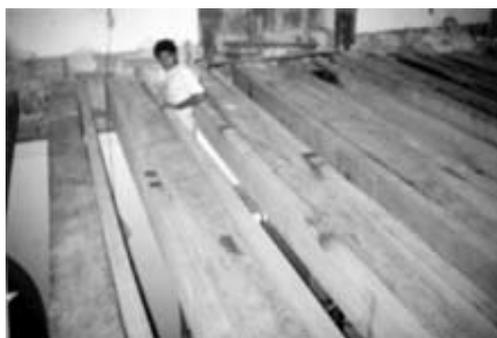
Figure 3b: Installation of two strengthening beams.

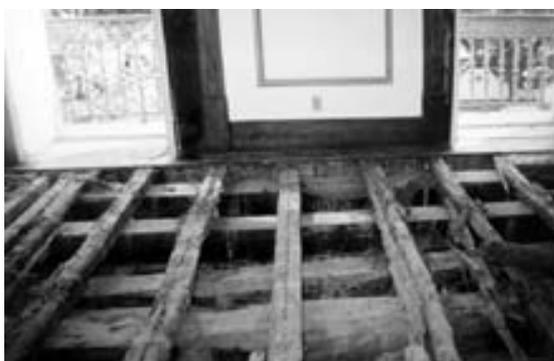
In the University Palace, occurred various kinds of sensibility to biological agents attack: for single termite specie and for concomitant attacks, even in the same wooden beam. The inspection of wooden beams revealed a superficial attack in some of them and a reduction of a wood section in others advancing till the core. Percussion was utilized with the help of hammers, comparing the sound generated for the rather hollow wood mass in comparison to the no destroyed ones (Mateus, 2002). Perforations were carried out with drilling machines for the analysis of extent of the *canaliculus* depths excavated by *xylophaga*.

Figure 4a : Degradation of wooden beams, Rector room, 1996.

- The removal of the floorboards and the ceiling boards of lower deck for further reutilization. Preservation of the both board systems, see Fig. 4a.
- Shoring the of the floor structure from the lower floor.
- Cavity opening in the masonry wall adjacent to the supports of the damaged beams, for a posterior installation of the strengthening beams.
- Temporary distribution of some of the damaged beams loads without support in the walls, to the adjacent beams, with the help of adequate temporary connection.

- Removal of the damaged beams, which previously supported the floor and the ceiling lining, see Fig.4a. Termite treatment of the beams to be kept.
- Supplying and transportation of the new beams to the work site employing wheeled carts and cranes. Installation of 6" x 6" *Tabebuia* sp wood beams from the ceiling lining in the place of the damaged ones.

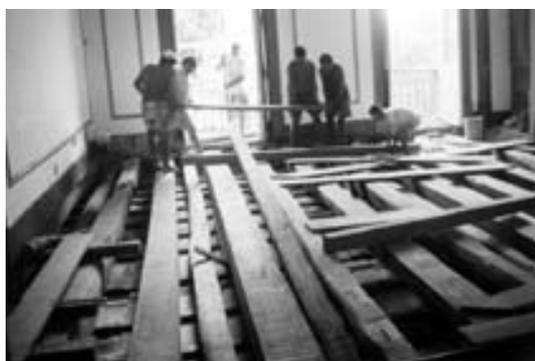
Figure 4b : Installation of floor 10" x 10" *Tabebuia* sp wood beams, 1996.

- Supplying and installation of floor 10" x 10" *Tabebuia* sp wood beams, replacing damaged ones, see Fig. 4b.
- Filling of the masonry opening with grout, making sure that each bearing wall would maintain its structural resistance.

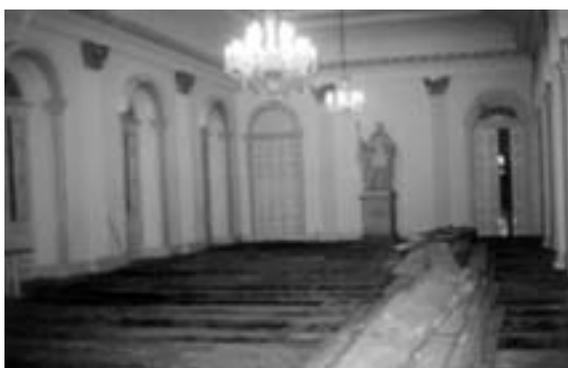
The room measures 9.10m x 18.14m and its floor is supported by 10" x 10" wooden beams presenting a 64cm approximate spacing, see Fig. 5a.

Figure 5a: The Golden Room restoration process, 1996.

- The 9.10m length is subdivided in two 6.04m and 2.36m beam spans supported by a 70cm thick intermediate wall, which separates, in the lower floor at ground level, a room and a gallery. The last one runs along the building inner garden.
- Similar procedures to the ones described for the other rooms have been adopted for the Golden Room, except for the wooden beams, which had been replaced in an alternate way, to avoid removal of the floor lining, since it remained supported by the remaining beams.
- The Golden Room after completion of restoration, see Fig. 5b.

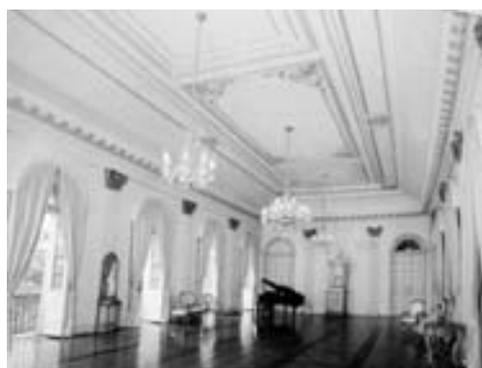
Figure 5b: The Golden room after completion of restoration work, 2002.
