An Outline of the Seismic Behavior of Historical Structures in North Western Anatolia

A. Ilki, M. Ispir, C. Demir, N. Kumbasar and S. Akman
Istanbul Technical Univ., Civil Eng. Faculty, Istanbul, Turkey

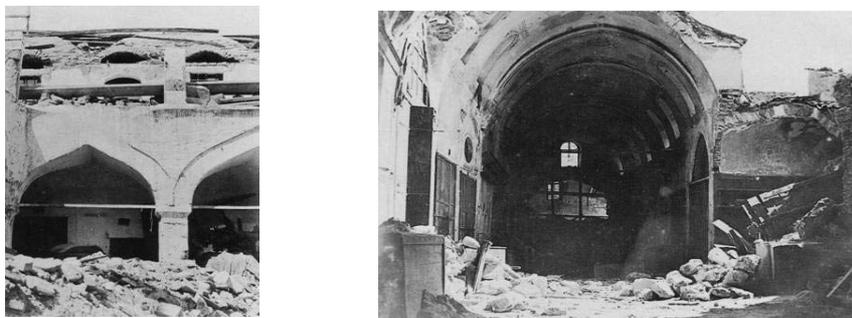
Damage to Istanbul was widespread, but its level was not severe. Buildings like mosques, churches, hans, public buildings, dwellings exposed to damage in varying levels. Many minarets collapsed (Ambraseys 2001). The names of these buildings were given by Pamukciyan (1994), Ambraseys (2001), Genc and Mazak (2001) and Sakin (2002). Some examples of these buildings are the mosque of Mihrimah Sultan at Edirnekapi, the Catholic Church at Yesilkoy, Covered Bazaar at Eminonu. While Ambraseys (2001) defined the damage to the mosque of Mihrimah Sultan as slightly damaged, Genc and Mazak (2001) and Pamukciyan (1994) stated that the damage was severe. Sakin (2002) stated that the minaret of the mosque of Mihrimah Sultan collapsed. The Catholic Church at Yesilkoy was demolished, (Pamukciyan 1994, Ambraseys 2001, Genc and Mazak 2001 and Sakin 2002). The earthquake induced severe damage to several shops in Covered Bazaar (Kapali Carsi), Fig. 2.

Figure 2 : Covered Bazaar after 1894 earthquake (Genc and Mazak 2001).

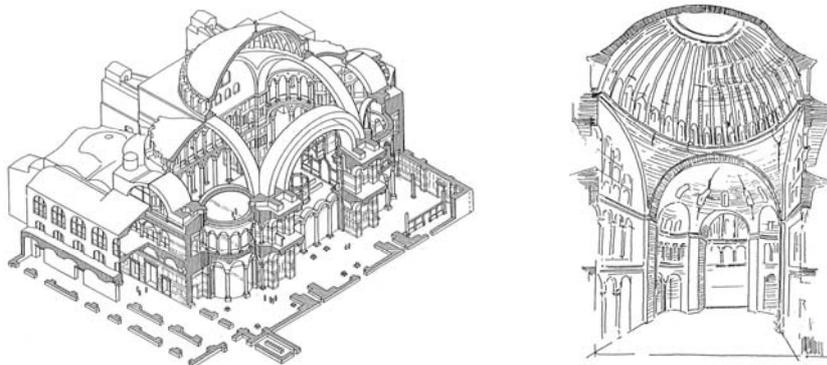
Figure 4 : The view of Hagia Sophia (Eyice 1994a) and the crack pattern sketched after the 1894 earthquake (Batur and Tanyeli 1993).

Information, regarding the damages caused by the earthquakes of 1509, 1754, 1766 and 1894 are tabulated in Table 2. A drawing that described the damage situation of Hagia Sophia after the earthquake is presented in Fig. 4, (Batur and Tanyeli 1993).

| Earthquake | Hagia Sophia Museum | Chora Museum | Fatih Mosque |
|---|---|---|---|
| 10.07.1894 | One of its columns, western part of its great apse and the decorations of cupola required repair, (Ambraseys 2001). Main dome was deformed, settlement and horizontal cracks were observed on the piers supporting the main dome and vertical cracks were formed in the vault of windows of dome, (Batur and Tanyeli 1993). | Half of the minaret fell down, (Genc and Mazak 2001 and Sakin 2002). [slight] | The minarets were damaged slightly, (Ambraseys 2001). Two minarets were collapsed, (Pamukciyan 1994 and Genc and Mazak 2001). [slight] |

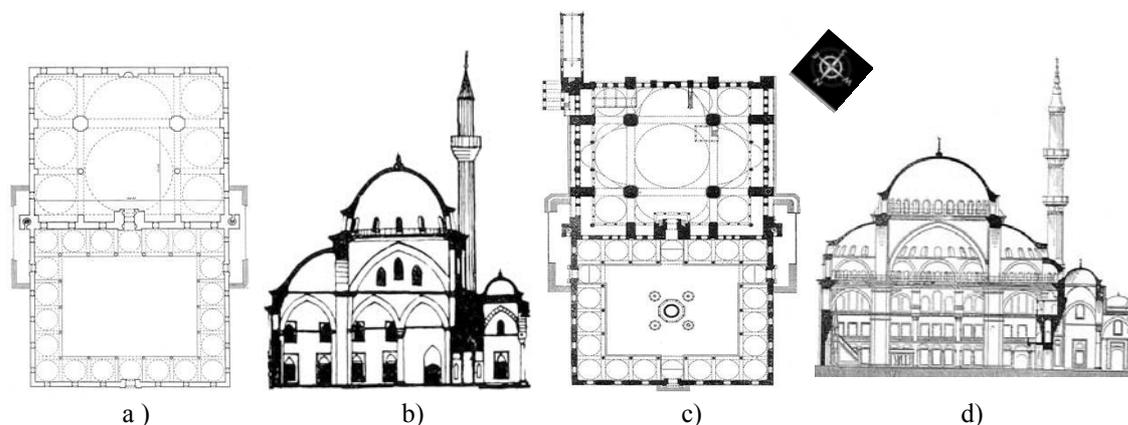
Since during the 1766 earthquake the structure saw great damage and it was not feasible to repair it, the mosque was reconstructed with a different plan, Fig. 6c. The new mosque (the present mosque) was built on the foundations of the old mosque between 1767 and 1771. The main space of the mosque was formed on a system of four semi domes that supported the central dome in four directions. The main dome over four arches was carried by four big piers, Fig. 6c,

Figure 6 : The plans and sections of earlier and later Fatih Mosques, respectively (a, c, d are modified from Ayverdi 1953 and b is modified from Kunter and Ulgen 1939).

| Earthquake | Hagia Sophia Museum | Chora Museum | Fatih Mosque |
|---|---|---|---|
| 22.05.1766 | The building was damaged slightly, (Mazlum 2001, Genc and Mazak 2001 and Mazlum 2003). [slight damage] | The main dome collapsed (Guler soy 1976, Pamukciyan 1994). [severe damage] | The main dome collapsed, the damage level of minarets was very serious, (Sakin 2002 and Unan 2003) .The mosque was reconstructed after the earthquake, Fig. 6. [severe damage] |
