Roofing as an Essential Element of Structural Integrity

Samuel Y. Harris
S. Harris & Co., Philadelphia, PA USA

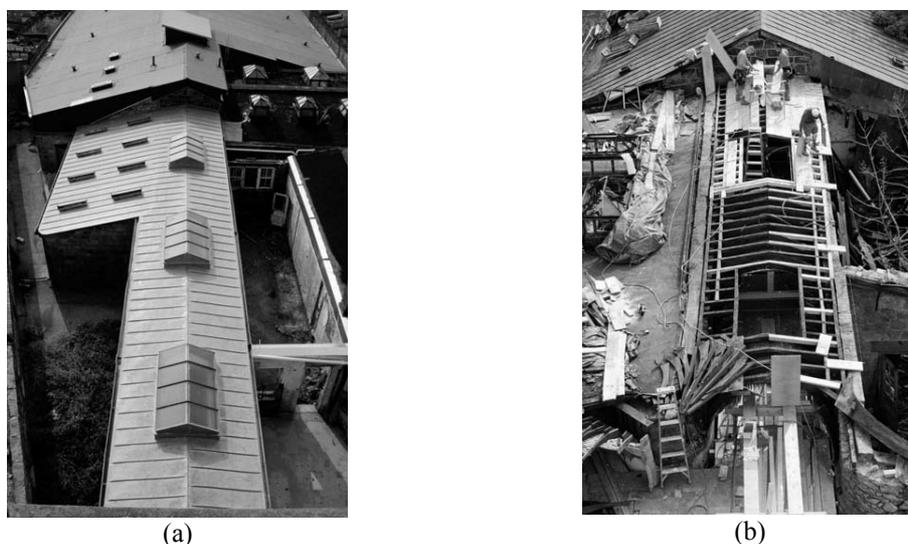
Figure 2 : (a) Cell Block Two, during renovations, 2002; (b) Cell Block One, after renovations, 2002

Cell Block One was determined to be the single most historically significant resource on the site and the fabric of the roof, albeit compromised by decay, was deemed important to save in situ. This particular area was encapsulated with an entirely new redundant roof which covers the cell block's original roof. The design of encapsulation of the existing structure into a "tent-like" structure around it was like putting the structure into a time capsule. This rendered minimum disturbance to the historic fabric, while waiting for a later date and funds for more comprehensive repairs with an adhered EPDM (ethylene propylene diene modified) protective cover. The Administrative Building was also an early candidate for intervention. In this case the existing asphalt shingles were removed, the sheathing repaired, and a replacement adhered EPDM membrane was installed. EPDM was a preferred choice as it is a single ply synthetic rubber which was developed specifically to resist ultra violet radiation damage. The polymers are artificially cross-linked and the chains re-formulated such that subsequent UV energy does not rupture the polymeric chains. It is available in 40mm, 60mm, and 90mm thickness; it may be adhered, mechanically fastened, or loose-lain and ballasted; and it comes in black or white exclusively. Seaming is achieved with adhesive which means that installation is compatible in and around flammable and irreplaceable historic fabric. Installations in the late 1970s and early 1980s displayed premature adhesive failures; however, membranes installed in the last fifteen to twenty years are performing with little if any measurable deterioration. The single greatest vulnerability is installation workmanship. The long-term deterioration mechanism has yet to be established; however, there will be one, whether it is manifest or not at this point, see Figs. 2.

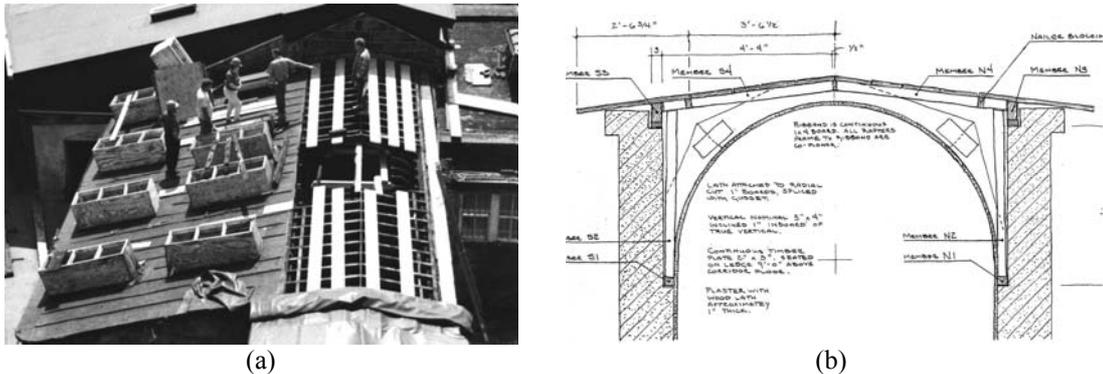
Figure 3 : (a) Section of the existing structure for Link 1, S. Harris, 2000; (b) Structural reconstruction and roofing campaign for Link 1, 2001

The project began at Link One, with a partial demolition to expose the form of the construction and the sizes of the elements. From this a matrix was prepared for each structural rib and each element within the rib. We assessed the restoration requirements of each specific piece of wood in the roof. From this rather precise assessment, the builder was able to submit a more precise bid, and we were also able to learn the exact costs of any modifications which may arise during construction. The merit of this approach, namely the inventory of every single element within the structure, has proven to be an invaluable management tool. As the demolition proceeded and more elements were exposed, we compared our assessment with the exposed conditions. Some elements proved to be in better condition than expected; others, worse. The matrix allowed us to control the adds and credits in an expeditious and accurate manner. We found that the areas of maximum damage from water intrusion were in the vicinity of skylight penetrations. This allowed in future investigations of even roughly comparable conditions to allow for greater replacement cost in comparable areas. This technique has allowed the institution to maximize retention of original fabric and to optimize cost control at the same time, see Table 1 and Fig. 3.

The detailed pathology of the sheet metal failure mechanism was studied at the test case of

Link One. Initially, the sheet metal failed because it admitted water in two distinct and regular modes. The first was at the flat seams of one pan connecting to the next; the second was at the eaves where the standing seam was inundated by occasional heavy rains, and the joint was actually submerged. When combined with modest pressure differential across the fine line pathway, water siphoned to the sheathing below. The water that entered through the flat seam lateral joints tended to penetrate further into the structure as it rolled across intersecting tongue and groove joints. Water that entered at the standing seams tended to collect at and to attack the fasteners of the standing seam attachment details.

The project entailed documenting the each and every piece of the structure, evaluating each historic wooden roofing element, removing the old metal roofing, repairing deteriorated members or replacing those beyond reparability, installing a new standing seam lead-coated copper roof, and conserving the historic plasters. This approach was

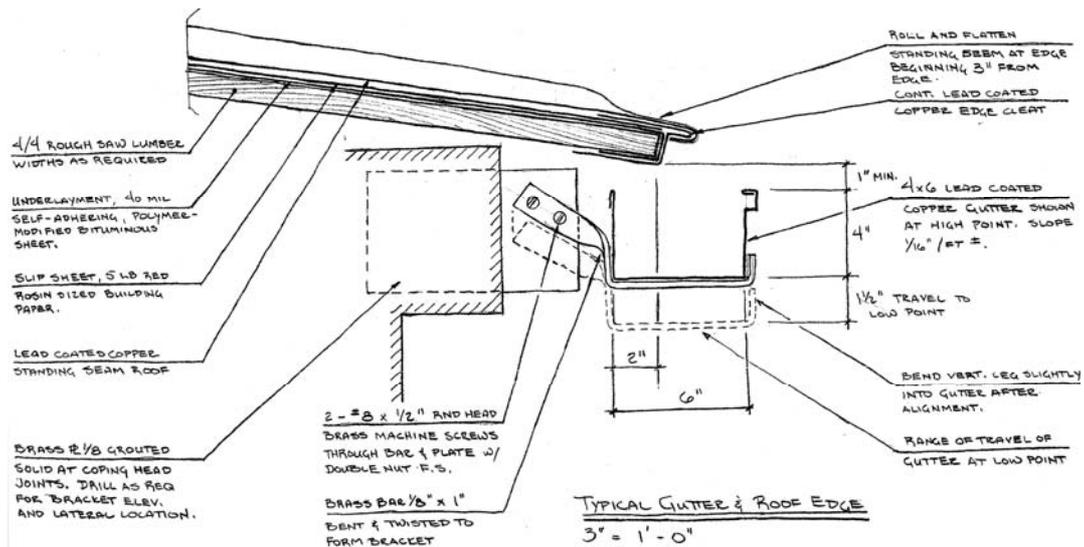
Figure 4 : Typical gutter and Roof edge detail for Link 1 Roof

Ti Based on this and subsequent investigations of the metal roofing at Eastern State Penitentiary, we have concluded that sheet metal roofing is not a perfect membrane system at all and should more accurately be described as a metal “shingle” system, meaning that the seams and joints provide avenues of pressure differentially driven water to surmount the seams and flood the joints. The metal, however, is an excellent protective cover for a more vulnerable, but improved true membrane below. These properties tend to work against the long-term durability of the system as a whole. Through the experiments at Link One, we have reasonably demonstrated that by switching the classification from a membrane system to a “shingle” system, we can re-detail the metal roof for greater integrity and durability at a lower cost. See Fig. 4.

By revising our attitude toward sheet metal as a roofing system, we now tend to view the metal as a physical cover and protection for the membrane roofing below the metal. In the re-installation for Link One, we placed a 40 mil adhered EPDM membrane on the reconstituted

and restored sheathing. We nailed the ties through the membrane with metal grommets around the nail shank to seal the perforation. When the sheets were seamed we deliberately left the seams open without solder. We have found that this system initially admits more water than a fully soldered system; however, this approach accepts the admission and directs water to the edge collectors without resulting interim damage.

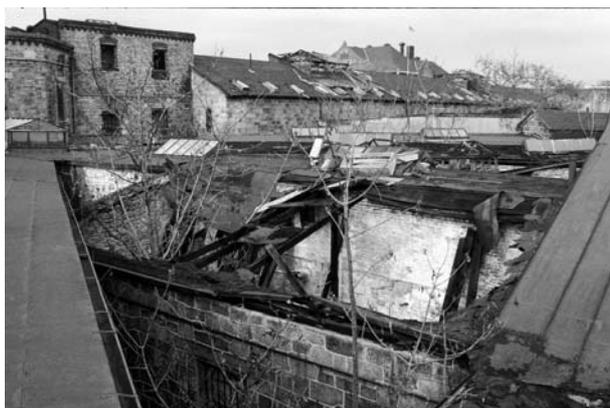
Figure 5 : Links to cellblock 2, 10 & 11 before repairs, 2003.

As the above projects were underway, the bulk of the site continued to deteriorate at accelerating rates. We had engaged in several fruitless experiments with "temporary" roofing measures. One of the more notable failures involved the use of conventional polyethylene sheet goods, some as thick as 12 mil, both transparent and black. The polymer is simply too brittle at temperatures below 5°C to withstand buffeting by winds. Although the material is also theoretically vulnerable to ultra-violet degradation, the brittle fracture properties preclude any display of UV vulnerability. The plastic simply shreds in cold winds. We have had similar results from polyester tarpaulins, which do deteriorate rapidly from UV and ozone embrittlement. See Fig. 5.
