Constructive Analysis of the Arches and Ribs of the Vault on High Altar of “Santa Maria” Church of Tolosa (Basque Country)

Amaia Garay, Isabel Rodriguez-Maribona, Jorge Domingo and José A. Ibáñez
Labein, Building and territorial Development Unit, Derio, Spain

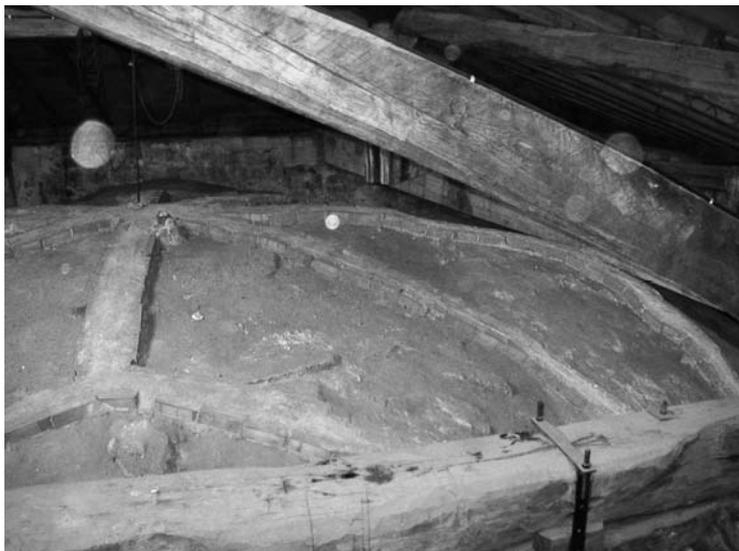
In 1992, after one of the keystone of one of the vaults come off, all the ribs were stitched and the vaults were reinforced with concrete on their side not visible to public, see Fig. 2.

Figure 2 : Reinforcement works in the extrados of the vaults.

The last restoration increased notably the rigidity of the vault, in the same way, the tensions increased owing to the effect of the beams resting on the vault.

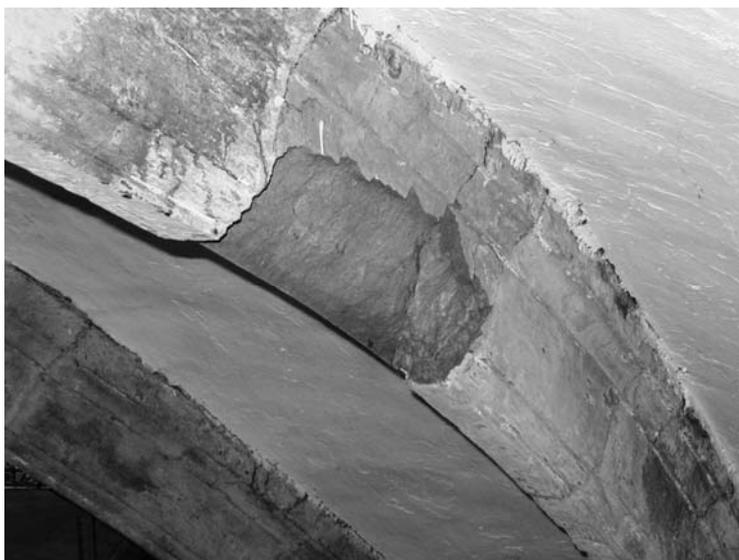
Few years ago, after the works carried out in 1992, in order to restore the vaults, part of the stony materials of the arches and ribs placed on the high altar began to come off and important local deformations happened. Immediately the church was closed and the architect in charge of the building required LABEIN to study the strange phenomenon, see Fig. 3.

Figure 3 : Damage detected.

This increase could not be absorbed by the structure and it collapsed by the surface that separated the disturbed material and the no disturbed.

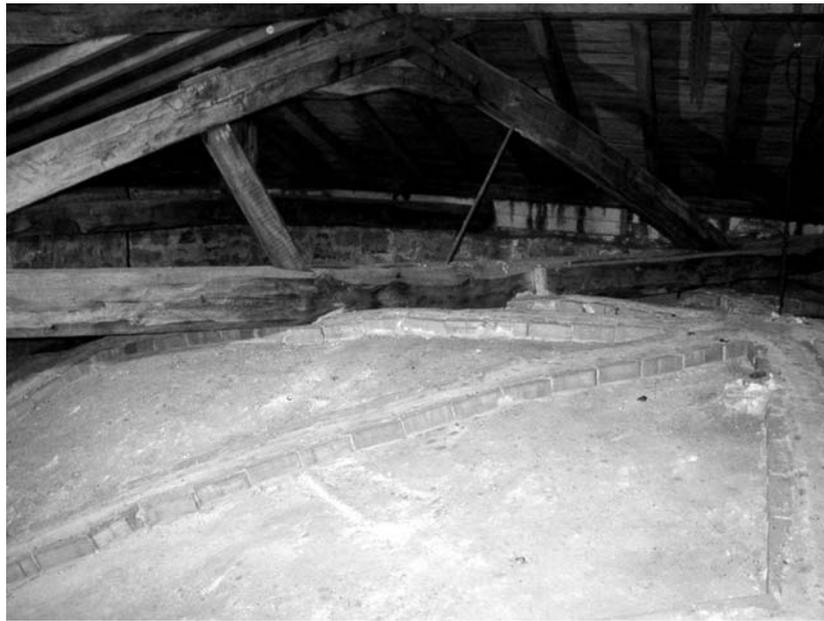
We suspected the reinforcement works in 1992 and the condition of the structure of the roof, with beams resting on the vault (see Fig. 7) were important to explain the collapse of the vault, but in that moment we had another factor to introduce in the diagnosis.

Figure 7 : Beam resting on the vault.

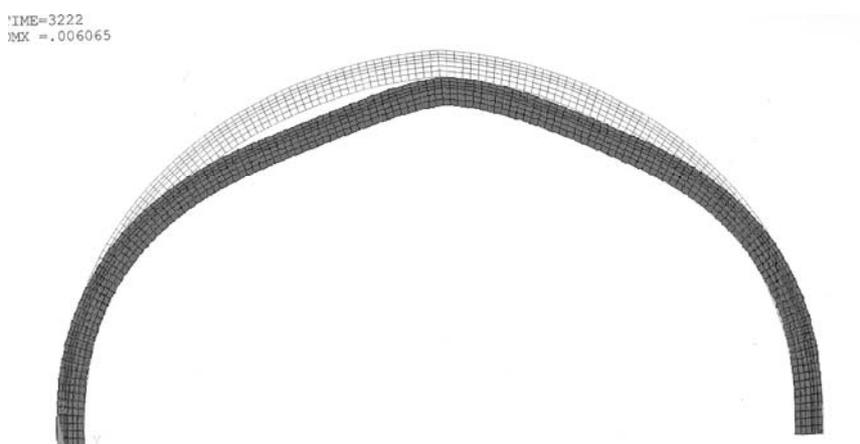
The results were very explanatory, the deformations obtained in the calculations were very similar with the deformations measured, and the critical points, with the maximum values of the traction tensions coincided with the parts of the arches with problems.

Figure 8 : Deformed shape of the one of the arches studied.
