Church of Saint-James at Leuven (B) – Structural Assessment and Consolidation Measures

ABSTRACT: The construction of the church dates back from 1220. During several subsequent building phases, the wooden roofs in the central and side naves were replaced with masonry vaults, and flying buttresses were added. The structure itself is located on a former swamp, resulting in large differential settlements. In the past, restoration works took place. However, due to the excessive cracks observed, it was decided in 1963 to close the church for service, to remove the severely cracked masonry vaults of the side naves and to shore up the pillars of the main nave. Additionally, in 2000, the remaining flying buttresses were removed and replaced by tie-rods. The focus of this paper is on the structural understanding of this historical building, to determine the most appropriate strengthening and consolidation measures, respecting the authenticity of the building and preserving it for the future.

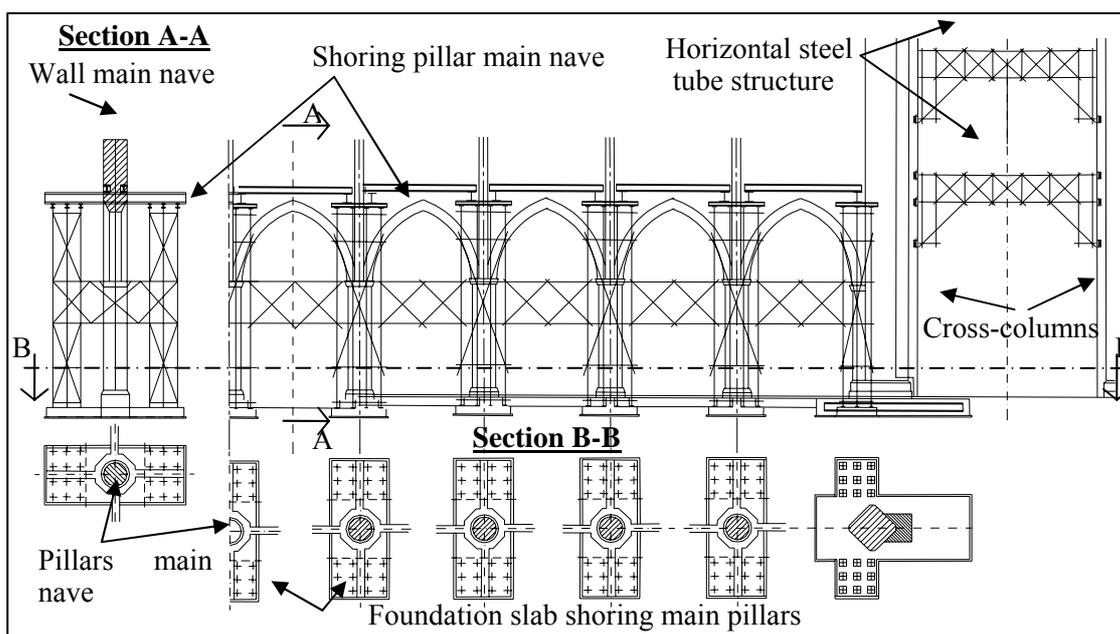
Figure 2 : Temporarily shoring of main nave and cross-columns of transept

In 1961, the collapse of the church was feared. To prevent further deterioration, it was decided to take immediate action. The plan contained 3 subsequent phases, Figure 2:

- Phase 1: Support of cross-columns against the lateral loading of the tower. Two steel tube structures are added in the crossing and concrete columns near the crossing pillars are constructed to get a distribution of the horizontal loading over the cross-columns;

- Phase 2: Goal is to replace the masonry pillars of the main nave by means of reinforced concrete columns and add a facing of natural stone at the outside of the columns. Additionally the foundation surface has to be increased to limit the soil stresses. At that moment in time, a pile foundation was considered not feasible. To enable the replacement of the columns, a temporarily shoring of the main nave is required. In the mean time, the masonry vaults of the side nave are dismantled, since these demonstrate a severe state of decay;
- Phase 3: Remedy the initial cause of the differential settlements: uncouple, detach the western tower from central nave.

Only preparatory phase one and phase two (partly) were executed. Until now the structure is supported, already during 40 years, by means of a temporarily shoring.

After consolidation of the foundation, the steel tube shoring can be dismantled in a controlled way. The horizontal support of the reinforced concrete columns against the cross-pillars will be replaced by means of horizontal anchors in the longitudinal direction (in the wall above the arcades) and in transversal direction (in the wall of the transept). In this way, the slender columns will again encounter sufficient lateral support without the presence of the reinforced concrete columns.

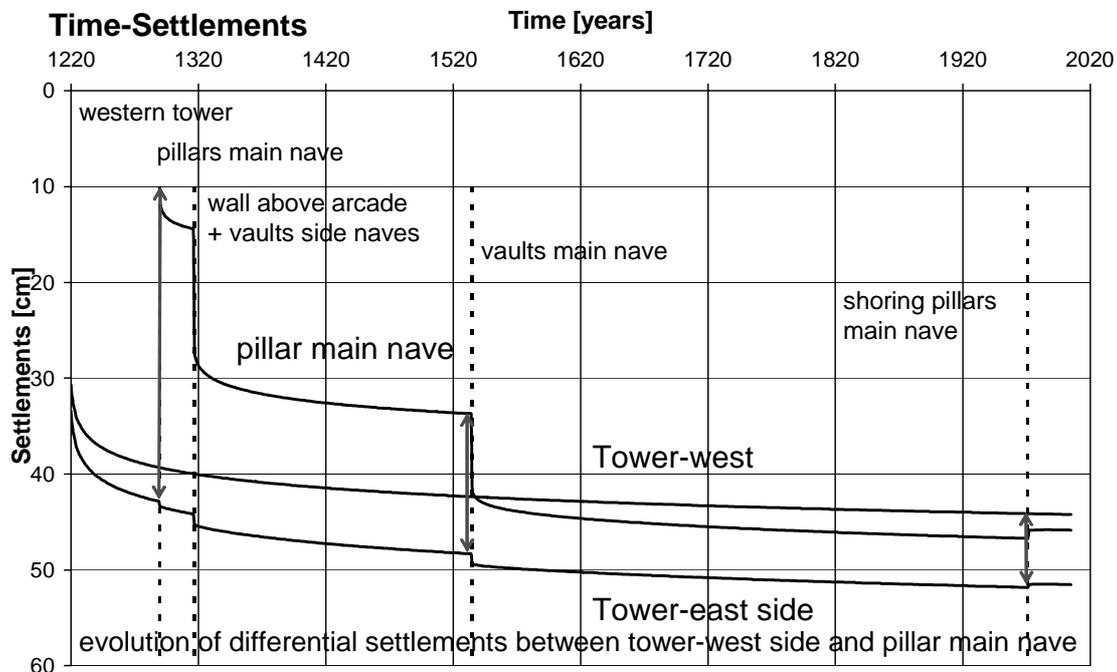
Figure 3 : Time dependent settlements

The time-dependent settlements are based on the formula of Buisman and Koppejan (Schuermans et al., 2006). In Figure 3 the settlements are outlined as a function of time for the west and east side of the tower as well as for the pillars of the main nave. It is clear that large differential settlements can be observed in between the different load-bearing elements.

The east side of the tower shows larger vertical deformations compared to the west side, causing its leaning over to the east side. The large settlements of the pillars of the main nave, constructed approximately 70 years after the construction of the tower, are significantly larger than those of the tower itself. This clarifies that the tower is not pushing against the main nave, since

the latter is moving down faster. These analyses results are very relate to the observed crack pattern, the instability of the flying buttresses and of the vaults of the side naves.

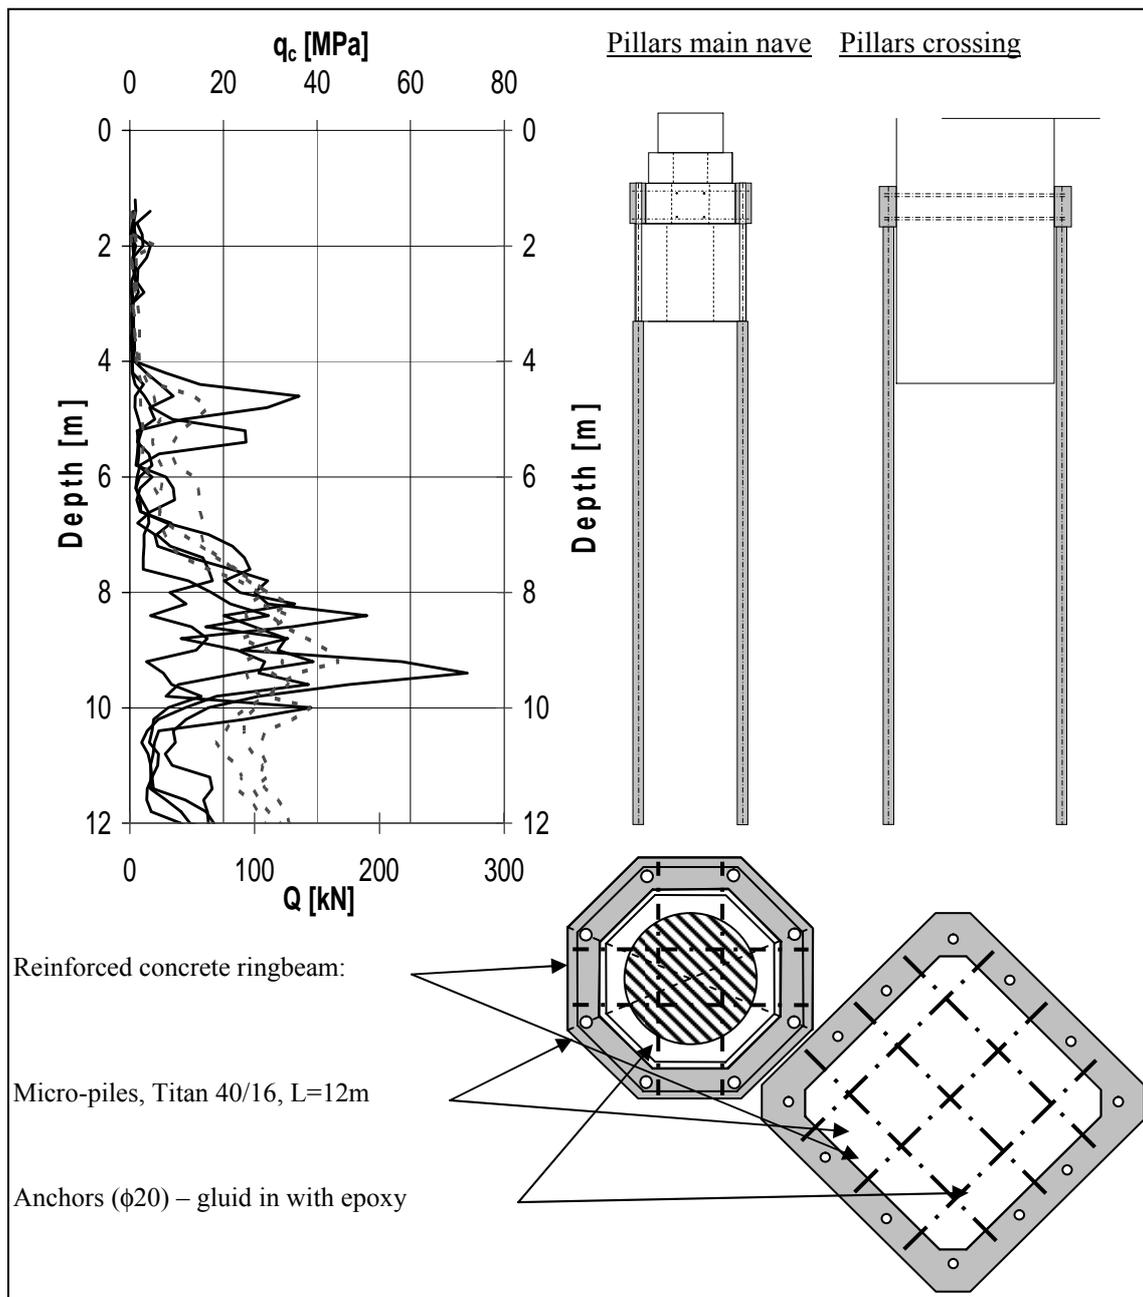
Figure 4 : Foundation strengthening of pillars

Investigation pits were dug at a pillar of the main nave, a cross-column and a pillar from the side nave. From these in site investigations the geometry of the foundation was retrieved, Figure 4. The quality of the masonry and the bottom level of the foundations are searched for by means of a core drilling through the foundation masonry. The cores revealed that the masonry was in excellent condition, built with regular blocks of natural stone and lime mortar joints. At the bottom of the masonry pillars, wooden elements were retraced. It is not clear whether these elements originate from beams or pillars. More important however is the fact that these wooden elements are rotten, limiting the overall load-bearing capacity of the columns. This is surprising, since these elements are located far below the phreatic surface.

To enable a good estimate of the differential settlements as well as the load-bearing capacity of the known foundations, four 200 kN cone penetration tests (Van Balen et al., 1995) as well as four in site vane shear tests are performed (Schueremans et al., 2006a), Figure 4. The latter are used to determine the cohesion of the clay-containing subsoil at foundation level. In fact the contribution of the cohesion in the load-bearing capacity is significant.

For the pillars of the main nave, a micro-piling with 8 piles corresponding with the octagonal cross-section of the pillars is proposed, Figure 4. In addition the foundation of the cross-pillars is strengthened with 12 micro-piles. The on set of the piling, with a length of 12 m, will be in the tertiary highly consolidated, or moderately consolidated clay-containing sand to provide sufficient point-resistance.

After consolidation of the pillars of the main nave and cross-pillars (west side) a new risk of the leaning of the tower is present, since both elements will be on a different foundation system. The vertical settlements of the pillars after consolidation will be very limited; the additional settlements of the tower are much more difficult to estimate. As a result, what is not the case at this moment in time – the pushing of the tower against the walls of the main nave - might become possible in the future. Therefore, three options are proposed. The first is to provide also a pile foundation under the tower, resulting in a similar foundation system for both elements and stabilizing all central movements. The second is to provide a long term monitoring of the slant of the tower. Based on the evolution of the slant, the necessity of additional strengthening of its foundation will be judged on regular time intervals. The third option is similar to the initial proposal, made in 1961. Detaching the tower from the main nave will prevent the risk of the tower pushing against the main nave. Since the foundation of the tower has proven to be sufficient for over more then 780 years, its load-bearing capacity might be judged to be sufficient, although it does not comply with actual design standards. Based on the calculations of the time-dependent settlements, the additional settlements of the tower are estimated to be limited: 0.3 cm for the oncoming century. Before, during and after detaching, a permanent monitoring of the slant of the tower enables to accurately follow up the consolidation measures taken. It provides the possibility to interfere and take action whenever required.
