## Investigation on the Limestone Ashlar Masonry in the São Francisco Monastery

Mário Mendonça de Oliveira, Rosana Muñoz, and Karina Matos A.F. Cerqueira  
*Federal University of Bahia, Polytechnic School, Department of Material's Science and Technology, Nucleus of Technology of Preservation and Restoration and Graduate Program of Architecture and Urbanism, Salvador-Bahia, Brazil*

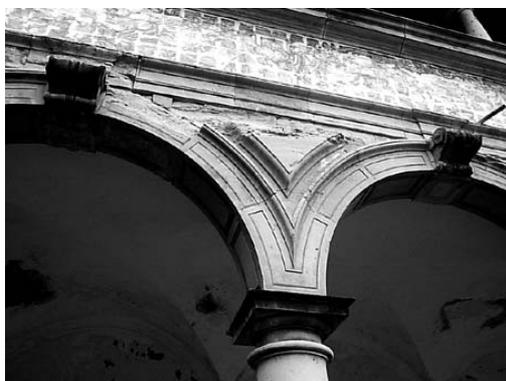
Among the problems that affect the monument two are important at the moment: one of them is the destruction of the vitrification of the images of the glazed tiles through the efflorescence of soluble salts and the other one is the masonry of its cloister, whose degradation is compromising the structural security of the building, particularly in the area which is most covered by glazed tiles (Fig. 3). Regarding the second problem we intend to present some investigations and observations which will probably contribute to the solution or attenuation of the problem.

Figure 3 : Stone decay in the arches.

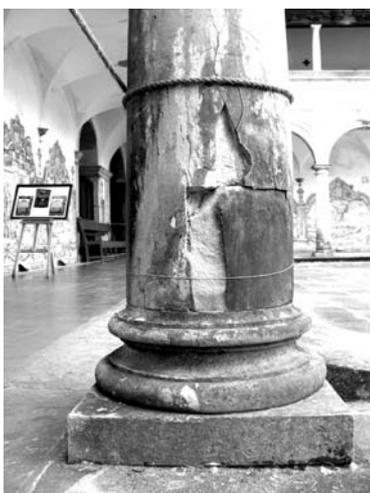
The density of the lithic material was calculated in  $2.4\text{t/m}^3$ , obtained through the Hubbard pycnometer. This tells us that this is not a very compact material, if compared to other types of local stones. Our more compact granites, for instance, are about  $2.9\text{t/m}^3$ . Consequently, lower mechanical resistance and more porosity is expected, which facilitates the capillarity of the water in a more accelerated degradation process (Fig. 4), as we confirm with subsequent analysis.

Figure 4 : Column base of the cloister with crushing signs

They were obtained through the measurement of the ultra-sound propagation in the cloister's columns using a *Controls* equipment employing a transmitter/receptor of exponential profile, due to the shape of the surface of the columns. It was observed with a certain concern that where the reintegration of the lacunas were made with Portland cement mortars, in previous "restorations", the ultra-sound signal didn't reach the other side of the column. That might mean that the inadequate cement application is getting loose leaving a void inside. In fact, in some parts, the detachment of the cementitious mortar is observed bringing about some portion of decayed stone (Fig. 4).

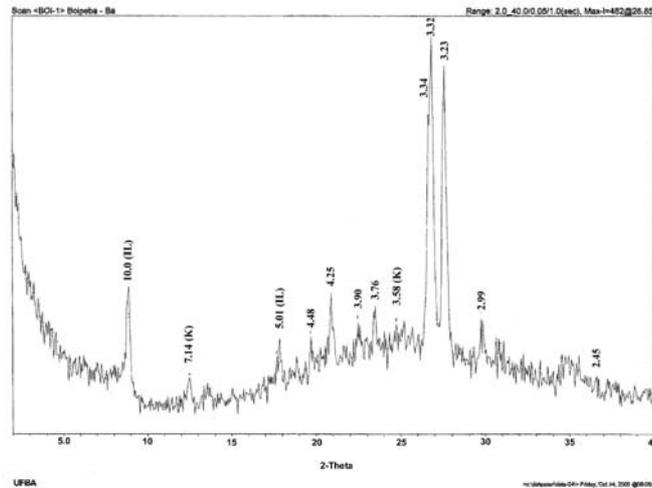
The clay type identification was done by RXD and its percentage in the rock through chemical analysis. The lithic material treated with diluted HCl leaves an insoluble argillaceous residue that submitted to XRD indicates the predominant presence of the argilominerals kaolinite and illite, this last one with some expansive property (Fig. 5). This represents one more reason for worrying regarding the durability of the masonry exposed to weathering, in a city of great pluviometric precipitation, high temperatures, intense saline spray and an environment very inclined to biodegradation. The carbonatic fraction, dissolved by acid, represents 92.8%, the major part is composed by  $\text{CaCO}_3$  and the rest by  $\text{MgCO}_3$  as observed in the petrography and XRD. These petrographic observations pointed out a dolomitic limestone confirmed by Lazzarini (Professor of applied petrography of the School of Architecture of Venice University and director of the L.A.M.A that kindly offered additional observations about *Boipeba*'s rock) who adds in his report: with very reduced crystals but also with well developed hydromorphic crystals (up to  $10\mu\text{m}$ ).

Figure 5 : RXD of the argillaceous residue of limestone.

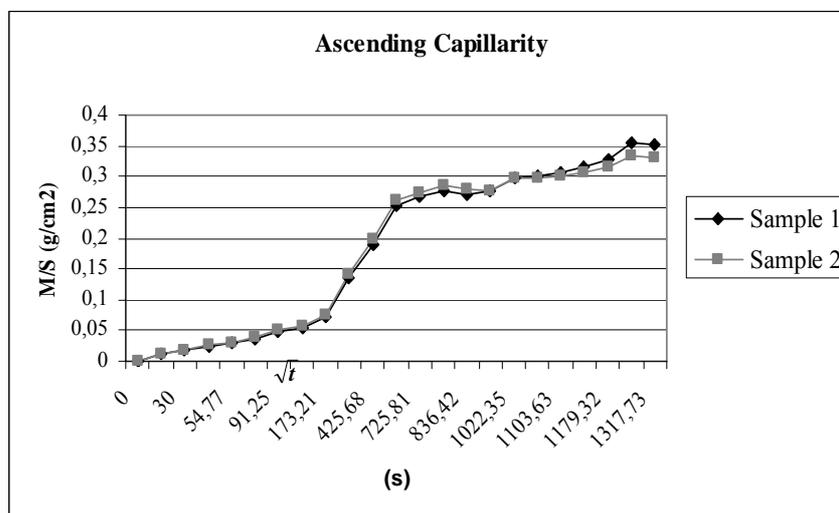
The rising capillarity tests demonstrate an atypical curve, what could be attributed to the presence of clay minerals in the rock (Fig. 6).

Figure 6 : Capillary rise graphic (two different samples).
