Partial Collapse of a XII Century Church due to a Wrong Retrofit

Nicola Augenti

University Federico II, Department of Structural Analysis and Design, Napoli, Italy

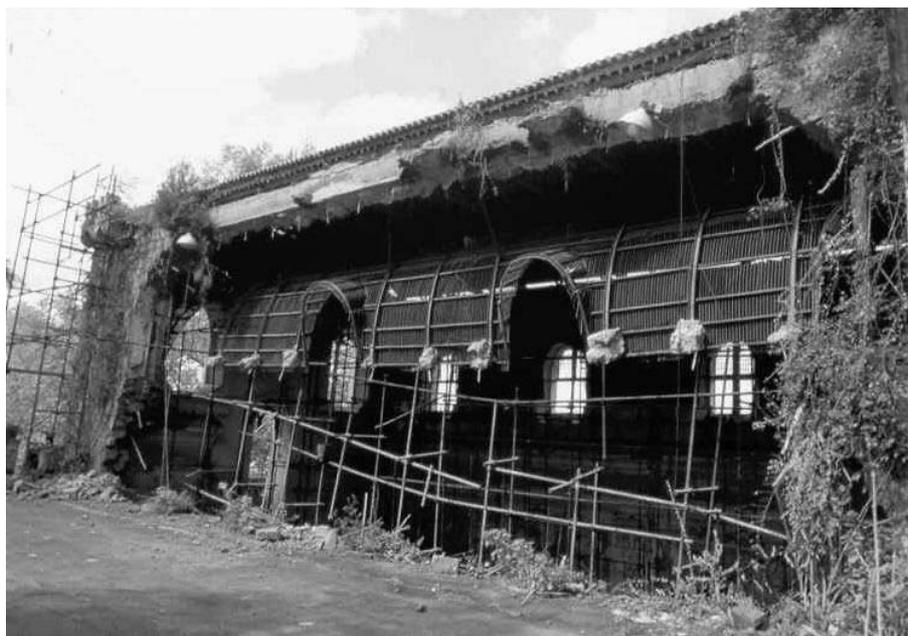
On the 30th of January in 2001, around 5 a.m., the spontaneous collapse of the whole right masonry wall inside the Church occurred. (see Figs. 5 and 6).

Figure 5 : Right collapsed masonry wall

In Figs. 5 and 6 the steel riveting which anchored the r.c. beam to the collapsed masonry can be noticed.

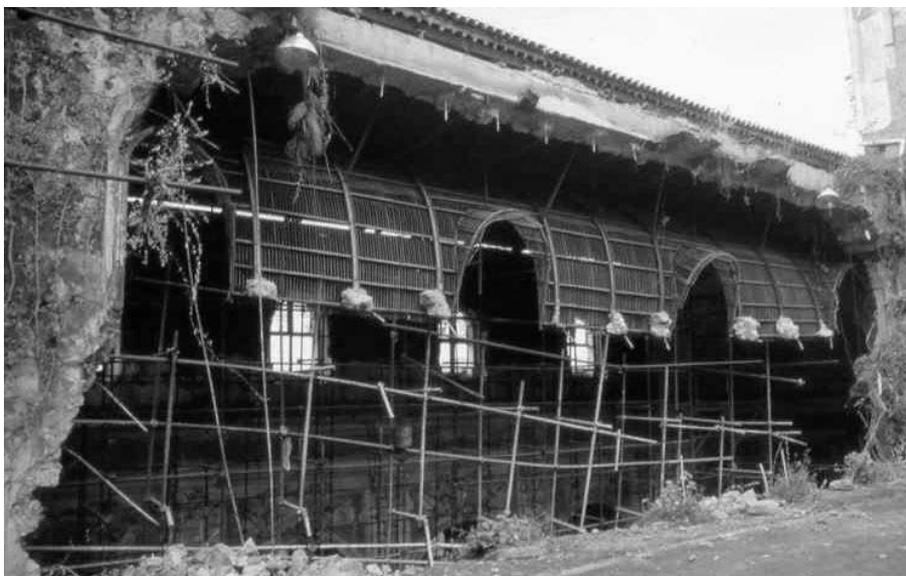
In consequence of the collapse the steel frame, which should have constituted the false ceiling

provided of fanlights underneath the new roof, remained suspended. The reinforced concrete beam on the top of the wall and the roof, made of steel trusses, were hanging up as well.

Figure 6 : Collapsed right masonry wall

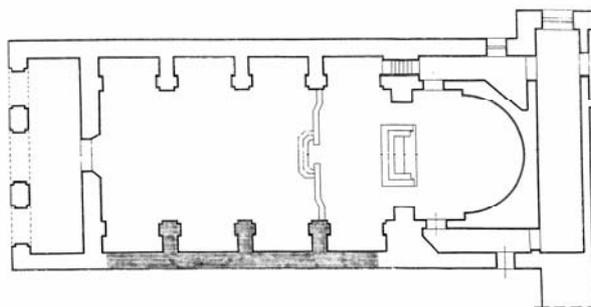
In the plan of Fig. 7, the longitudinal right part of the fallen down masonry is hatched in grey.

Figure 7 : Collapsed right masonry wall

The held inquiries have allowed to assure the dynamic of the collapse which occurred because of the falling down of the three buttresses of the right longitudinal walls of the nave which delimited the lateral chapels (see Fig. 7). In the inferior part of the masonry piers some steep sliding surfaces, along which the masonry structure had slipped, formed.

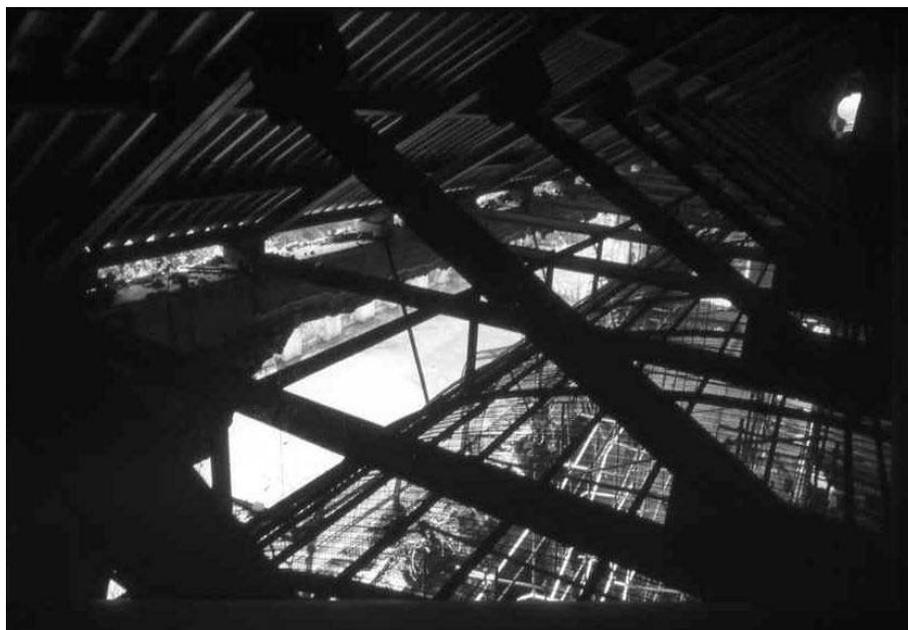
Fig. 8, shot inside the roof system, shows the new steel roof truss that sustained the roof and the new r.c. beam on which it leaned on. Furthermore it can be noticed that, beneath this beam, the masonry wall was completely collapsed.

Figure 8 : Collapsed left masonry wall

- the substitution of the old wooden roof truss with heavy steel truss beams had overloaded the ancient bearing walls (see Fig. 8); This load had been ulterior overburdened by the presence of a big beam in r.c. realized on the top of the masonry walls for the leaning of the new steel truss;

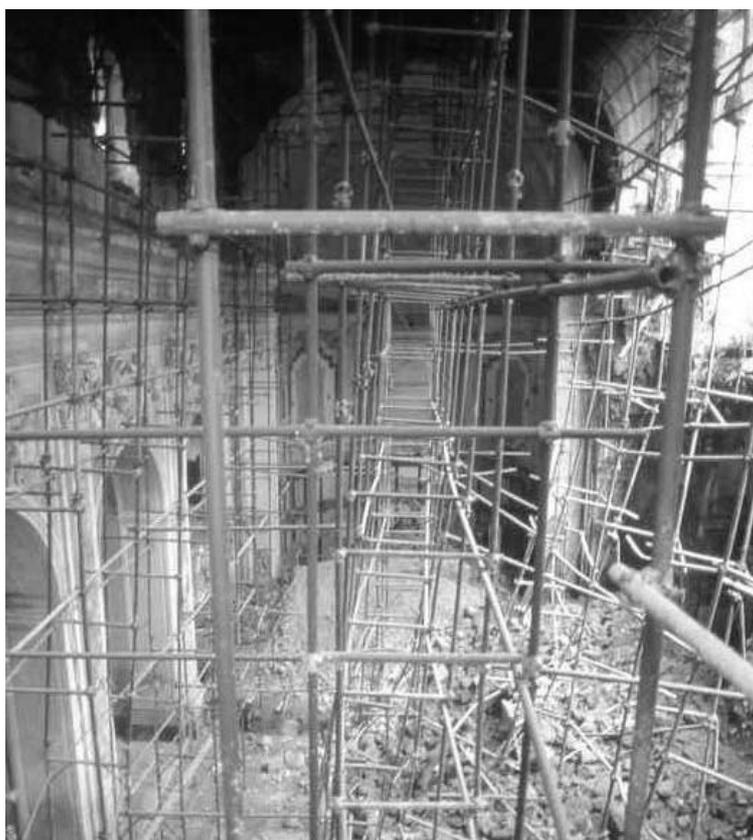
In Fig. 9, a view of the collapse from inside the Church can be observed. It is still possible to notice the scaffolds left in order to realize the counter ceiling underneath the new roof, which had not been completed.

Figure 9 : Inside view of the Church.

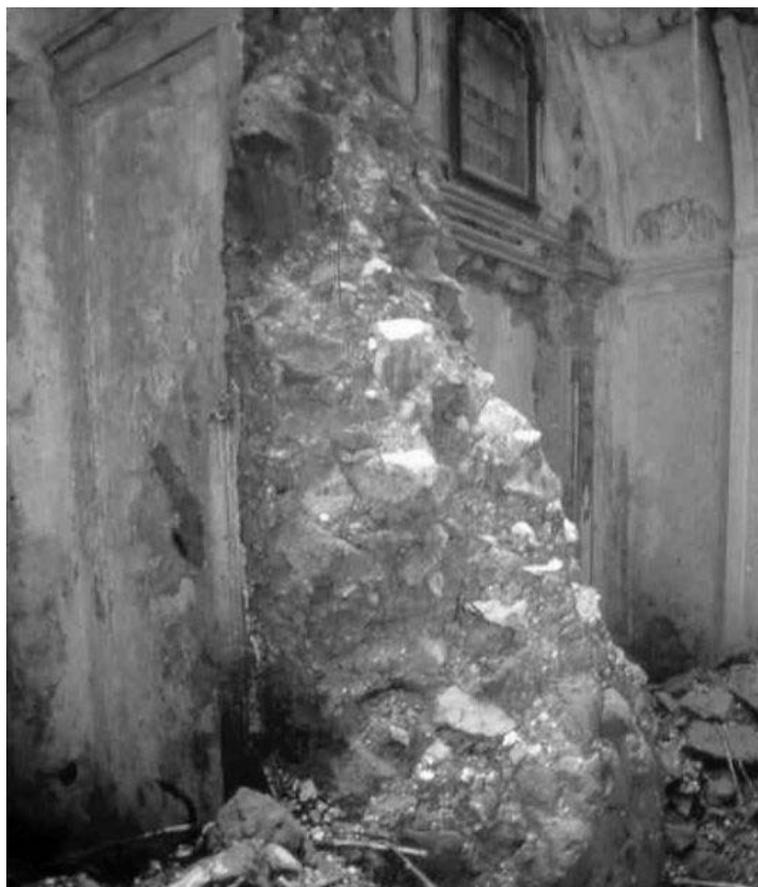
In Fig. 10 one of these surfaces, after the rubble removal, can be observed.

Figure 10 : Cracking surface of the first pier.

After having removed the neighbouring rubble with extreme caution, the central buttress has been demolished until a trustable masonry surface, on which new piers could be built, was individuated. Starting from this section, a new regular masonry in squared tufa stones and cement mortar has been realized.

This wall has been erected until the height of the intrados of the roof beam in r.c. was in equilibrium in the empty space. In this way an effective cribbing of the structures in precarious equilibrium, dividing into two parts the length of the beam, has been realized. Successively, in complete safety conditions, it has been possible to rebuild the collapsed parts.

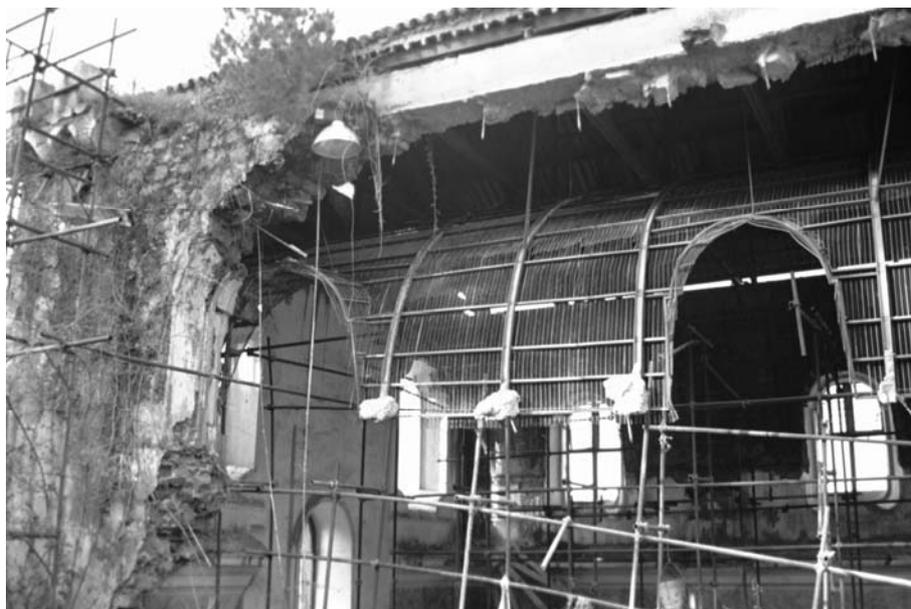
- the injection of cement mortar has been conducted, however, in a bad manner; after the collapse it has been verified that the steel bars, drawn out of masonry, lacked of the collar in cement mortar (see Fig. 11);
- collecting and removal works of the rainwater from the external wall of the right longitudinal wall of the Church did not exist; waterproofing works able to avoid the water seepage between the embankment and the masonry wall had not been realized as well;
- the incomplete and faulty waterproofing of the new roof had determined huge water seepage also in the internal side of the external walls.

Figure 11 : Particular of the collapsed area.
