Pathologies Caused by Man on the Foundations of Historic Buildings

ABSTRACT: The church of Losa del Obispo presents a series of cracks and displacement, both brought about by the same cause. During the nineteen sixties, two buildings that stood beside it were demolished and up to 1.5 metres of soil was removed from the side of the church leaving the foundations of the bell tower and the right wall of the church laterally exposed. This action triggered the following pathologies: leaning of the lateral facade of the church into the square and subsidence of the lateral wall of the church. After analysing the situation and evaluating the different options for its repair (pre-tensing the wall against the ground, adding piers, inserting abutments...), the restoration project drawn up for the church involves the lateral underpinning of the foundations in the form of a bench for public use and the insertion of trusses in the vaults to prevent further movements of the wall.

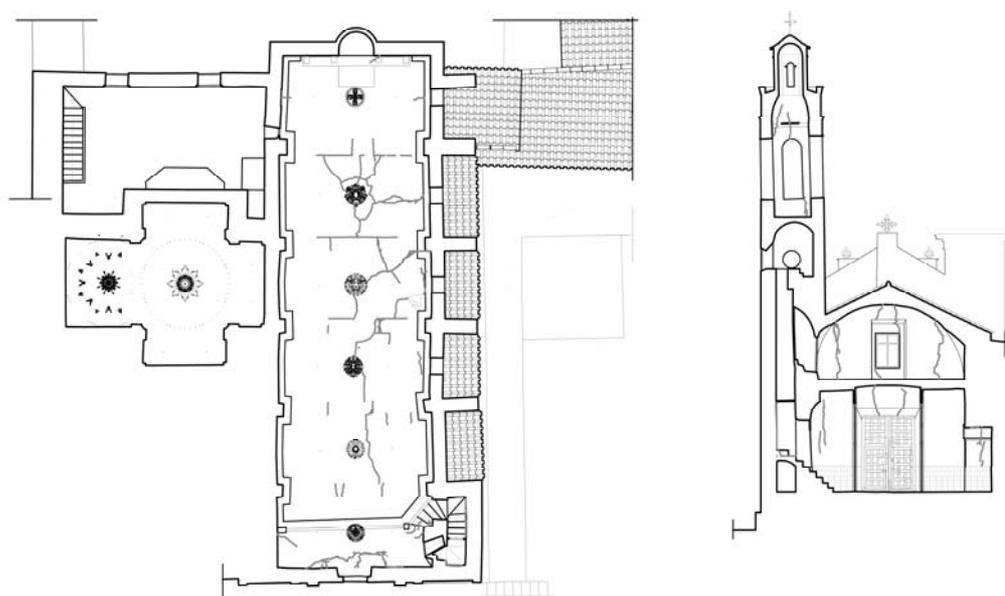
Figure 2 : Map of cracks in the church.

In the first place, a preliminary study was carried out with a thorough survey of the church, and a detailed map of the existing cracks was drawn up (Fig. 2). The combined systematic study of the direction, trajectory, opening typology, rotation and relative displacement of the cracks made it possible to elaborate a rigorous diagnosis of the phenomena caused and their extent. These damages can be summed up in the two points below:

- Leaning of the lateral facade of the church into the square, with the subsequent longitudinal cracking of the interior vault. The tilt of the lateral facade is evident and has been marked in the plans (Fig. 3). This overhang also exists in the church's bell tower.

- Subsidence of the lateral wall of the church, which is reflected in the cracking in the paving and the cracks at the corners of the windows at lunette level, typical of this sort of movement.

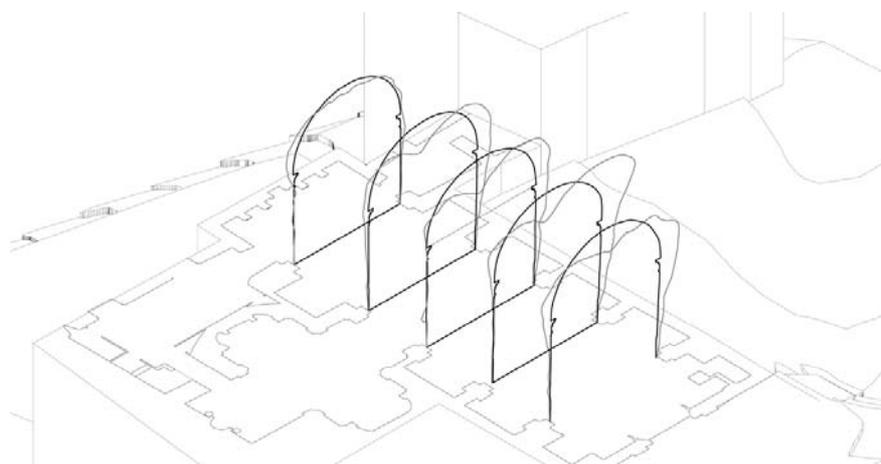
Figure 3 : Deformation of the arches.

Other minor pathologies have been observed, such as the subsidence of the arches in the south-east side of the nave, detected in the flat line of the arches, and cracks in the upper fenestration of the lunettes. Furthermore, the back facade of the church is slightly leaning outwards as well. There are minor cracks in other spots, due to isolated subsidence of arches and leaning of the exterior facade, presumably stable, and, in any case, the lack of activity will be verified by inserting movement monitors. Besides, the church presents problems of damp from leakage around the soffit and intrados of the vaults, resulting from the cracks produced by the movements of the church and lack of maintenance on the roof. The problems of damp are also caused by capillarity in the socles in the side chapels, the chancel and the main facade.

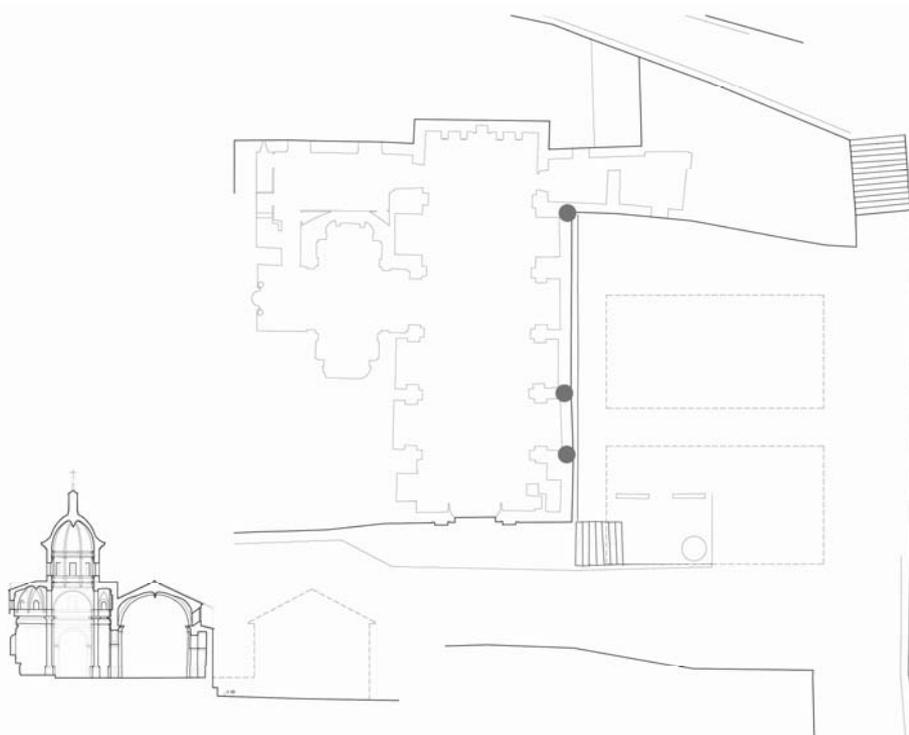
Figure 4 : Ground plan of the church and square, site of the missing buildings and position of probes made.

All the important phenomena of cracks and displacement of the church seem to stem from the same cause, which was our initial working hypothesis. After dreadful floods in the town in 1957, two damaged buildings that stood in the square, separated from the northwest facade of the church by a narrow lane, were demolished. At the same time, the square was levelled, and up to 1.5 metres of soil was removed from the old lane, leaving the foundations of the side wall of the church exposed (Fig. 4). This undermining of the lateral wall of the church no doubt gave rise to the most serious pathologies the church suffers today.

In order to verify this hypothesis, probes were performed on the lateral wall of the church, particularly on the thicker part of the socle, to find out whether there were foundations and, if so, how deep they went. In fact the three probes carried out revealed in the first place that there were no thicker foundations under the wall, and, more important still, the foundations of the lateral facade of the church and the bell tower had been completely undermined when the paving of the square was levelled. The soil under the foundation wall was covered laterally by a socle 1 metre high made of rubble and rough masonry to avoid the direct view of the danger. In the light of these data, it is surprising that the structural pathologies of the church are not a great deal worse than they actually are.

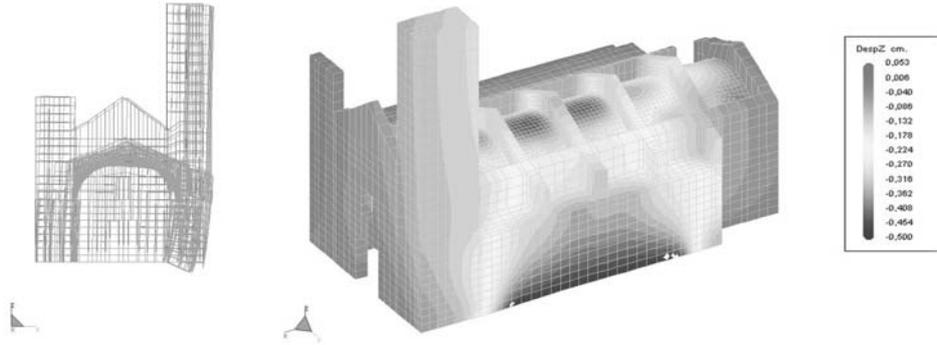
Figure 5 : Deformation model.

In view of the structural pathologies described above, it was considered appropriate to perform an analysis of its stability during the diagnosis stage as complementary research to the restoration process to provide reliable models about its structural behaviour and exact criteria for the restoration project of the monument (Fig. 5).

- c. An analysis was carried out to determine the possible repercussion on the monument of the demolition of the buildings that had been attached to it and the rehabilitation and levelling of the adjacent square. For this purpose, on the basis of the structural models and the state of gravitational loads defined above, differential subsidences were applied on the supports of the piers looking on to the square, which cause perceptible leaning in these piers and, consequentially, possible structural damage in the vaults and walls of the nave of the church.

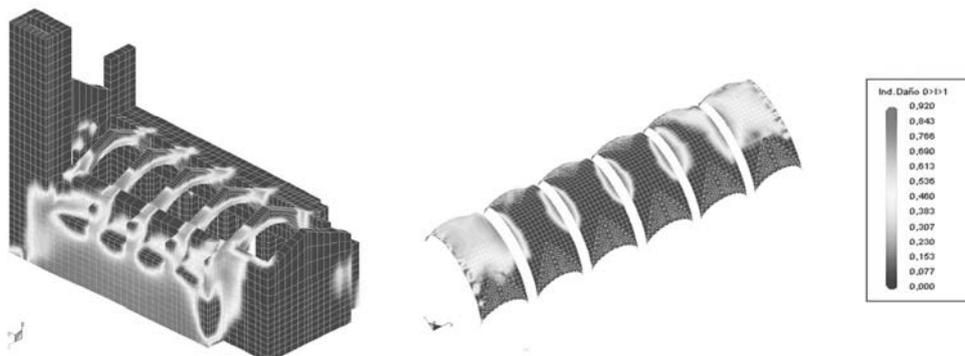
Figure 6 : Model of damages.

1. For these dimensions, form and gravitational loads, the monument as a whole does not present significant damage, as we can gather from the assessment of the model of damages in the non-linear analysis.
2. In the hypothesis of subsidence and leaning of the pilasters facing the square, the maps of damages of both the fabric and the masonry of the building present a good correlation with the real figurative map described above (Fig. 6).
