## Structural Analysis of Historic Temple of Augustus in Ankara, Turkey

A. Turer and T. Eroglu

**ABSTRACT:** The Temple of Augustus, one of the invaluable monuments survived from the Roman age, is located in Central Anatolia in the capital city of Turkey, Ankara. Ruins of the approximately 20 centuries old temple has reached to recent times with structural instability and expedited stone deterioration due to environmental conditions. Some of the inscriptions have been disappeared and the remaining ones are in danger of disappearing. Stability of the North wall of the temple is another major concern. Studies on temporary roof protection, stone conservation, site restoration, and structural monitoring are being studied by a multi-national and interdisciplinary team. This paper discusses structural concerns, nondestructive (ambient monitoring) testing results, and 3-D Finite Element Model (FEM) based analysis aspects of the project. Some retrofitting schemes are also suggested based on the structural problems.

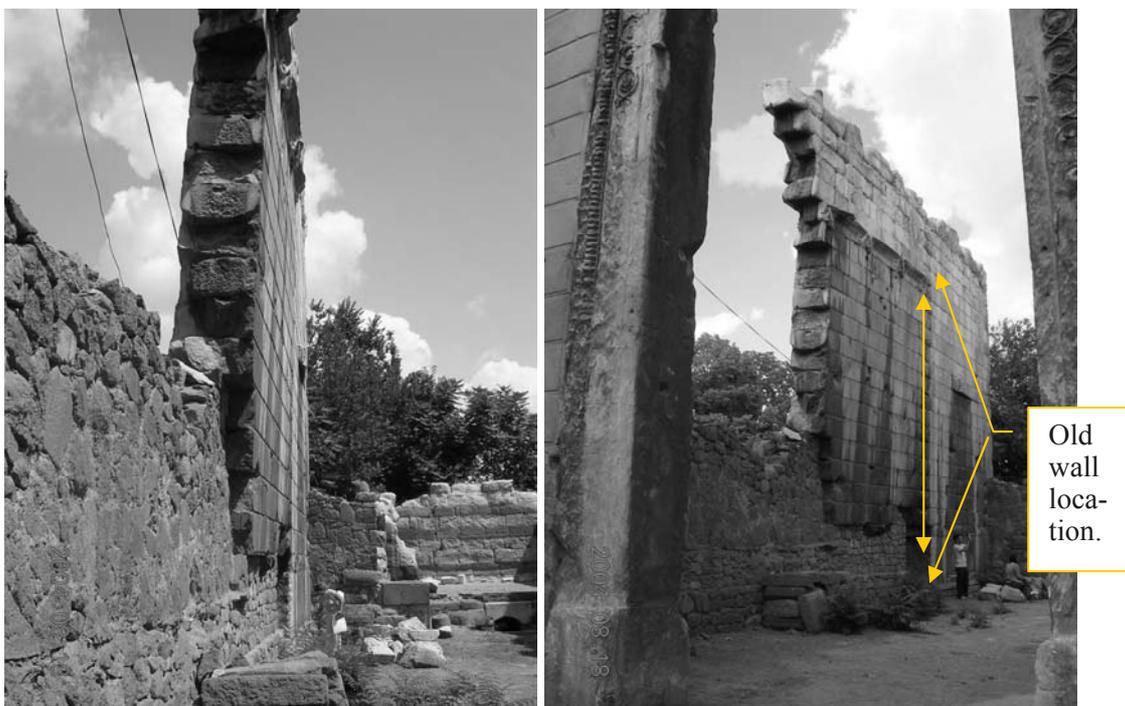
The current status of the temple poses several serious problems from structural and stone conservation points of view. The partially damaged North cella wall and entry gate lintel is in danger of collapsing. Some stone blocks located at the upper part of the wall of cella looks unstable

Figure 3 : General front view of the North cella wall.

The damaged section of the North wall exhibits structural instability and poses vulnerability against lateral forces. The 11 meter high wall is only supported from the base and slightly inclined towards South (Fig. 3). The stability of the rocks at the top of the wall is another threat for pending damage (Fig. 3). It is recommended that the stones that are not stable at the top of the North wall and at the entrance gate should be carefully removed and placed on ground against falling off on their own. The North wall should also be laterally supported with strong A-frames (Fig. 7); however, the supports may be placed a few centimetres away from the wall without touching it. The frame support would be ready to support the wall if the stability is lost due to wind, earthquake, or other unforeseen effects.

The long-term monitoring studies will initially concentrate on the tilt, temperature, and humidity measurements. Two tiltmeters will be placed at the North wall, which is found to be the most critical structural section of the temple. Measurements will be taken at every 60 minutes to measure daily and seasonal tilt changes. Measurements will reveal if the wall inclination is increasing over time and whether temperature has any effects on the tilt.

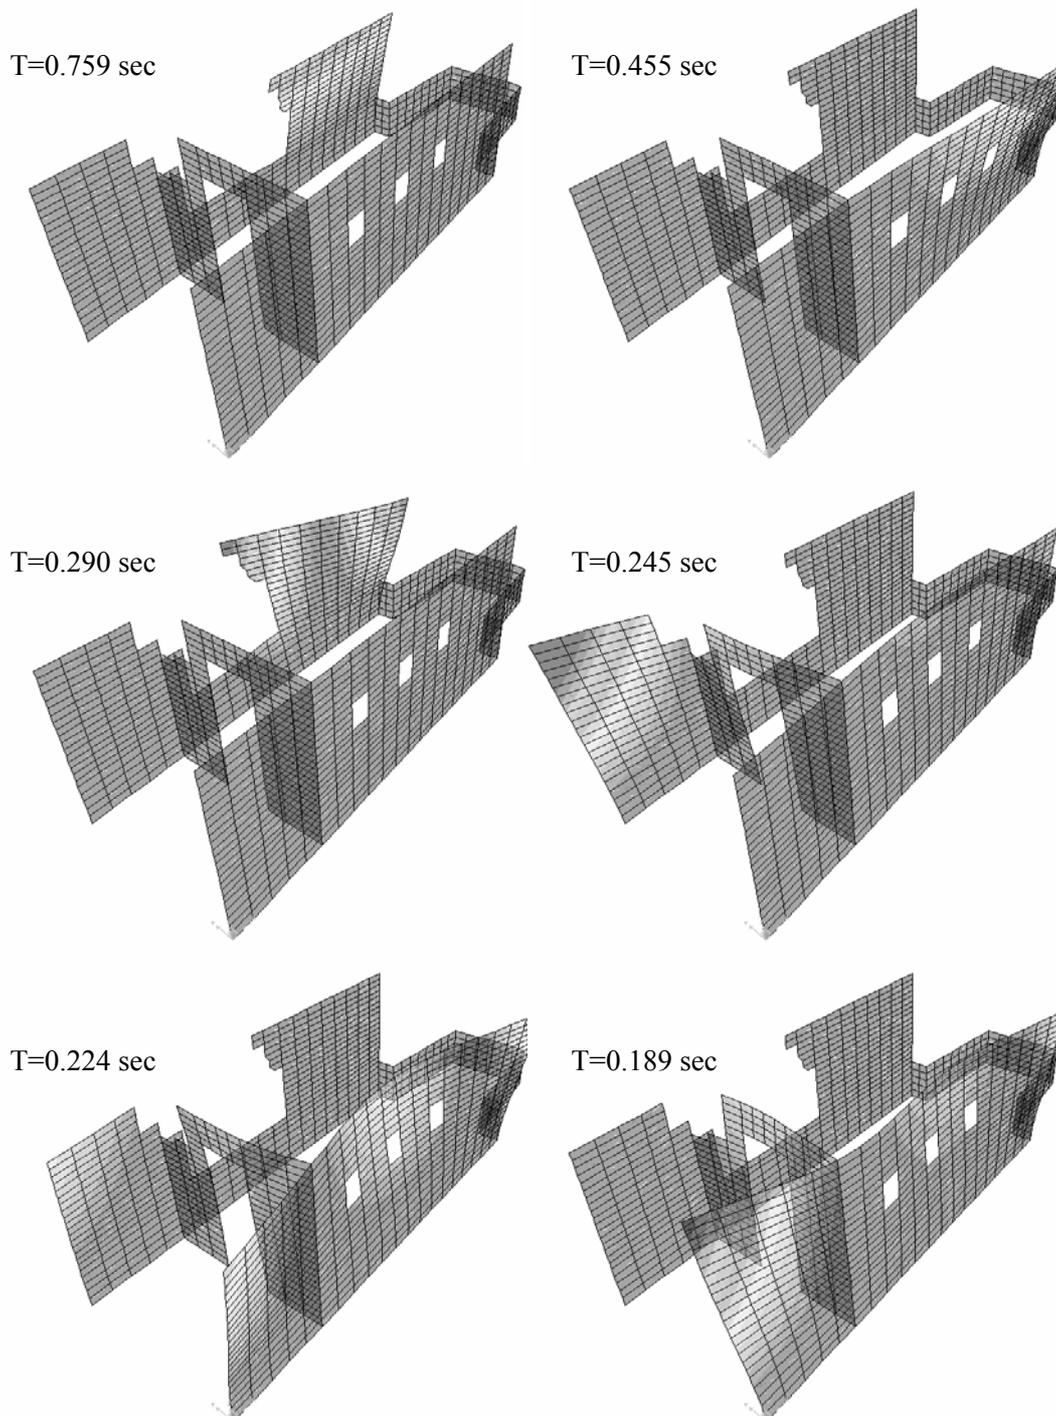
Figure 5 : Calibrated FE model simulated mode shapes

South-West wall, which is located outside the temple gate, has visible cracks which are dominantly excited by the  $T=0.189$  sec (5.3 Hz) mode (Fig. 5) which is also located at the highest range of the response spectrum. A steel mesh-frame might be placed on the South-West wall upper corner to prevent out-of-plane failure and slow down any possible shear failure (Fig. 7). Although the entrance gate lintel was strengthened in the past using steel belts, it presents a dangerous condition (Fig. 7) since the beam is heavy, damaged, poorly supported, and supporting belts are heavily rusted in their current state. For preservation of temple's current state and prevent any further damage to the stone blocks and inscriptions, the temple may be covered using a temporary roof which would prevent rain and direct sunlight exposure while permitting proper ventilation. Two possible roof cover options are shown in Fig. 7.

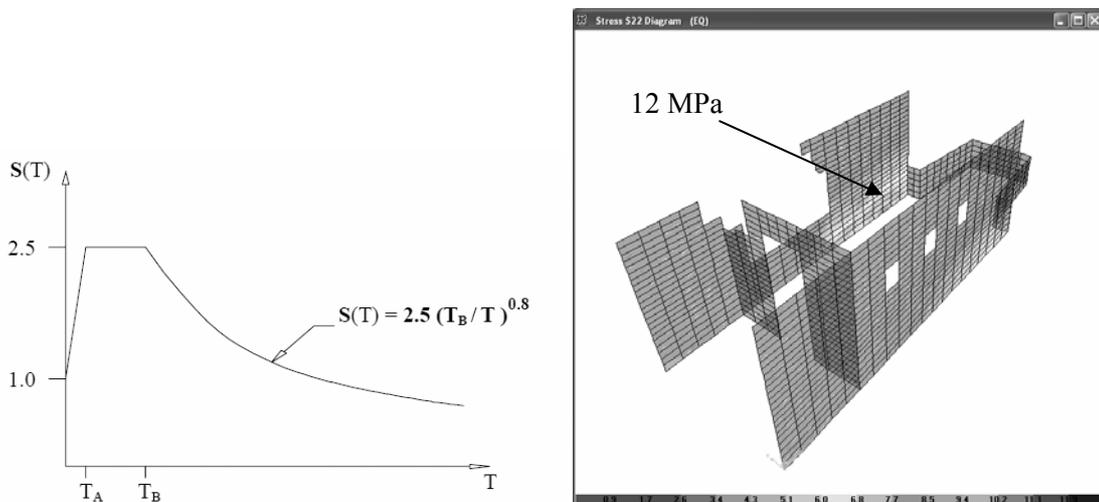
Unfortunately, analytically and experimentally obtained vibration periods of  $0.76 \text{ sec}$ ,  $0.46 \text{ sec}$ ,  $0.29 \text{ sec}$ , and  $0.24 \text{ sec}$  mostly coincide with the response spectrum generated for the site conditions. Considering a dense sand, gravel, or silty clay soil conditions (Type B or C soil, Turkish seismic code, Specifications for Structures to be Built in Disaster Areas, 1997) and Z2 or Z3 site class,  $T_A$  and  $T_B$  are found to be equal to  $0.15 \text{ sec}$  and around  $0.4\text{-}0.6 \text{ sec}$ , respectively. The spectrum coefficient  $S(T)$  comes close to  $2.5$  which is the highest amplification factor in the spectrum for the measured structural periods. The earthquake analysis using the relevant response spectrum and  $0.3g$  ground acceleration (reduction factor  $R$  was taken as  $1.0$ ), maximum of about  $12 \text{ MPa}$  tensile stress is calculated at the base of the North wall. Maximum dead load stress on the same wall is only about  $0.4 \text{ MPa}$  indicating that the stone and its joints will experience excessive tensile stresses, far beyond limits, in the order of  $8$  to  $11 \text{ MPa}$ . About  $2000$  year old masonry construction with missing tension connectors between blocks has no chance but collapse during a possible earthquake. Preventive measures against earthquakes are strongly recommended for collapse prevention. Future monitoring results will reveal wall inclination changes over time which might be affected by busy street traffic vibrations, differential settlement, wind, eccentric support conditions, and/or small earthquakes.

Figure 6 : Turkish response spectrum for earthquakes

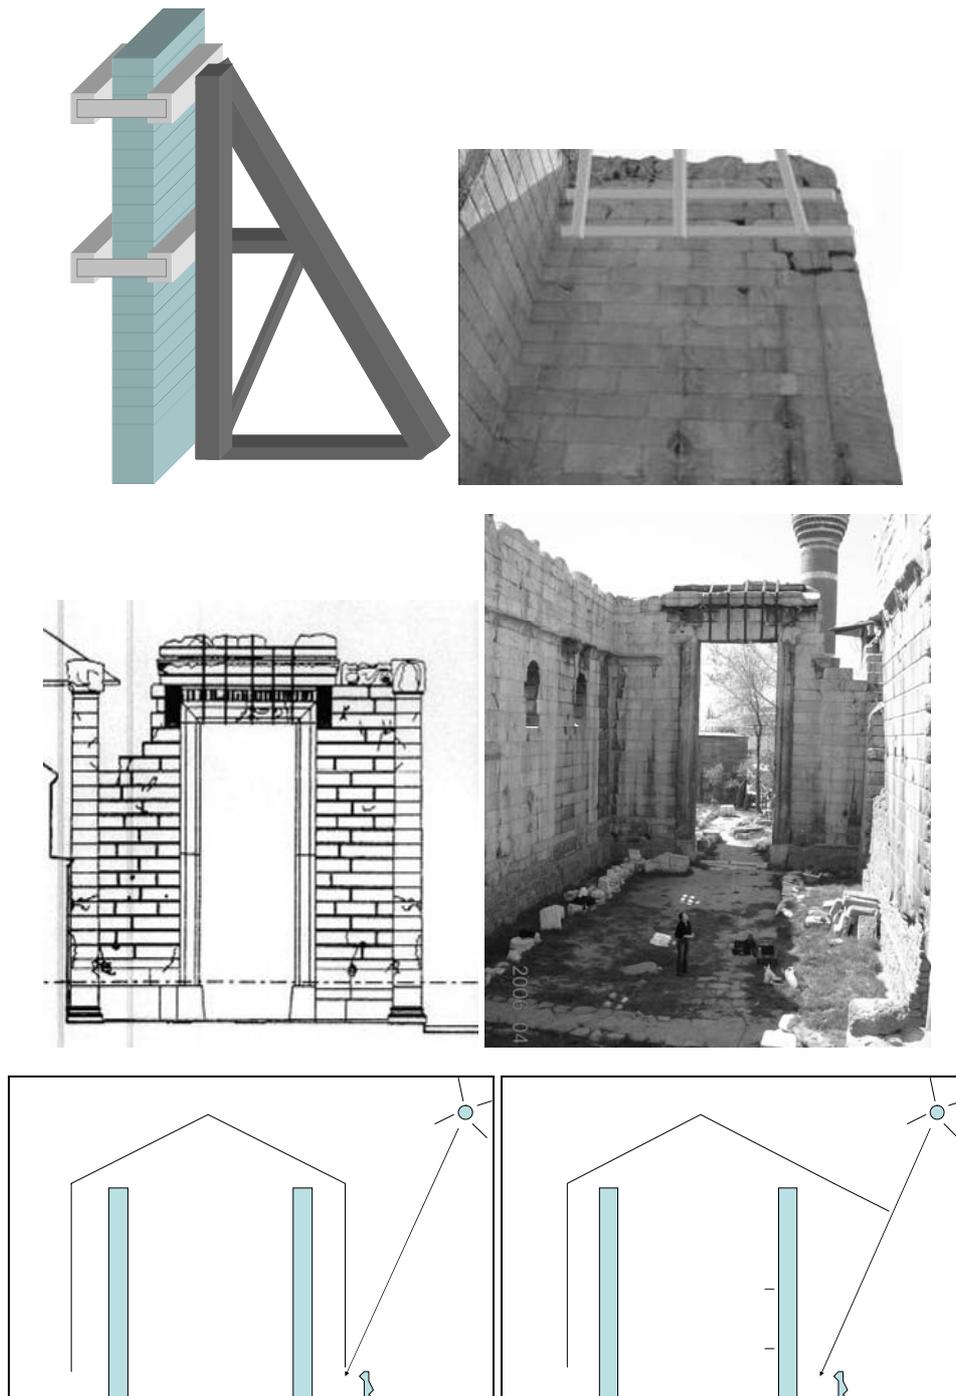
Figure 7 : Possible preventive measures for the Temple of Augustus.
