Structural Intervention in a Historical Chapel

ABSTRACT: The chapel of “S. Jorge de Aljubarrota” was erected in 1393, after the victory in the battle of Aljubarrota, one of the most important battles in Portuguese History because it settled the national independence in relation to Castile. The chapel was built exactly where, on the 14th of August of 1385, the standard of general D. Nuno Álvares Pereira was positioned. Since the foundation, the chapel has experienced several interventions and morphological changes, accurately registered from 1872 to the present time. During the most recent inspection, in 2003, it was observed that the vault of the main altar was severely deteriorated. It was decided to perform a research to identify the possible causes of the observed anomalies; to evaluate the structural safety of the construction; and to propose a solution. Taken into account that consolidation of stone blocks is not possible and that the structural safety of the vault is not assured, minimum intervention is not a choice and a reversible action presents major disadvantages. As a result, the total substitution of the vault is the projected intervention.

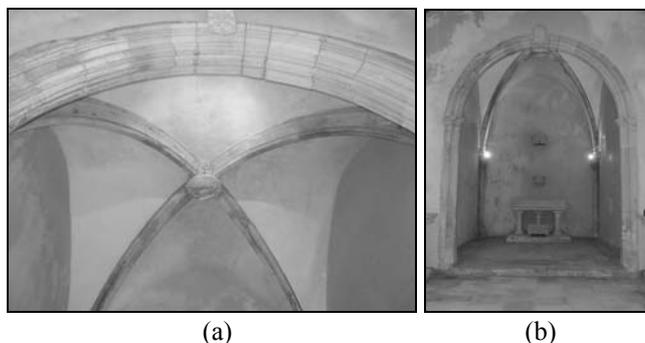
In 2003, due to a high state of degradation of the chapel, an inspection and diagnosis of the situation was performed by IPPAR (Portuguese Institute of the Architectural Heritage). It was concluded that the state of the roof allowed the infiltration of rain water, justifying the moisture spots visible at the vault (Fig. 2a), as well as at the chapel walls (Fig. 2b).

Also in 2003, IPPAR began conservation works on the chapel. Starting the removal of a cement based mortar that covered the vault, for subsequent substitution by a lime based mortar, it was observed that the stone blocks of the vault exhibited a high state of degradation, showing a viscous consistency and a saturated humidity state in depth. It was decided to abort this operation and to cover again the zones where the cement mortar had been removed.

Figure 2 : Moisture spots – (a) at the vault; and (b) at the chapel walls, in 2003, before the intervention.

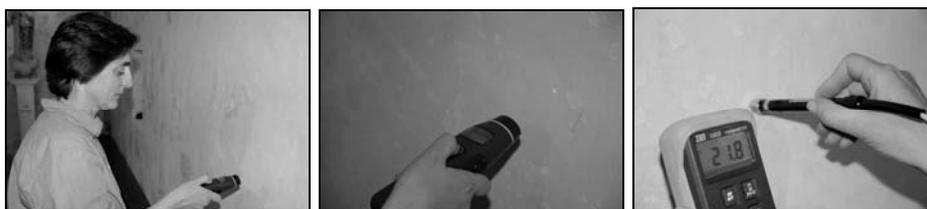
Considering the relative humidity as a decisive factor for the presence of efflorescences and stone degradation, in situ testing of temperature and moisture were performed (Fig. 3). Although measurements were made in summer, the value of environmental humidity inside the chapel varied between 70 and 82 %. Temperature measured inside the chapel did not suffer significant differences, assuming values between 22 and 24 °C, whereas the temperature measured on the walls surface was fixated on 21 °C. According to (Henriques, 2001), for these values of relative humidity and temperature, water condensation on the walls is possible to occur, for a temperature reduction to 18-19 °C.

Figure 3 : Temperature measurements inside the chapel.

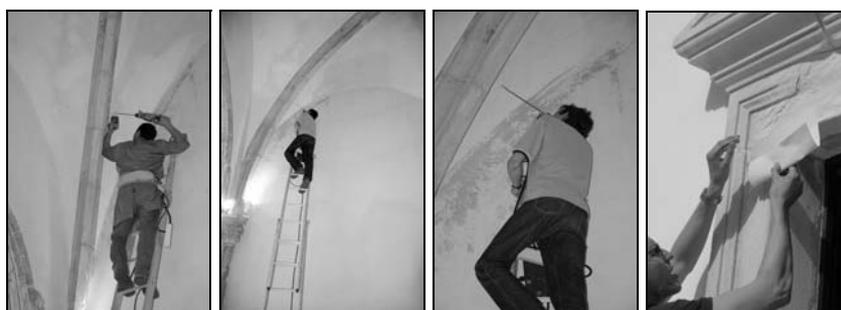
To analyse the state of conservation of the vault, three soundings were conducted at the base (Fig. 4a), followed by a visual inspection using an endoscope (Fig. 4b and c). The level of humidity was measured at the laboratory from samples obtained at different depths and varied between 9 and 12%. The material collected presented a viscous consistency and exhibited a bright color indicating the possible rocky origin.

It was not possible to analyse thin plates of the removed material since it did not present the necessary cohesion. For this reason, only a mineralogical analysis by X-ray diffraction of this sample was performed (Júlio et al. 2006). To obtain a reference for comparison of this rocky material with other in the chapel, a sample was removed from the main door pediment (Fig. 4d).

Figure 4 : (a) Sounding at the vault base; (b) and (c) Inspection with endoscope; (d) Collect of sample from the main door pediment.

Comparing samples it was possible to conclude that limestone of identical composition was present in both, composed by Calcite (CaCO_3), Quartz (SiO_2) and traces of clayey minerals. There was not found any salt in both samples. The macroscopic analysis of the samples allows to state that this material is a white limestone, dominantly oolitic.

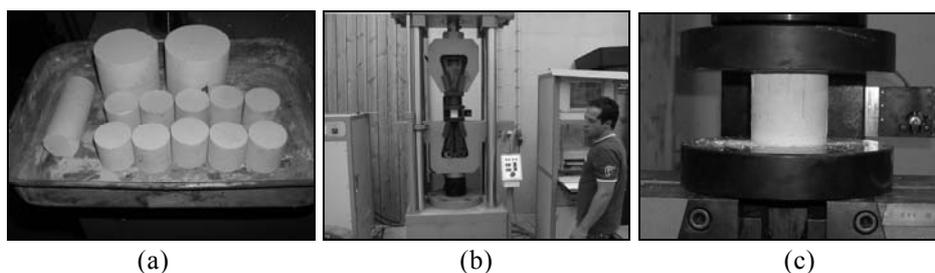
Since it was verified that the stone material removed from different elements of the chapel – vault, walls, and main door pediment – are limestones of identical composition, it was decided to mechanically characterize this material by determining the compressive strength of samples obtained from healthy blocks placed near the chapel during the intervention in 2003 (Fig. 5a). Tests were performed with a universal testing machine (Fig. 5b and c), registering an average value of 58 MPa compressive strength.

Figure 5 : (a) Samples obtained from a limestone block; (b) and (c) Compression test of a sample.

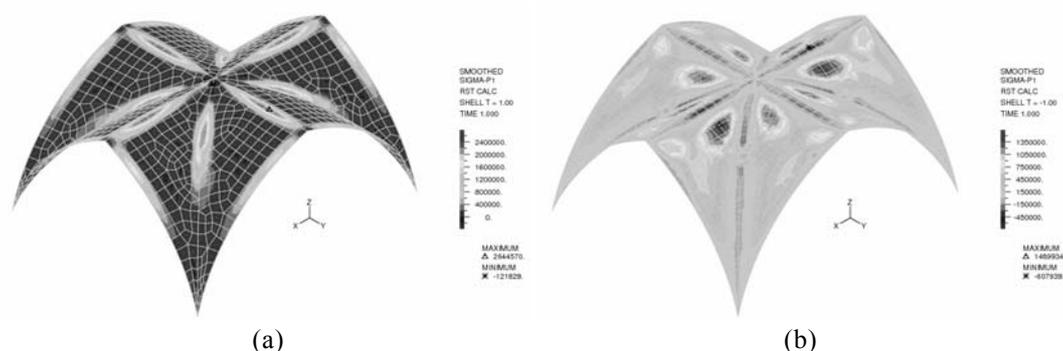
Results, in terms of principal stresses, obtained from the static analysis, i.e. considering the isolated action of the dead weight of the structure, indicate that the level of stresses is, generally, of small importance (Fig. 7). In the case of the highest compression stresses, of approximately 2.5 MPa, this can probably be assured by the mortar layer. However, for the maximum tension stresses, the registered value of 1.5 MPa, especially at the intrados of the vault, should indicate cracking that can not be observed, until now, in place. This fact leads to the conclusion that, in spite of the high level of degradation of the stone blocks of the vault, the self-sustaining capacity of the latter is, so far and somehow, assured. It should be noted that, however, if a decrease of strength and of cohesion of the stone blocks is registered, due to an evolution of the degradation process and/or the change of the conditions of temperature and relative humidity, it will be predictable a progressive disorganization of the mortar layer with eminent collapse of the vault.

Figure 7 : Principal stresses σ_1 at the vault - (a) outer faces; and (b) inner faces.

At the envelopes of principal stresses, σ_1 and σ_3 , for the combinations of actions considering the seismic action, it can be observed, as expected, significant increase of the maximum values of tension and compression principal stresses comparing to the situation of isolated action of the vault self-weight. For instance, it can be observed that tension stresses of around 5 MPa can occur at the inner layer of mortar, which, evidently, can not be resisted by this material.

The numerical modelling of the structural behaviour of the chapel, subjected to the action of its dead weight, was performed assuming the most unfavourable situation: null strength and cohesion of the vault blocks, i.e. considering only the nervures and cement based mortar layer with 3 cm of width as structural elements. From the maximum values of tension in the mortar layer of the intrados of the vault and taken into account the inexistence in situ of these, it is licit to conclude that: (1) the vault has not reached yet the extreme state considered, still having, at least, part of its self-sustaining capacity; this situation is confirmed by the written elements given by IPPAR, referred to the last intervention performed, where it is mentioned that part of this mortar layer was removed and the collapse of the vault has not occurred; (2) in the case of changes in the hygrothermic conditions of the vault, the state of degradation of the stone can develop and approach a critical situation, i.e. a decrease of strength and cohesion of blocks can occur reaching the limit situation assumed in the numerical simulation, which would imply the collapse of the vault. From the dynamical analysis, it also results evident that the stress increase introduced by an intense earthquake will imply the collapse of the vault.

In the case of generalized degradation of the stone, at the surface and in depth, the substitution of the blocks of the main-altar vault is, in this case, the correct option, i.e. the one that best safeguards the monument.
