The Monumental Bridge of Monte Carmelo (Italy): Strategies for the Historical and Architectonical Preservation

Chiara Calderini, Sergio Lagomarsino and Sonia Resemini

University of Genoa, Department of Structural and Geotechnical Engineering, Italy

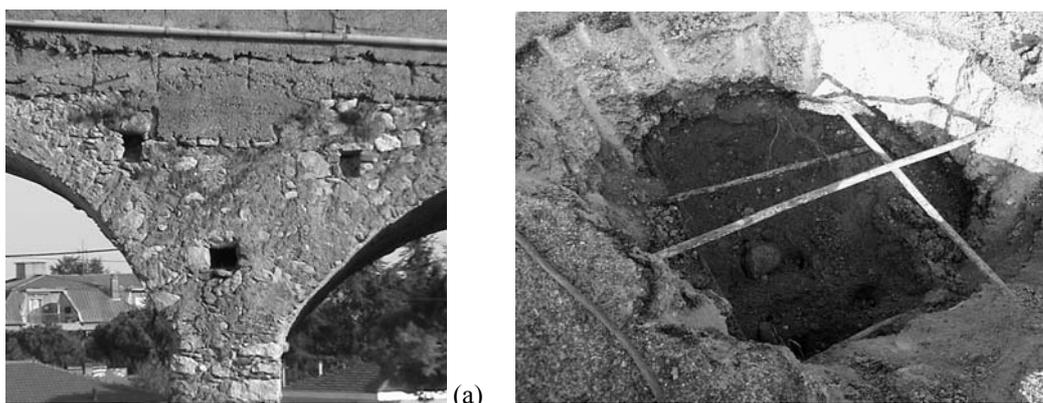
The quality of the stone masonry is low. Actually, it is constituted mainly by poor rubble or river stones, connected by mortar and small stone chips. Masonry appears, therefore, quite uneven and chaotic (Fig. 2a).

Figure 2 : (a) Masonry typology and evidence of the reinforced concrete beams loading spandrel walls; (b) Inspection well on the deck, where it can be observed the reinforced concrete slab.

- construction of reinforced concrete beams positioned in correspondence of each pier, thus loading the spandrel walls; the height of beams is 0.6 m;
- realization of a reinforced concrete slab in place of the original deck (thickness 0.25 m). The slab is supported not only by the concrete beams, but also by the spandrel walls and, in some cases, the crown of arches is loaded; the reinforcements of the slab are bi-directional (Fig. 2b).

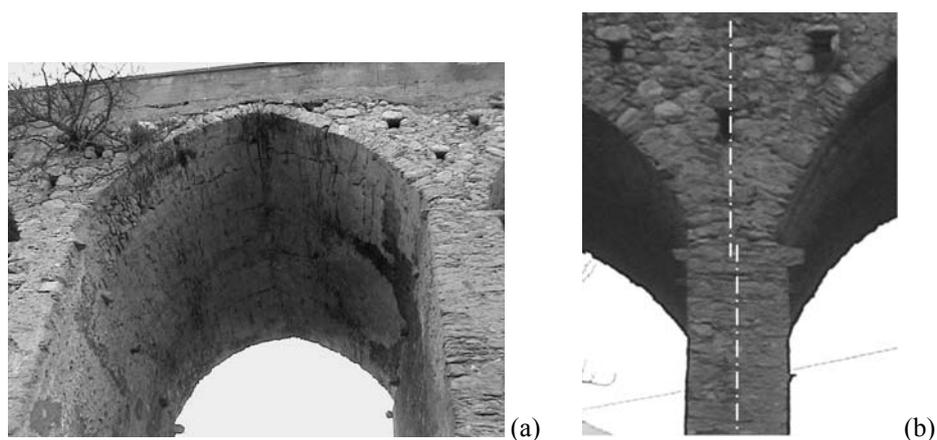
- leaning of piers;
- out-of-alignment of the springings of arches and the top of piers (Fig. 4a);
- remarkable deformations of the arch rings (Fig. 4b).

The cause of the above described phenomena are of different types. The slope of the deck may be considered a “predisposing” cause: as a consequence of the asymmetry of arches, the thrusts acting on springings are not perfectly equilibrated. “Activating” causes may have been the seismic events suffered from the bridge throughout its history. In particular, the following earthquakes should be considered: the earthquake in 1831 and its principal after-shock, whose macroseismic intensities were VI and VIII respectively (Mercalli 1897); the earthquake in 1887 of magnitude $M_s = 6.4$, as to the parametric catalogue NT4.1 (Camassi and Stucchi 1997). The sussultatory components of the seismic shock could have instantly reduced the compressive stress acting on the hingsings of the arches, allowing the arch base to move with respect to the piers.

A remarkable damage was observed in the 5th span (Fig. 4), where the hinging at the crown of the vault may be associated with the effect of the earthquake: the slender piers may have oscillated out-of-phase, bringing nearer and farther the arch springings. The 5th span is exactly in the middle of a set of spans (0-9) with similar dynamical characteristics; the above described phenomenon could have been emphasized from such a specific position.

Figure 4 : (a) Deformation of the arch rings; (b) Out-of-alignment of piers and arches.

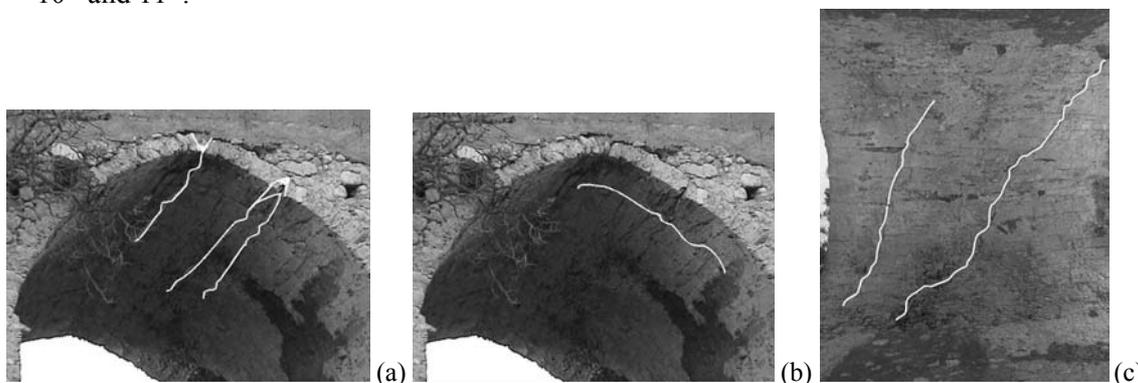
- cracks associated with the formation of hinges in arches (Fig. 5a). Such cracks, in most of the cases, are more clearly visible on the external rings than on the intrados of vaults (such observation is meaningful as far as safety issues are concerned);

- cracks parallel to the longitudinal axis of the bridge, 0.5 m far from the external rings of the vaults (Fig. 5b). These cracks are common in masonry arch bridges. They are usually caused from: the effect of the spandrel walls loading vaults; the building realization of the vaults themselves, involving a different care in the construction of the intrados and of the external arch rings;

- diagonal cracks, at the intrados of the vaults (Fig. 5c); such cracks are uncommon for masonry arch bridge and may be associated mainly to seismic actions. The more remarkable crack is visible under span 9th, while other considerable cracks can be observed under spans 10th and 11th.

Figure 5 : (a) Transversal cracks; (b) Parallel cracks; (c) Oblique cracks (span 9th).

- widespread consolidation of masonry, with the aim of infill the cracks and restore the mechanical behaviour of the material; local interventions are supposed in order to prevent the evolution of specific damage phenomena (e.g. the insertion of a transversal tie-rods, able to limit the out-of-plane movements of the spandrel walls or wing walls).

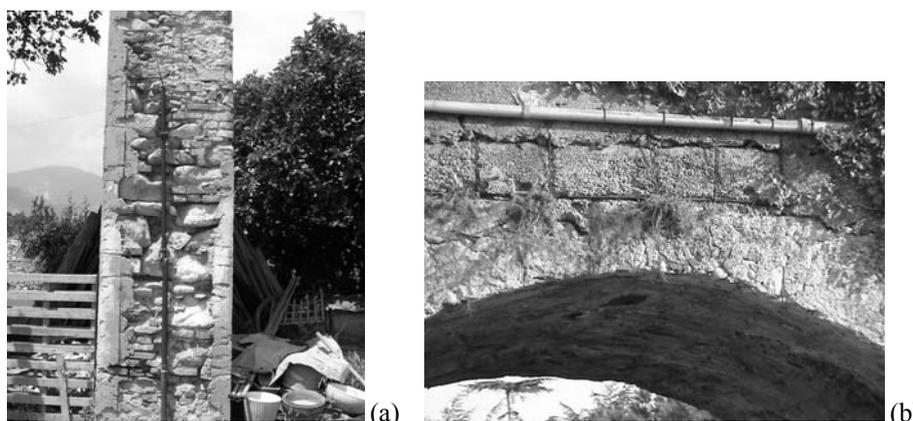
The masonry of the bridge is degraded, with widespread cracks and upsets of stone elements. “Predisposing” cause of such damages is the poor quality of materials and the lack in maintenance (Fig. 6a). However, the current use of the bridge could be another possible “activating” cause. Originally, the bridge has been realized for light and pedestrian traffic. The recent building development of the area produced an increase in traffic. Thus, highest static and dynamic loads burden on the bridge, producing also remarkable vibrations. Probably, these latter are stressed by the presence of the reinforced concrete slab introduced in the 50’s, that produced an increase in stiffness of the deck, reducing the damping capacity of the structure. Vibrations could produce, by the time, degradation phenomena in masonry structures.

The reinforced concrete structure presents some degradation phenomena, particularly located in the external ends of the slab and in the tie-beams connecting the parapets. The “spalling” of the reinforcements is well evident (Fig. 6b). The phenomenon may be associated to an inadequate thickness of the surrounding concrete.

Figure 6 : (a) Degradation of a pier's masonry; (b) Spalling in the reinforced concrete slab.

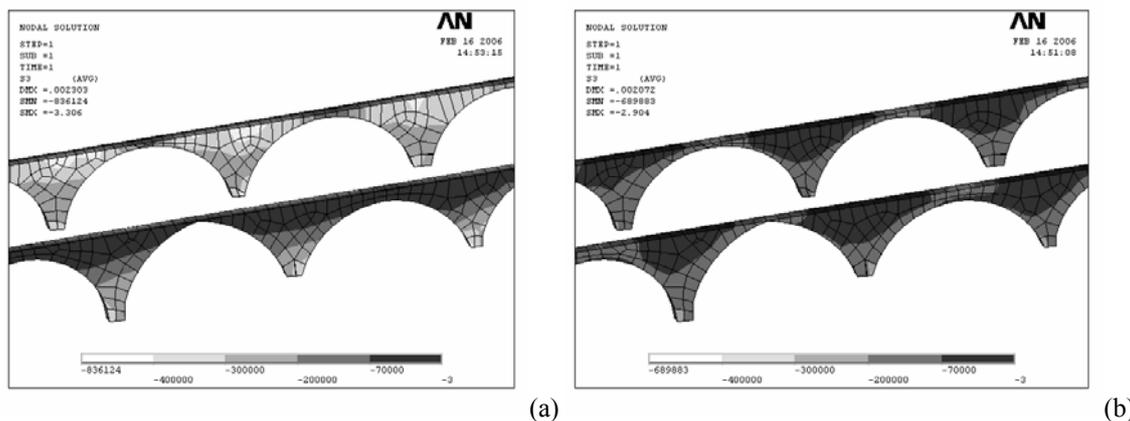
In Fig. 8, the minima principal stresses (compression) in the spandrel walls are represented, before and after the introduction of the concrete structures. Besides an increase in stresses, in the current configuration it can be noticed the bi-axial bending of the spandrel walls associated with the presence of the reinforced concrete beams.

As far as vaults are regarded, even neglecting the typical tensile stresses at the intrados associated with the type of analysis performed (the building phases were not considered), it is important to point out the presence of tensile stresses. It means that, even considering only permanent loads, as a consequence of the deformed shape of arch rings and of the presence of concentrated loads on spandrel walls, the natural compressive stress state of arches have been altered. The maximum value of the vertical displacements at crown in the current configuration is 0.0032 m, while in the original one was 0.0019 m.

Figure 8: Minima principal stresses in spandrel walls (internal and external view) – span 5th and 6th [N/m²] (a) current configuration; (b) original configuration.

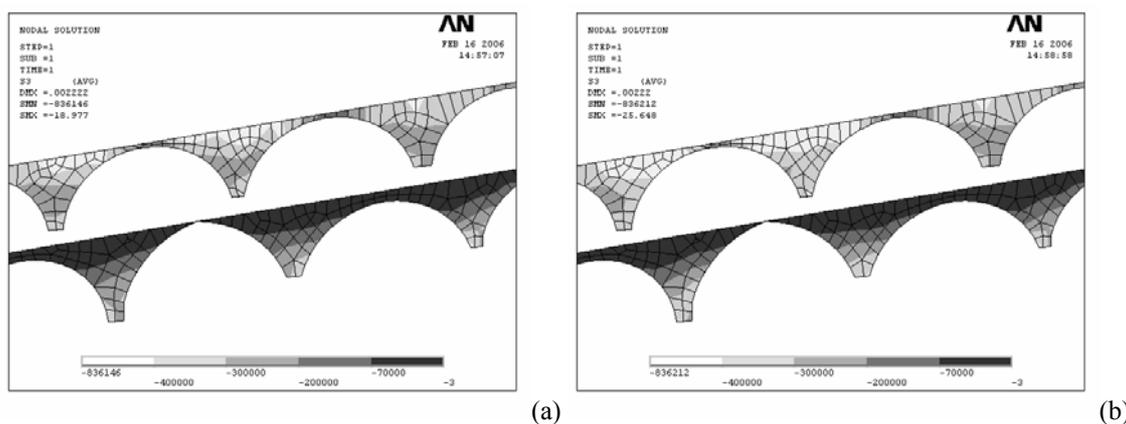
The analyses showed that position 1 is the worst one for the structure. It can be noticed (Fig. 9) that the spandrel walls carry remarkable compressive stresses on the internal side; moreover, the bi-axial bending is stressed.

Finally, the numerical analyses pointed out that, in the current state and considering only the self-weight, the structures carry quite high stresses. Even if such stresses are reasonably far from the safety limits, however by comparing the current state with the original one it can be observed that the compressive stresses are higher in each structural element (vaults, piers, spandrel walls); moreover, the introduction of the concrete structure produced a stress concentration in the spandrel walls, as a consequence of the concentrated loads transmitted from the reinforced concrete beams. On the basis of these considerations, it can be stated that the retrofitting intervention realized in the 50's was inadequate and even harmful.

Figure 9: Minima principal stresses in spandrel walls (internal and external view) in span 5 and 6 [N/m^2] - current configuration: (a) load case A -10000 N; (b) load case B -40000 N.

- restrictions on the through traffic, both in terms of loads (maximum 35000 N) and speed; it is possible to restrict the traffic because a new road, not passing through the bridge, will be constructed;
