Altarpieces Constructive Systems and Material Characterization, SC, Brazil

Maria A. Nunes, Ângela do Valle and Sérgio C.B. Nappi
Federal University of Santa Catarina (UFSC), Florianopolis, SC, Brazil

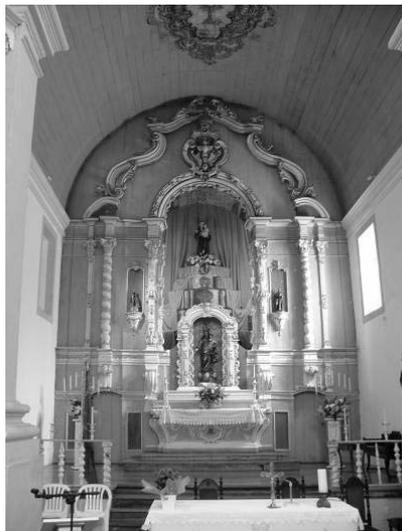
Figure 3 : Nossa Senhora das Necessidades church high-altarpiece.

According to historical sources the altarpiece was built in 1759, and its authorship is unknown. However, through written documentation, local inspection, and results of laboratory analysis, it was verified that various interventions have modified its appearance. It is supposed that its present aspect is the result of a remodelling partially occurred between 1856 and 1862, and completed later in 1956, see Fig. 3.

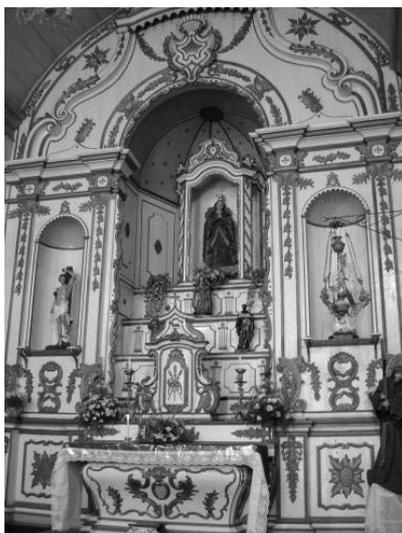
Figure 4 : Nossa Senhora da Lapa church high-altarpiece.

The Nossa Senhora da Lapa Church was consecrated in 1806, situated in Ribeirão da Ilha, Florianópolis and protected by Municipal and State legislation. Its altarpiece is built in polychrome gilding wood and is characterized by presenting simplified carving cut according to the rococo style. During historical files research, data execution and authorship references have not been found. Through inspections in the polychrome layer, it was verified that it has been repainted in the past, see Fig. 4.

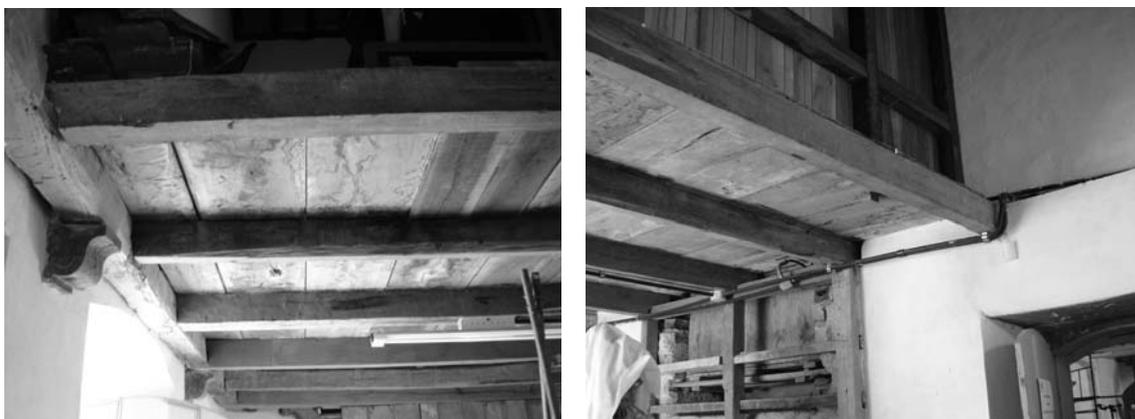
Figure 5 : Nossa Senhora das Necessidade Church altarpiece back.

The Nossa Senhora das Necessidades high-altarpiece front part is separated from the back by a masonry wall. This disposition is classified as an anchorage system wall dependent, since the entablature is fixed at the beam grid and the latter is embedded in the masonry. The ornamental elements are fixed through metallic dowels to the main structure and by means of "L" profiles or wood elements to secondary structural system. Analyzing the tribune anchorage, it could be classified as a merged system since the floor beams extremity is supported by consoles embedded to the wall while the beam middle is carried by struts connected to the floor structure. The extremities beams are supported by the walls, see Fig. 5 and Fig. 6.

During the process of evaluation of the state of conservation of the structural parts of the high-altarpiece, it was found evidence that some parts of it have been attacked by termites. However, no termites were found. It is important to emphasize that there was no loss of mechanical properties of these woods since the attack of termite was superficial.

Also it was verified that specific boards and bars of the wooden floor of the tribune had been attacked by xylophages' microorganisms, causing the appearance of superficial spots, without damaging greatly the structure of the wood. This situation suggests the necessity of periodic maintenance of the roofing and draining system, together with cleanness of the monument and of the spaces, both external and internal. These factors, frequently, may compromise the integrity, security, and authenticity of the cultural heritage.

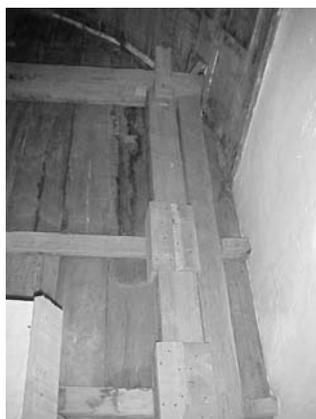
Figure 7 : Nossa Senhora da Lapa altarpiece's anchorage system embedded in the masonry wall.

The back part of the high-altarpiece is supported by a merged anchorage system. The entablature and the ornamental elements are connected to the main structural system. The main upper beam is sustained by the walls and by the struts supported by the floor system. Further that, the structural system was modified during interventions carried out in the past. It is possible to notice some elements superposition, replacement of original struts and beams, some carried out carelessly, see Fig. 7.

Among the pathological problems detected one gives credit that, beyond the attack of termites, the substitution of improper form of structural parts compromises the integrity and the security of the Nossa Senhora da Lapa high-altarpiece. Some joints do not fulfill the function of linking between the parts, meet dimensioned badly and they had not respected the original model.
