Structural Damages in the S. Francisco Church (Évora-Portugal)

A.S. Gago and A.R.G. Lamas

ICIST - Instituto Superior Técnico, Department of Civil Engineering, Lisbon, Portugal

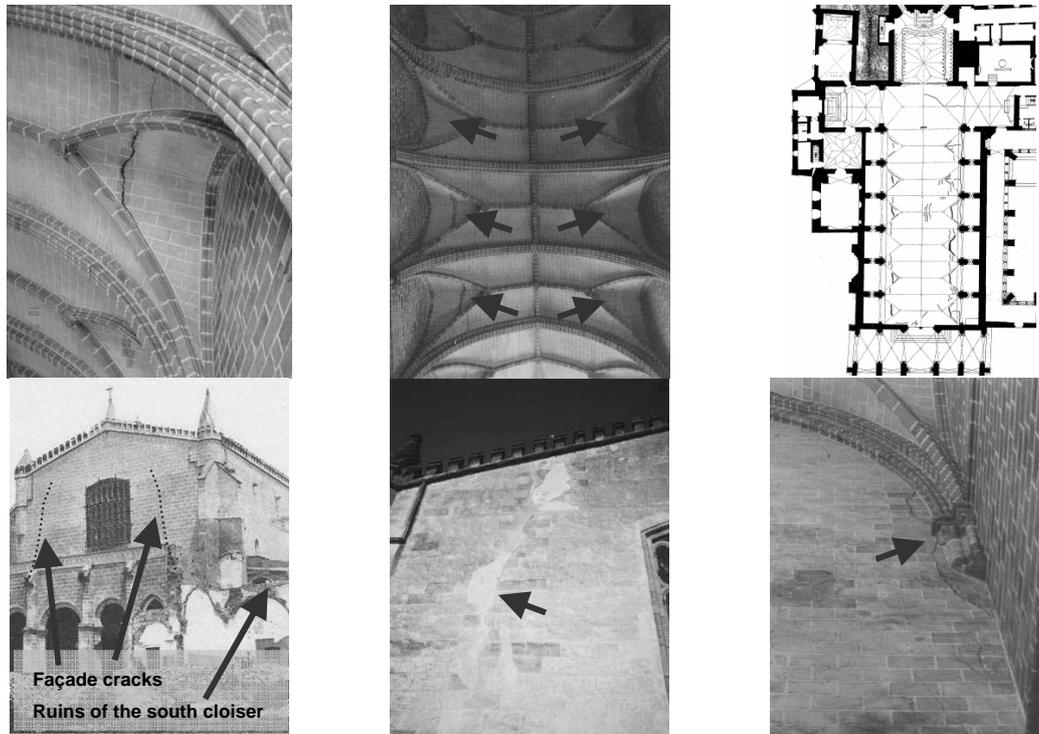
The S. Francisco church in Évora shows, symmetrically, along the nave, full thickness cracks in the intrados of the vault (Fig. 2 and 4). An extension of these cracks is visible on the façade, where two symmetric cracks could also be seen (Fig. 2). The vault cracks (in the doubled curved

surfaces, near the longitudinal walls), and on the façade (on both sides of the central opening) were detected in several inspections during the 19th and 20th centuries [LNEC 1998] and seem to have a slow evolution. The most important historical document about the building damages is a 1884 report by the civil engineer Adriano da Silva Monteiro, describing the cracks which are visible today. According to this report the cracks were already visible in 1834, before to the repairing works of 1860 done by a British architect, John Bouvie Junior. During these works the plaster of the inner face of the vault was repaired and the present appearance, with painted joints to resemble block masonry, is apparently of that time. In July of 1876 Adriano Monteiro did his first inspection and detected the vault cracks which had apparently been repaired by John Bouvie. In May of 1884 he verified no evolution on the width and length of the cracks and stated that there were no signs of threatening danger. However, he recommended to follow the evolution of the phenomenon and to reconstruct the cloister close to the church's south external wall. This recommendation was intended to increase the lateral bracing of the church, since he believed the vault fracture was connected with the outwards movements of the church's external walls. None of the recommendations were not followed and the cloister was completely demolished years later. According to the Adriano Monteiro's report, the existing cracks on the inner face of the nave vault and on the façade, and the cracks detected two hundred years ago have similar localization and dimensions. He also described cracks, aligned with the vault cracks, in the external loading walls which were demolished in 1937 during works on the church's roof (Fig. 3).

Figure 2 : Top: cracks in the nave vault; Bottom: cracks in the façade [left: view of the church during the works in the square in front (1873) where the façade cracks and the ruins of the southern cloister can be seen; centre: external face of the façade wall in 1998; right: present internal view of the façade].

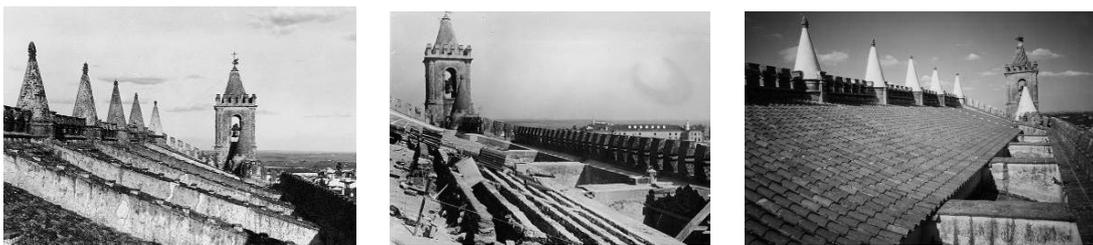
Figure 3 : Views of the church's roof [left: old view with the external loading walls; centre: works during 1937; right: present view]

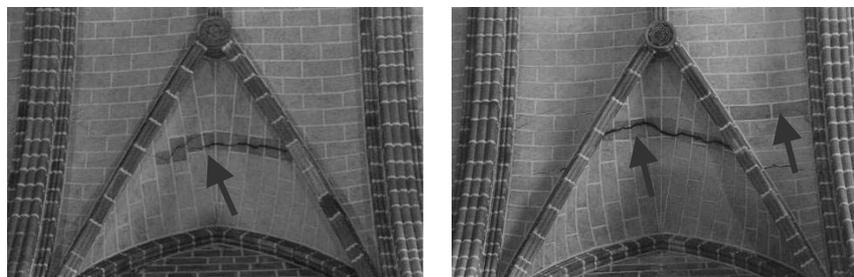
The plaster near the vault cracks exhibits signs of a reparation (Fig. 4), which was apparently done after the 19th century inspection. After this repair the cracks reappeared. In the same way, the façade cracks repaired in 2001 are reappearing today. According to the historical data, the phenomenon seems to be due to the reactivation of old cracks and not to the formation of new ones. On the other hand, since they correspond to those described in the 19th century this suggests a stabilisation of the cracks after some dimension has been reached. Despite this interpretation, it is essential to understand the origin of the phenomenon and to know what is happening on the building. Is the structure moving? Are the crack widths increasing? For that propose a monitoring system was installed, with displacement transducers, in order to record any possible movement of the structure.

Figure 4 : Details of the cracks in the inner face of the vault, where signs of previous reparation of the plaster (darkest areas) can be seen.

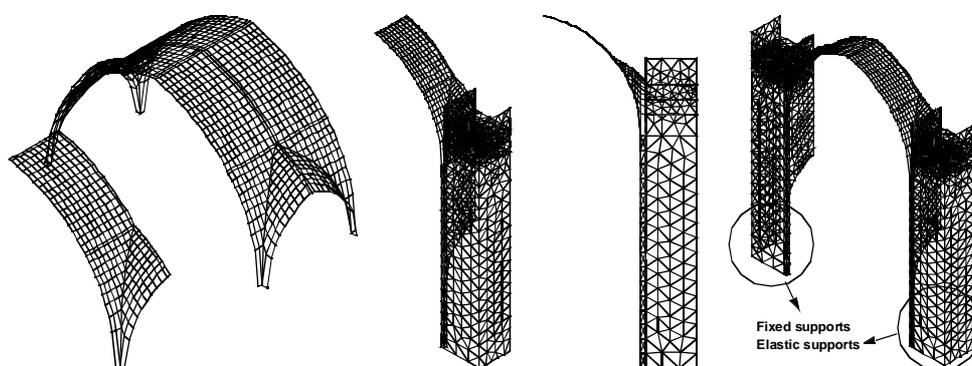
cracks. In order to reduce the number of degrees of freedom, boundary conditions appropriate to simulate the apparent symmetry of the structure were used. A vault module with pin connections at the base was first analysed (Model I in Fig. 5). The objective was to investigate if the origin of the cracks could be related to the simple behaviour of the vault under self weight. The distribution of tensile stresses obtained [Gago&Lamas 2001] suggests a crack pattern different from that observed in the building. This led to the conclusion that the cracks did not appear as a consequence of the structural behaviour of the vault itself.

A second finite element model of the vault and the vertical adjoining structure was then analysed (Model II in Fig. 5), assuming pin supports at the base of this structure. The consideration of the deformability of the vertical structure results in a stress distribution with high tensions developing in directions in agreement with the observed crack pattern. This indicates that an outwards movement of the supporting structure can produce tensile strains on the upper face of the vault and generated cracks. Since the compression stresses on the lower face of the vault are parallel to the cracks, they do not produce any restriction to crack opening, and so the cracks can propagate from the upper to the lower face. This mechanism of crack generation is similar to the mechanism described by Heyman for “Sabouret” cracks [Heyman 1996]. If the cracks were formed on the extrados of the vault and propagated to the inner face, crossing its thickness, wider cracks should be visible below the roof covering. This was confirmed when the roof over

Figure 5 : Preliminary finite element models with elastic linear behaviour [Gago&Lamas 2001]. Left: Model I; Centre: Model II; Right: Model III

Although the cracks are visible on both sides of the vault along the nave, the cracks on the South side are slightly more pronounced. To understand this difference a complete model with fixed supports on one side and elastic supports on the other was analysed (Model III in Fig. 5). It shows that the tensile stresses are much higher on the side near the fixed supports, indicating that asymmetry in the stiffness of the soil foundation or in the stiffness of the vertical wall can produce asymmetry of the crack pattern. The comparison between the small asymmetry of the existing crack pattern with the strong asymmetry of the results obtained with this simulation makes less credible the hypothesis of differential settlements between the North and the South walls.

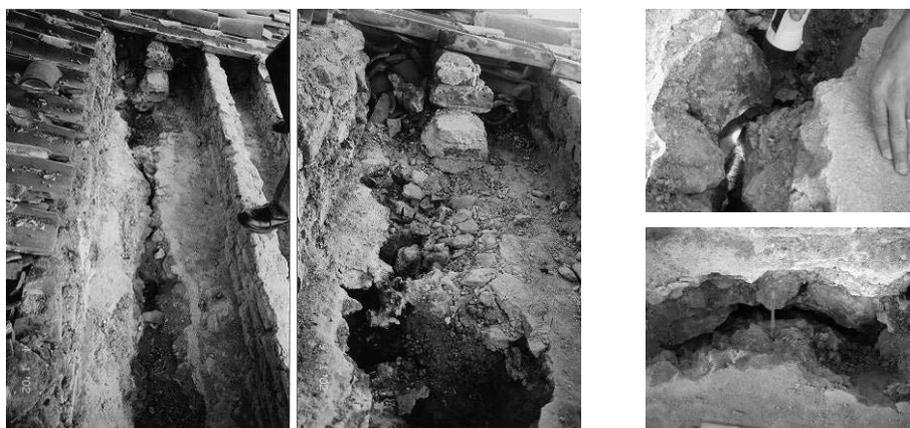
the area of the biggest crack in the vault (about 6 cm wide) was partially uncovered. In fact, after removing the tiles a large crack, about 12 cm wide, crossing completely the vault thickness, was visible (Fig. 6) confirming the described assumption.

Figure 6 : Crack on the external face of the vault

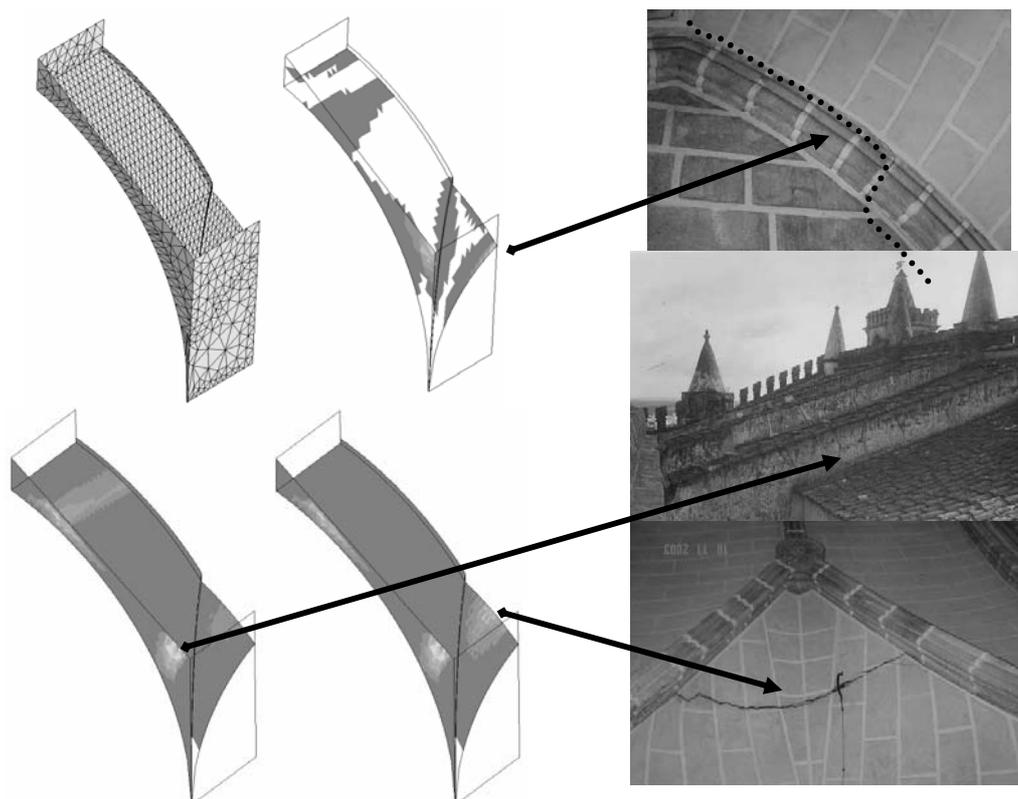
To corroborate the interpretation that the cracks are due to the widening of the distance between the vault supports, horizontal displacements with a linear distribution in height were imposed in the shell model, to simulate a rigid body rotation of the vertical supporting structure around its base. The results (Fig. 7) showed damages in the connection between the vault and the wall for small rotations of the longitudinal wall. As it can be seen in Figure 7, those damages were also detected during the inspections. Increasing the lateral displacements, a progressive redistribution of stresses occurs and damages appear on the upper face of the vault, on the external loading walls and, finally, on the lower face of the vault. The maximum horizontal displacement imposed to the model was 10 cm. During the first inspection (using a crude method) a 10 cm vertical displacement of the top of the southern external wall was measured. This magnitude corresponds to a wall average inclination of 0.4%, which is consistent with that detected during the rigorous geometrical survey. Although the finite element model did not consider second order geometrical effects the results are sufficiently accurate from a qualitative point of view, namely for the prediction of the damages (location, relative intensity and development), and can be used to explain the building behaviour. As it can be seen in Figure 7, the damages simulated by the model and the present visible cracks have similar locations, confirming the preliminary diagnosis: the cracks are due to the increasing of the vault span and they have appeared first on the upper face of the vault and later propagated to the lower face.

Figure 7 : Non linear finite element model with curved shell elements. Top: finite element mesh (left), damages on the lower face of a low level of imposed horizontal displacements (centre) and damages in the connection between the vault and the vertical wall (right). Bottom: damages on the upper face (left) and on the lower face (centre) for an imposed 10 cm top displacement and cracks on the roof walls and on the vault intrados (right).

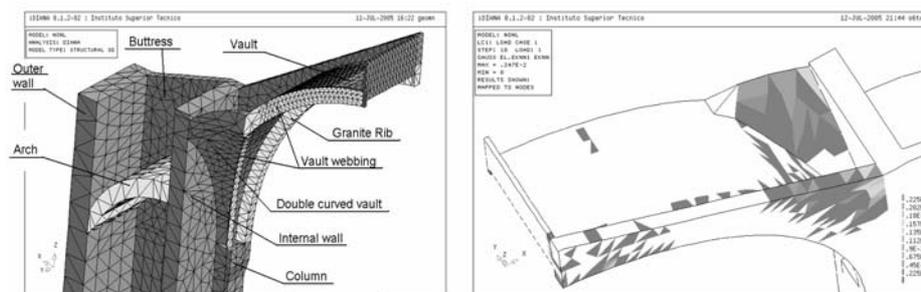
In the solid finite element model a representative part of the structure was simulated (Fig. 8), considering for the different parts (rubble masonry, ashlar granite masonry) different mechanical characteristics. Non linear behaviour (non tension resistance) was only assumed in the vault elements. The results (Fig. 8) have confirmed those of the previous models: cracks on the upper face of the vault appeared when 30% of the self weight was applied, confirming that this load has an important role in the initiation of cracking in that area. As happened in the previous non linear finite element model, with the increment of the dead load the cracks on the upper face of the vault spread to the lower face and damages on the external loading walls appeared.

Figure 8 : Non linear finite element model with solid elements. Left: finite element mesh Right: damages on the numerical model [Apostolov et. al., 2005].

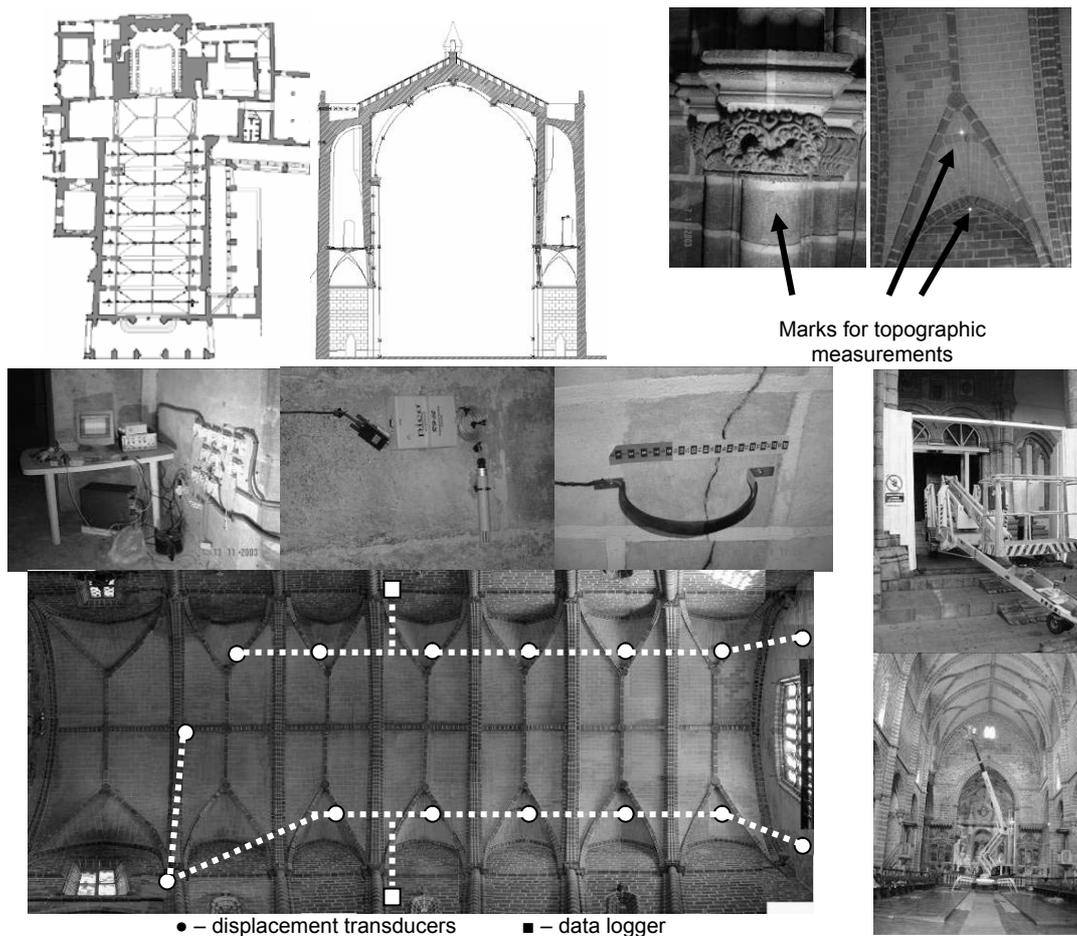
Although historical information indicates a slow evolution of the phenomenon, it is important to confirm if the cracks are or not increasing. For that purpose a monitoring system was placed in the building. During the installation of the displacement transducers, using a special platform (Fig. 9), a detailed survey of the intrados vault surface was done. The cracks were measured, photographed and filmed and the crack pattern recorded in sketches. Each crack in the inner face of the double curved vault, as well as the façade cracks, was instrumented with a displacement transducer (0.1 mm precision). Five devices to measure the temperature inside the walls (10 mm deep) and 4 devices for registering the environmental temperature and humidity were installed at different levels of the church. The system is connected to two data loggers which can daily record the readings. The first results indicate a reduced level of deformation, which can point to a stabilization of the phenomenon. However, the recording must be extended to a longer time period in order to dissociate climatic influences and have secure conclusions.

Figure 9 : Survey of the S. Francisco Church. Top: drawings of the geometric survey and topographic marks; bottom: monitoring system and platform used for inspection and installation.

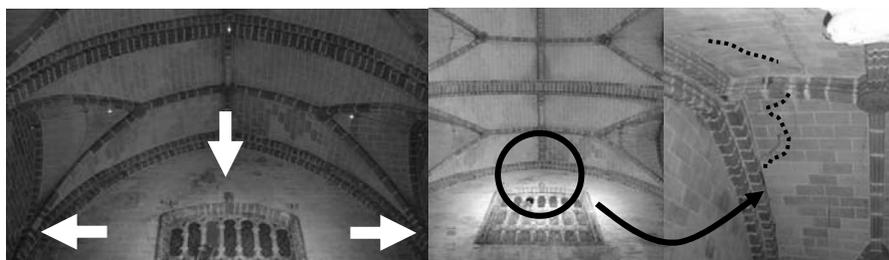
The numerical models show a connection between the cracking phenomenon and the widening of the vault span, due to the vault's horizontal thrust, confirmed by the geometric survey which indicates an outwards inclination of the longitudinal walls. This can be due to the deformation of the vertical structure or to soil consolidation under the foundations. On the other hand, the cracks are less visible near to the transept (Fig. 2), where massive transversal walls limit the horizontal movement of the vault's supports, and more visible in the middle part of the nave, where the transversal bracing is less effective. They are again less visible near the main entrance, where the façade wall limits the horizontal movement of the supporting structure. Near to the façade crushing cracks on the vault crown are visible (Fig. 10). All this can be explained by an increasing of the vault span. It is possible that tension stresses in the upper face of the vault were generated in the first years of the building, when the scaffolding was removed, or years latter, due to the consolidation of the soil foundation and creeping of the vertical structure. However, the first report of the crack phenomenon dates about 3 centuries after the building's construction and there is no information about previous interventions related with these damages. In the beginning of the 19th century the building and the adjacent constructions were abandoned and highly destroyed. Particularly the constructions contiguous to the North and South longitudinal walls, which certainly contributed to their lateral bracing, were in an advanced state of ruin. As a consequence, Adriano Monteiro recommended the reconstruction of the cloister near to the South wall as a measure to avoid the aggravation of the vault damages. Instead, it was demolished, as well as other buildings adjacent to the North wall. This may not have initiated the cracks but by reducing the lateral bracing of the church it has contributed to their widening and propagation from the upper to the lower face of the vault. The cracks became proba-

bly visible in the vault intrados at that time. In the numerical models it is well shown that compression stresses appear parallel to the crack direction on the lower face of the vault. Filling the cracks with mortar does not change the stress paths and the cracks continues to behave like a joint. After some years, the structural movements (due, for instance, to temperature and humidity changes) make the filled mortar to separate and fall from the edges of the crack, and the crack reappears. This is the possible interpretation of the reappearance of the cracks some years after having been repaired.

Figure 10 : Crushing of the vault crown due to the vault span increasing.

The results of the monitoring system will allow a more solid interpretation of the evolution of the phenomenon. The remedial measures to be implemented are dependent of these analyses. If the phenomenon shows any sign of evolution a drastic intervention should be taken. In any case, the reinforcement solution has to prevent the vault span from increasing, and tie rods (connecting the bases of the main arches of the vault) seems the more effective solution. It has a limited esthetical impact and will confer a better structural behaviour for vertical and horizontal loads.
