Structural Analysis of the Church of Sint Lambertus in Maastricht

Ilse A.E. de Vent and Gerrie J. Hobbelman

Delft University of Technology, Faculty of Architecture, Delft, The Netherlands

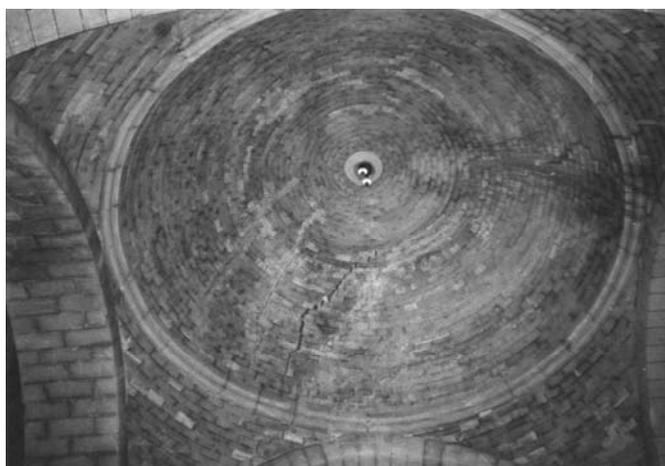
However, in December 1985 the condition of the building deteriorated so seriously that the church had to be closed immediately, see Fig. 3. A new investigation was started, this time also including measuring; in 1988, 1990 and 2001 the level of the bed joints, differential settlements and dilatancies were measured.

Figure 3 : Crack pattern in one of the cupolas.

Concerning the current condition of the building it can be concluded that the combination of huge thrusts and differential settlements has caused the crack development. Especially the southernmost cupola shows large cracks. Furthermore, the model analysis gives evidence that earlier measures had a positive effect, but are not sufficient.

The southernmost cupola is the most critical part of the structure. It has been cracked severely and is about to collapse. Furthermore the crack development is still increasing. By demolishing this cupola, it is possible to cut out the affected spot out of the structure, by which the rest of the building will be safeguarded. The calculations give evidence that this intervention hardly has any negative consequence for the total structure, which is remarkable. From the composition of the building, one could assume that the small cupolas by means of their weight contribute to the neutralisation of the thrusts of the main dome. The demolition of one of these cupolas would, in that case, have had a negative effect on the structure as a whole. Apparently these cupolas are not heavy enough to play a substantial role in the neutralisation or reduction of the thrusts.

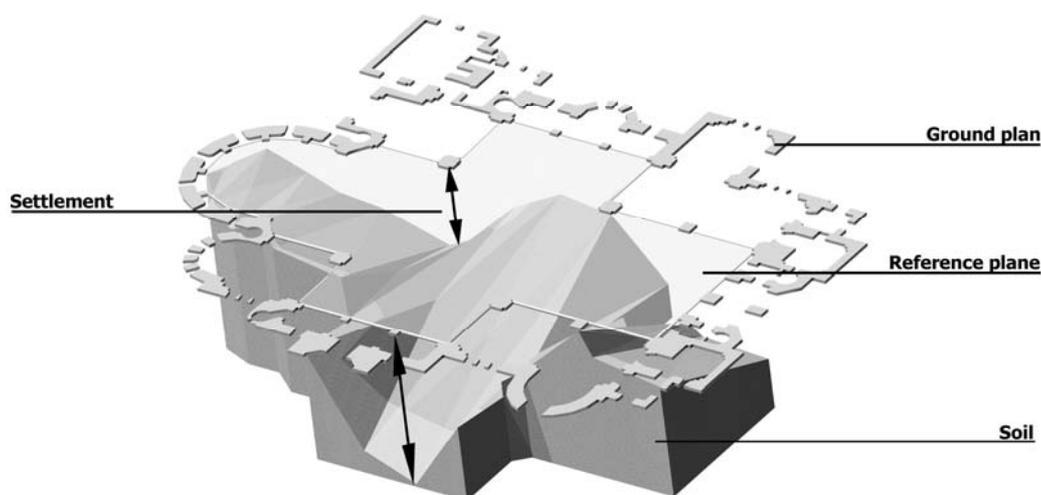
To investigate the cause of the problems more precisely, in this research project a visualisation was made in which the measured settlements were projected enlarged onto the underground, see Fig. 4. This projection shows that the whole building has been subject to settlements but that the most considerable differences in settlement appear at the location of the transept. If this image is subsequently compared with a plan of the former fortifications, it becomes evident that it is precisely this transept that is built on top of a dry moat between two ramparts, see Figs. 5, 6. It can be presumed that the dry moat has probably been filled while levelling the site but that the ground had not been settled sufficiently at the time of erection.

Figure 4 : Settlements visualised as subsidence of the soil under the building.

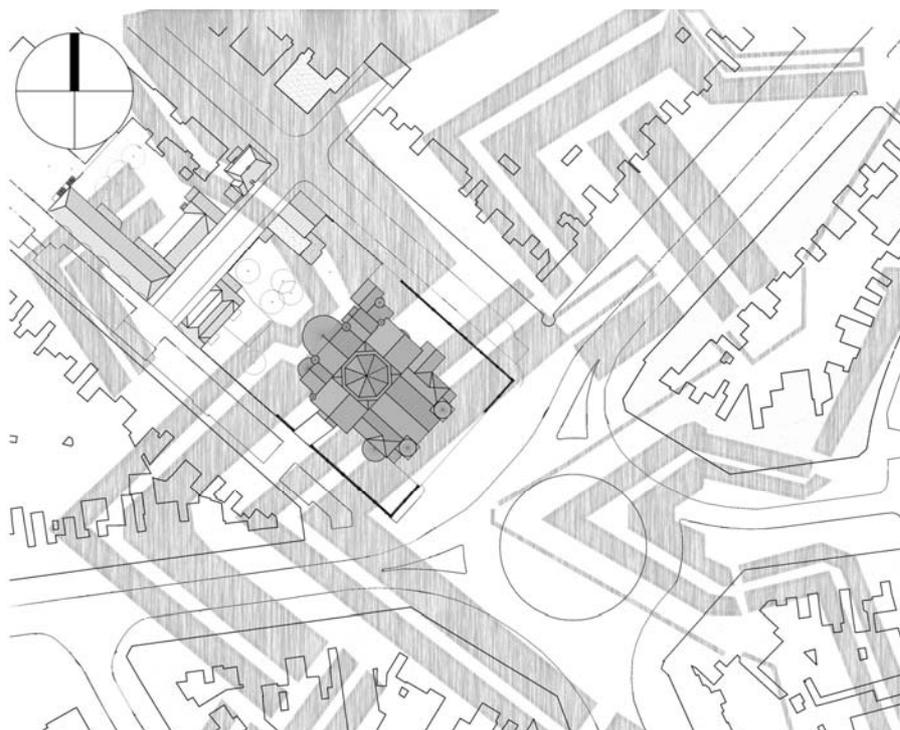
Figure 5 : Site plan with the former fortifications in grey.

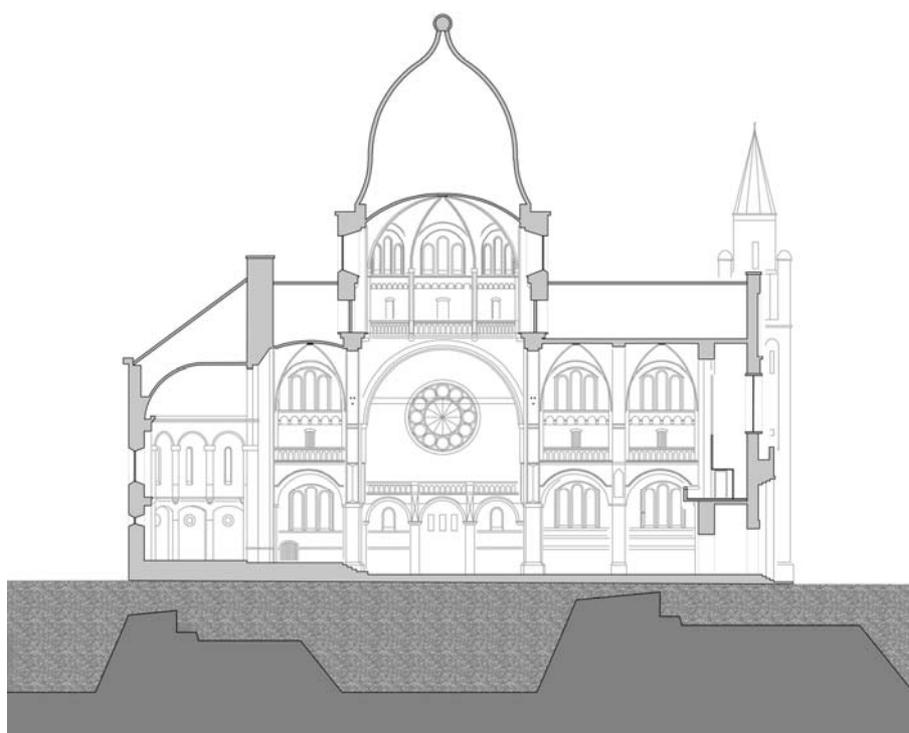
Figure 6 : Cross section of the church with former fortifications in the subsoil.

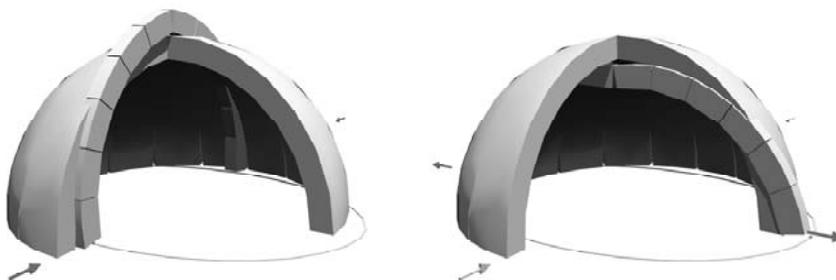
When analysing the resulting displacements of the church of Sint Lambertus in the current situation, it becomes evident that the largest settlements take place in the north-eastern part of the building. However, the most considerable differences in settlement are located in the south-western part. These very differences in settlement will cause crack development. The small cupolas are loaded by the thrust of the main dome in such a way that they are pushed outwards and deform slightly. At the bottom of these cupolas tensile stresses appear on either side of the outwards pointing forces. This will lead to crack development perpendicular to these tensile

stresses, see Fig. 8. The direction of this crack development in the model appears to correspond with the actual cracking in the church building, see Fig. 9. Also the differences between the north-eastern and the south-western part in the model, as shown in the resulting displacements, correspond with the differences in crack development between the various cupolas in the building.

Figure 8 : Crack development in domes due to imposed deformations.

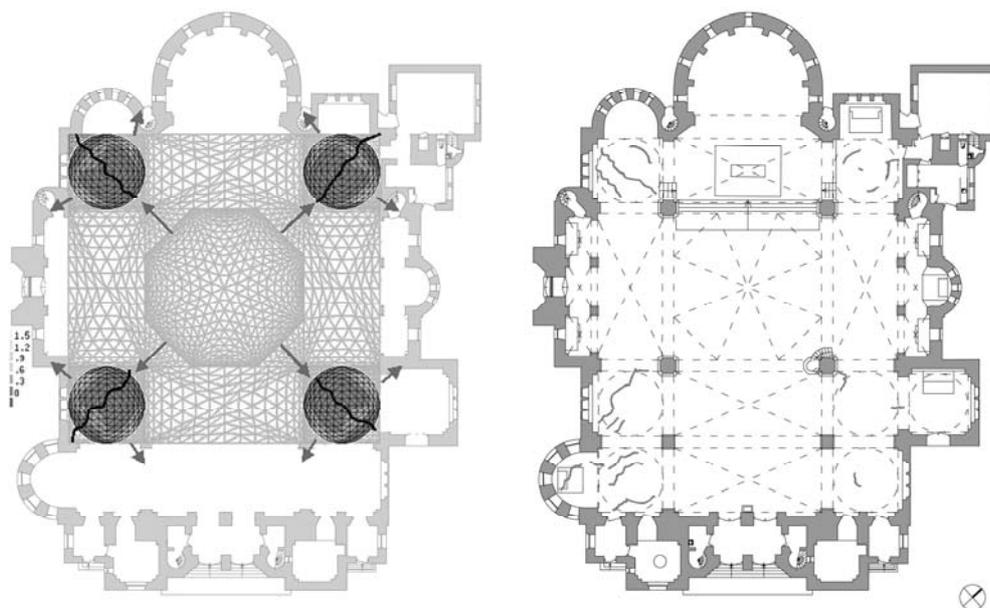
Figure 9 : Left: Tensile stresses; Right: the interrelated crack development.
