A Case Study on the Restoration and Strengthening of a Historic Stadium in China

ABSTRACT: The Jiangwan Stadium, which is a Municipal Level Cultural Relic Preservation Site in Shanghai, was built up in 1935. The structure members were deteriorating with aging although they were repaired for several times. For reserving the original features of the Cultural Relic Preservation Site as far as possible, the principle of the repairing work is eliminating all the unsafe factors in the structure members according to relative laws of Cultural Relic Preservation. There are some defects in the structure members, such as: severe carbonation of concrete; corrosion of steel rebar and breakdown of concrete coverage. In order to eliminate these defects and resume the safe state of the structure, the relative solutions are adopted.

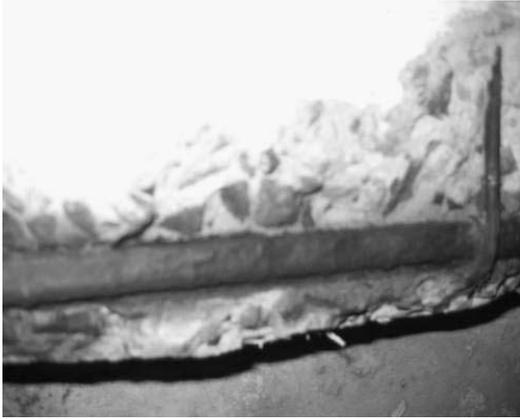
During the last 70 years, the concrete structure members have deteriorated with aging. Strength grading of concrete is very low in general . In several concrete members, Strength grade of concrete is even lower than C15. The process of carbonation has developed out of concrete coverage depth in almost all of beams and columns, which directly led to the accelerative development of steel rebar's rusting. It seems that concrete carbonation and the side effect caused by it occurred more popular in the hypaethral stand of the playing field. An inspection of the building itself revealed that there were some steel rebar exposed in the air with breakdown of concrete coverage and obvious vertical cracks were investigated in some beams' side surface, as figs. 4~5 shown .

Generally, as concrete carbonation has developed for a certain extent, the alkalescent circumstance in the concrete coverage which help to prevent steel rebar from corrosion would be destroyed. As a result, corrosion of steel rebar would develop more adequately. As steel corrodes the iron turns into iron oxide or rust. The rust takes up to four times the volume as the steel. This puts pressure on the concrete and causes cracking and spalling. Then cracks would come into being and even concrete coverage breakdown would occur somewhere, which would lead to farther steel rebar's corrosion. Such-and-such, a vicious circle would go on and on, and the concrete members would deteriorate gradually. From the above all, a conclusion could be drawn that concrete carbonation was the primary cause of concrete member's deterioration. So carbonation rehabilitation should be regarded as the first step and also the most important step of the concrete member's repairing work.

Figure 4 : Steel rebar corrosion

In order to prevent development of concrete carbonation and corrosion of steel rebar, corrosion inhibitor is delivered in a liquid form and spray-applied over the surface of concrete members that are subject to corrosion. Corrosion inhibitor can help to resume the alkalescent circumstance in the concrete members and form a protective coating over the steel rebar's surface, in which steel rebar is prevented from corrosion and concrete carbonation is slowed down Obviously.

In the surface area where concrete coverage breakdown was severe, unsound concrete was removed entirely. To the corroded steel rebar exposed in the air, abrasive method was taken to clean it, and spreaded corrosion inhibitor all over the surface. then high strength mortar was painted to mend it (Fig.8).

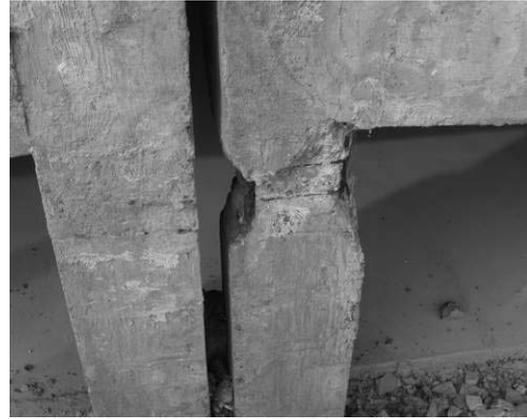
Figure 5 : Breakdown of concrete coverage

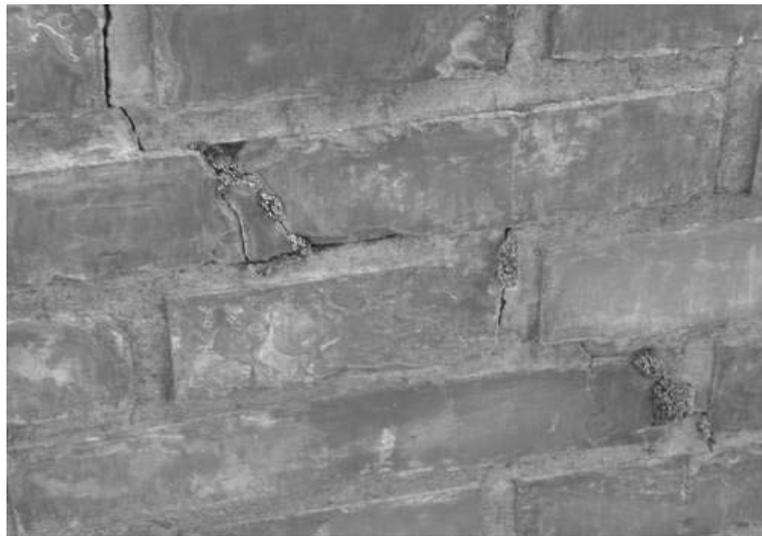
According to the inspection report and site investigation, Strength grade of sand mortar in the brick wall is very low. Moreover, the outer surface of external wall is fair-faced brick wall, and the sand mortar in the exposed joint was weathering more or less. Somewhere in the external wall of Playing field and Gymnasium, diagonal cracks caused by nonuniform settlement or temperature stress can be obviously seen (Fig.6). Fortunately, the cracks were almost stable according to site observation. The filler brick wall hasn't been connected to the reinforced concrete frame by tie bars when it was laid. It seems possible that the filler wall would collapse if earthquake occurs, especially for the external wall somewhere which has inclined outwards slightly.

Figure 6 : Diagonal cracks in the wall

In order to solve the steady problem of external filler wall, strengthening method of bar-mat and cement mortar was applied. Cement mortar surface with steel bar-mat, which was about 35mm in thickness, was attached on the wall's inner side to strengthen it. Steel bar-mat was connected tightly with both the filler wall and the concrete columns and beams (Fig.10). On the four-side boundary between Steel bar-mat and the frame members, steel bar-mat was welded with the bonded rebars which were post-installed into the concrete columns and beams. "L" shape tie-bars, which were post-installed in the wall at one side and welded with steel bar-mat at the other side were applied to attached the filler brick wall to steel bar-mat.

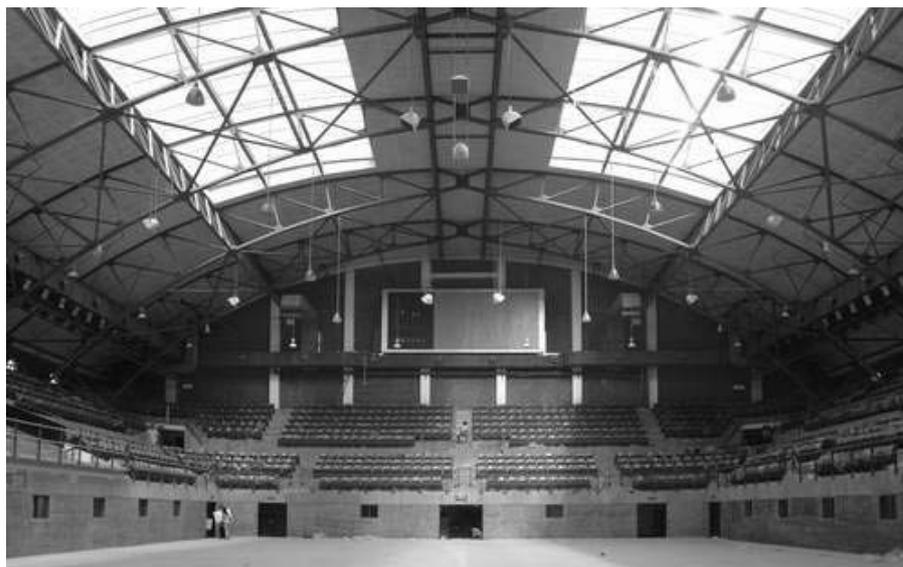
The structure of Gymnasium's roof is steel truss of three-hinged arch (Fig. 7). Although it was designed and built up 70 years ago, the whole steel truss structure looks fairness all the same. The steel truss structure is still normal in work until now except that few steel members were deformed by accidental outside force and some members became corroded slightly.

Figure 7 : Three-hinged arch roof of Gymnasium

In the steel truss roof of the Gymnasium, all corroded steel members were cleaned by abrasive methods, then corrosion-proof paint were painted all over the surface. Few steel member which was deformed severely by accidental outside force was taken placed by new section. Static analysis of steel truss was carried out and the results showed that some lower chords of the steel truss are lack of strength in buckling out of plane. In order to strengthen it, two pieces of longitudinal bracing truss were added at the relative segment. The longitudinal bracing truss was connected to upper and lower chord of steel roof truss with high strength bolt .

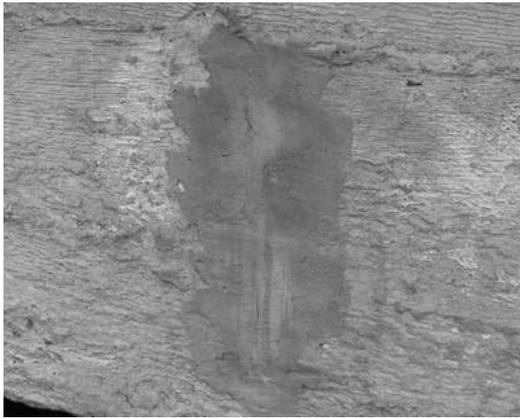
Figure 8 : mend with high strength mortar

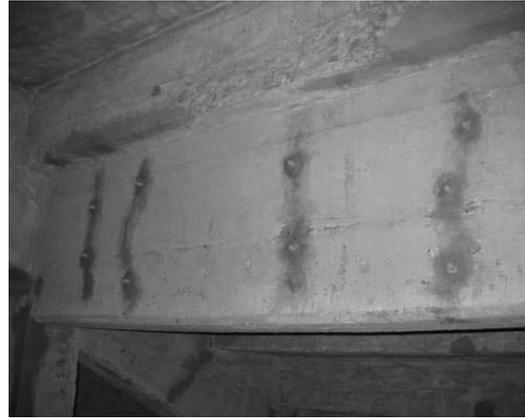
Figure 9 : Cracks treated with grout pipe

A static load test was carried out in the site to find the reason why cracks occurred in some beam's side surface. No development tendency of cracks was found during the test. It can be implied that the cracks were brought out by the temperature stress or the construction joint due to the fact that waist steel was absent in the beams. Therefore the cracks can be considered stable. Cracks on the surface of concrete members were sealed by epoxy resin so that the steel rebar inside the structure would not corrode. To the cracks which were deep and wide ($>0.3\text{mm}$), grout-injector method was adopted and epoxy resin was poured deeply into the cracks by the use of grout pipe (Fig.9).

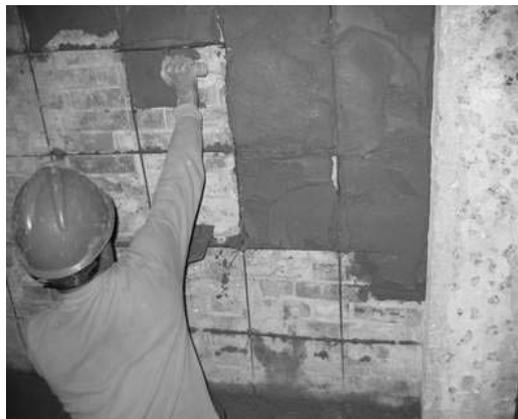
Figure 10 : strengthening method of bar-mat and cement mortar

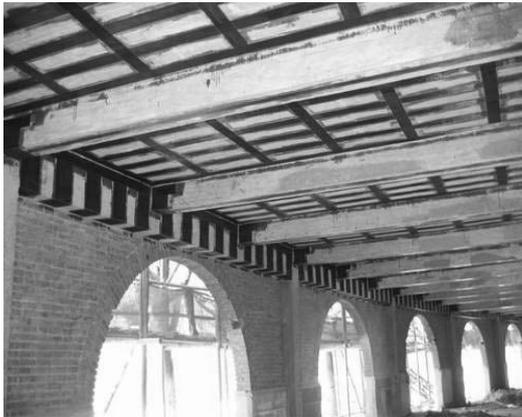
During the structural repair designing, Static analysis of integral structure without the consideration of seismic was carried out, and the corrosion of main structural members was also taken into account. The calculating results revealed that some beams and slabs are underreinforced under the service load according to the existing specification. To the beams and slabs which

Figure 11: CFRP strengthening in slab

were lack of strength or were deteriorated by the corrosion of reinforcing steel rebar, carbon fiber reinforced polymer (CFRP) wrap system is applied to strengthen them (Fig.11, Fig.12).

There were two kinds of carbon fiber reinforced polymer (CFRP) in use : carbon fiber sheet and carbon fiber plate, which was 0.11mm and 1.2mm in thickness respectively. In general, Carbon fiber plate (50mm in width) was externally and longitudinally bounded at the bottom of beam sections over the entire span for flexural strengthening. In stead of carbon fiber plate, Carbon fiber sheet was externally and longitudinally bounded at the upper of beam end sections for flexural strengthening for that carbon fiber sheet was free to bending anchorage at beam end. Carbon fiber sheet was also externally and longitudinally bounded at the upper and bottom of slab sections for flexural strengthening or wrapped over beam section as 'U' shape hoop for shearing strengthening. The clear spacing of carbon fiber sheet hoop is 200mm in general and the width of the hoop is varied from 100mm to 300mm.

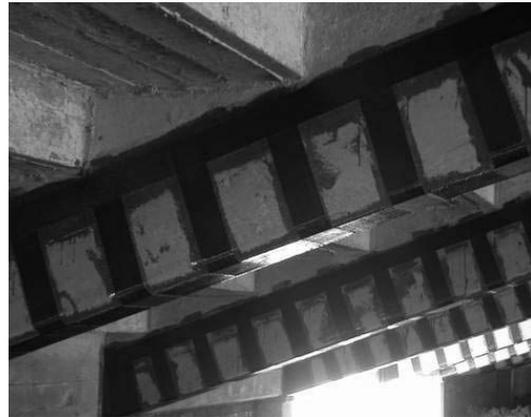
Figure 12 : CFRP strengthening in stand beam

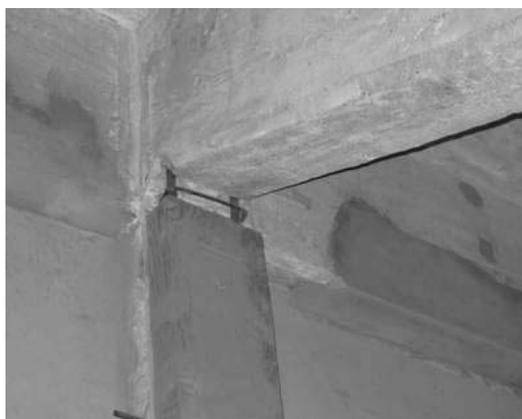
Figure 13 : one-side Enlarging section size

As the calculating results shown, there were some concrete columns overreinforced and some other columns underreinforced. To these columns, the structural solution adopted was the strengthening method of enlarging the member size. The columns which are lack of strength are coated with reinforced concrete to be strengthened. As it was cultural relic preservation site, many architectural elevation and joint were preserved. So the relative columns had to be strengthened by enlarging the section size at three sides or at one side in order to maintain the original architectural features, as Fig.13 and Fig.14 shown.

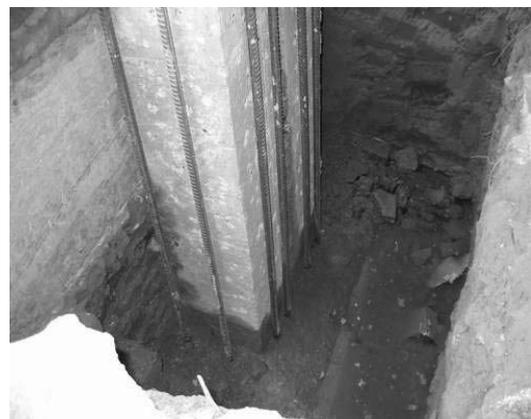
Figure 14 : Three-side Enlarging section size
